# **NORTHWEST ARKANSAS REGIONAL PLANNING COMMISSION**

## **RAZORBACK TRANSIT BUS STOP ENHANCEMENT PLAN**

October 2025 | FINAL

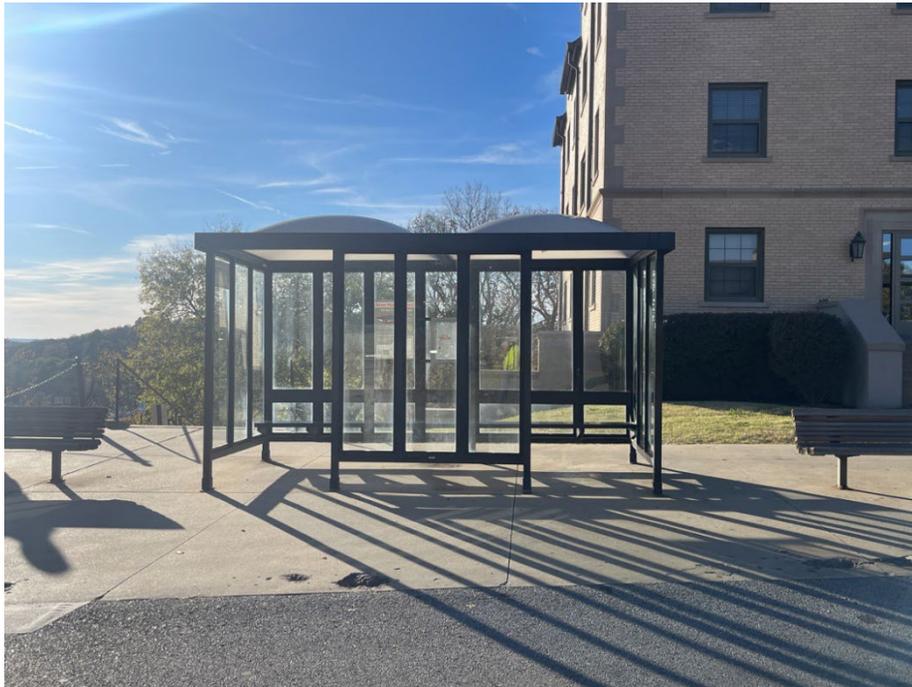
High-ridership boarding stop with a fully built-out landing area, sidewalk access, seating, lighting, and both bike and scooter parking. However, a bollard has been removed from the sidewalk, creating a potential hazard or accessibility issue. Repair or replace the missing bollard to maintain safe pedestrian conditions and prevent unauthorized vehicle access. Ensure the sidewalk and boarding area remain clear and fully accessible.

Weekday Activity	215
Weekend Activity	0
Stop Position	Far-side
Adjacent Property Description	University Hall
Landing Area	Concrete
Sidewalk	Yes
Sidewalk Condition	2 = Poor Shape, some cracks or breaks
Shelter	Yes
Seating	Yes
Lighting	Yes
Bicycle Parking	Yes
Scooter Parking	Yes

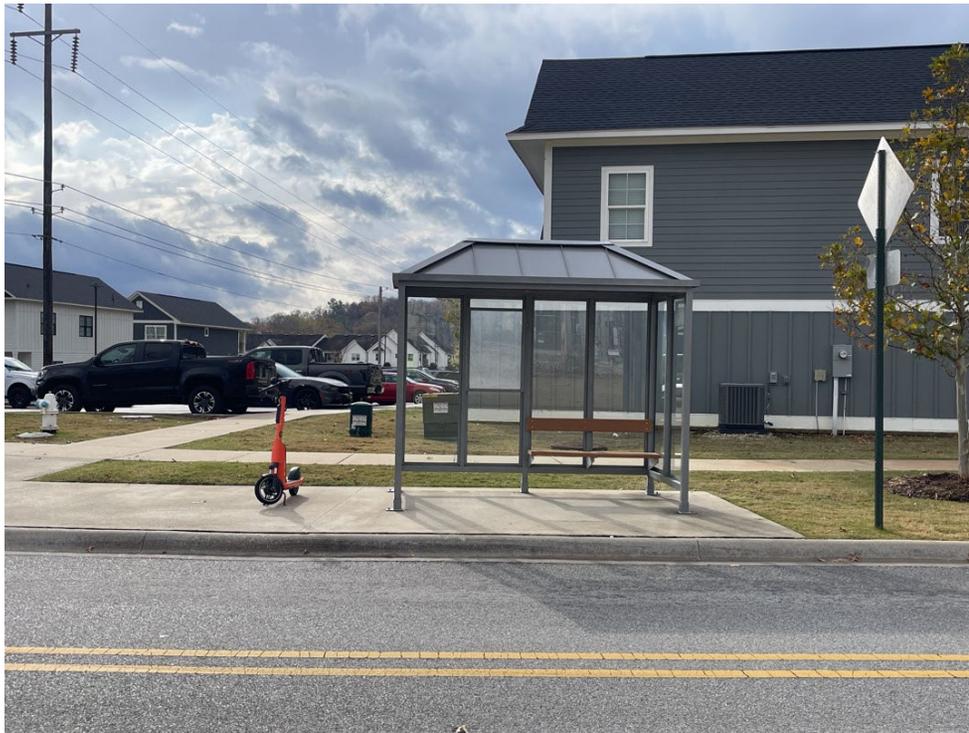
Weekday Activity	38.8
Weekend Activity	0.6
Stop Position	Near-side
Adjacent Property Description	Residence - Townhouse, University Student Housing
Landing Area	Concrete
Sidewalk	Yes
Sidewalk Condition	5 = new or cosmetically excellent
Shelter	Yes
Seating	Yes
Lighting	Yes
Bicycle Parking	No
Scooter Parking	Yes

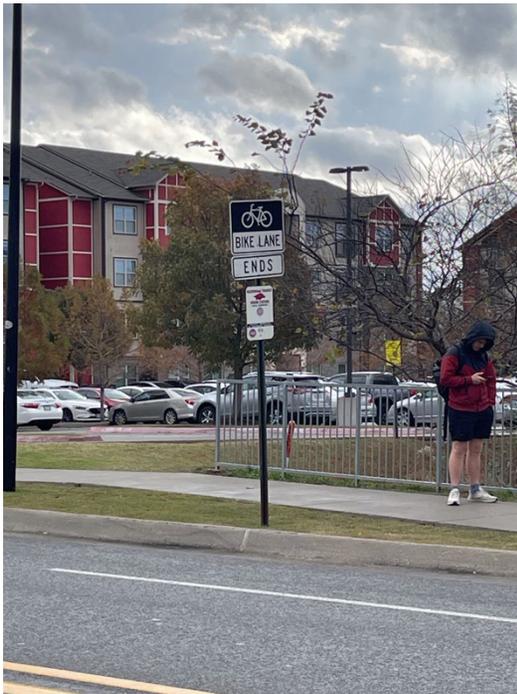
High-ridership boarding stop adjacent to a Park and Ride lot, with boarding occurring from a narrow strip along a driveway. The current sign is mounted on a shared pole and partially obscured, and there is no accessible landing pad, seating, or micromobility parking. The site is not currently shelter ready but could be upgraded with modest improvements. Construct an accessible landing pad with a clear sidewalk connection and install a bench. Add micromobility parking to manage scooters and reduce clutter. Coordinate improvements with nearby stops 149553 and 149556 to ensure a consistent and accessible experience across this segment.

Weekday Activity	56.2
Weekend Activity	2.5
Stop Position	Near-side
Adjacent Property Description	Park and Ride
Landing Area	Concrete
Sidewalk	Yes
Sidewalk Condition	4 = good - No immediate repair
Shelter	No
Seating	No
Lighting	Yes
Bicycle Parking	No
Scooter Parking	No

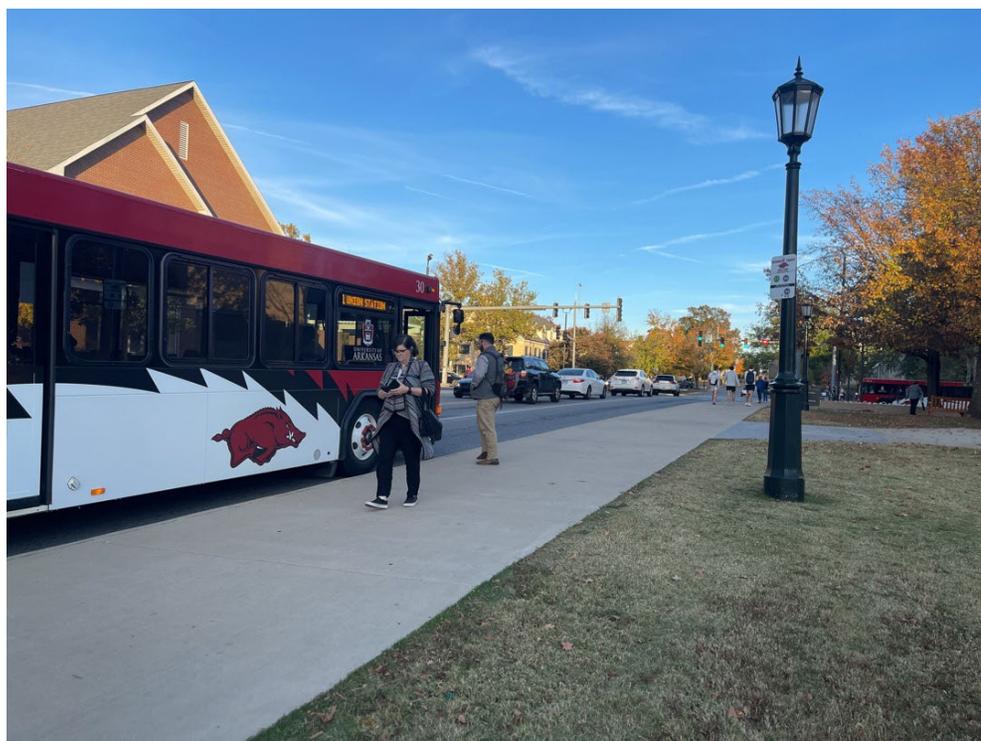
Weekday Activity	314.5
Weekend Activity	2.8
Stop Position	Near-side
Adjacent Property Description	University Hall
Landing Area	Concrete
Sidewalk	Yes
Sidewalk Condition	5 = new or cosmetically excellent
Shelter	No
Seating	No
Lighting	Yes
Bicycle Parking	No
Scooter Parking	No

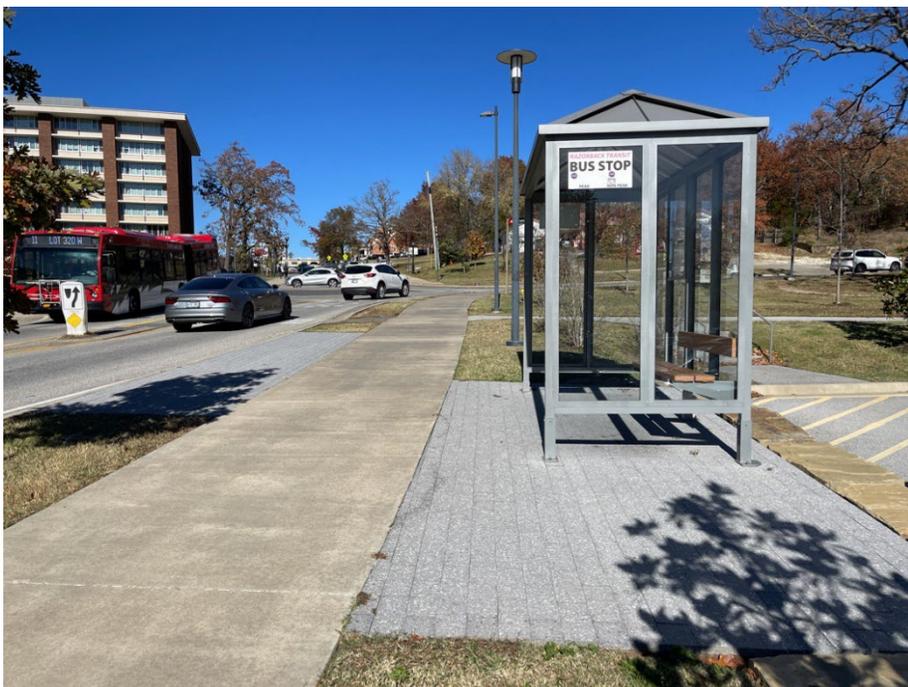
Low-ridership boarding stop located adjacent to Adohi Hall student housing. The stop features a high-quality shelter with seating, an adjacent sidewalk and paver boarding area in excellent condition, and nearby street lighting. While basic infrastructure is fully built out, no dedicated in-shelter lighting or micromobility parking is present. Add in-shelter lighting to improve visibility during early morning and evening hours. Consider adding micromobility parking to support scooter use and reduce sidewalk clutter.

Weekday Activity	12
Weekend Activity	3.3
Stop Position	Near-side
Adjacent Property Description	Park and Ride
Landing Area	Pavers
Sidewalk	Yes
Sidewalk Condition	5 = new or cosmetically excellent
Shelter	Yes
Seating	Yes
Lighting	Yes
Bicycle Parking	No
Scooter Parking	No

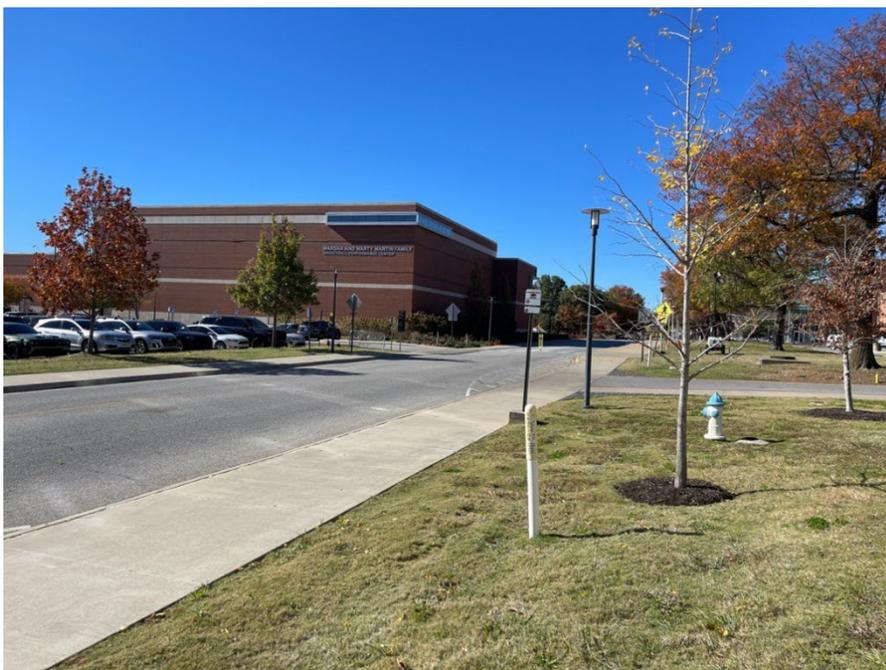
Low-ridership balanced stop located outside Adohi Hall, adjacent to a well-maintained sidewalk with a new landing pad and nearby street lighting. While core infrastructure is in excellent condition, there is no seating, shelter, or designated micromobility parking. The site is situated along a mid-block crosswalk with good visibility and open space nearby that could accommodate additional amenities if needed. Add micromobility parking to accommodate bikes and scooters commonly used in the area. No further improvements are recommended at this time given ridership levels and existing infrastructure quality.

Weekday Activity	5.7
Weekend Activity	2.2
Stop Position	Far-side
Adjacent Property Description	University Hall
Landing Area	Concrete
Sidewalk	Yes
Sidewalk Condition	5 = new or cosmetically excellent
Shelter	No
Seating	No
Lighting	Yes
Bicycle Parking	No
Scooter Parking	No

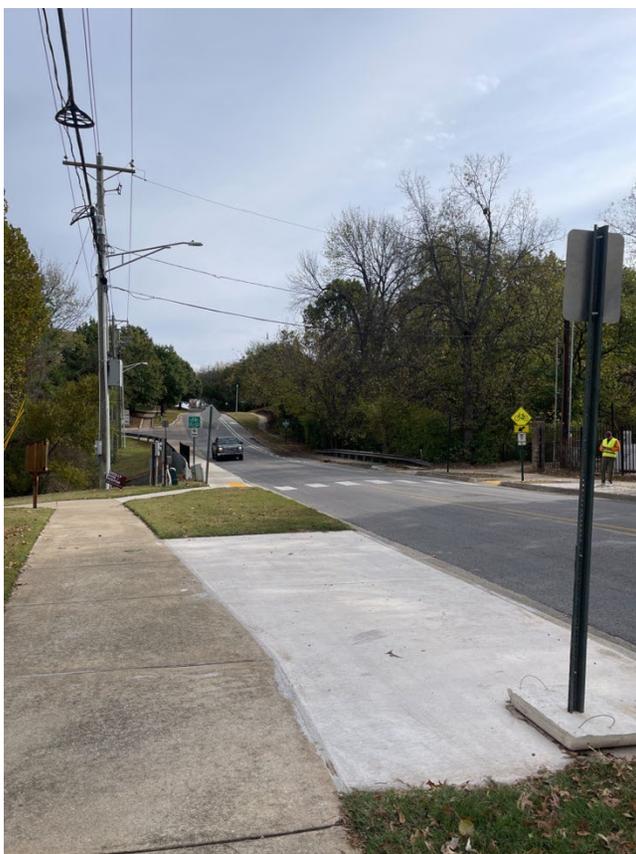
Moderate-ridership balanced stop with an adequate landing area, sidewalk connectivity, and existing lighting. No seating is present. The site is shelter-ready. Install bench to improve rider comfort. Add a shelter to provide weather protection and enhance visibility, leveraging the existing infrastructure.

Weekday Activity	28.1
Weekend Activity	8.3
Stop Position	Near-side
Adjacent Property Description	Apartment Building
Landing Area	Concrete
Sidewalk	Yes
Sidewalk Condition	4 = good - No immediate repair
Shelter	No
Seating	No
Lighting	Yes
Bicycle Parking	No
Scooter Parking	No

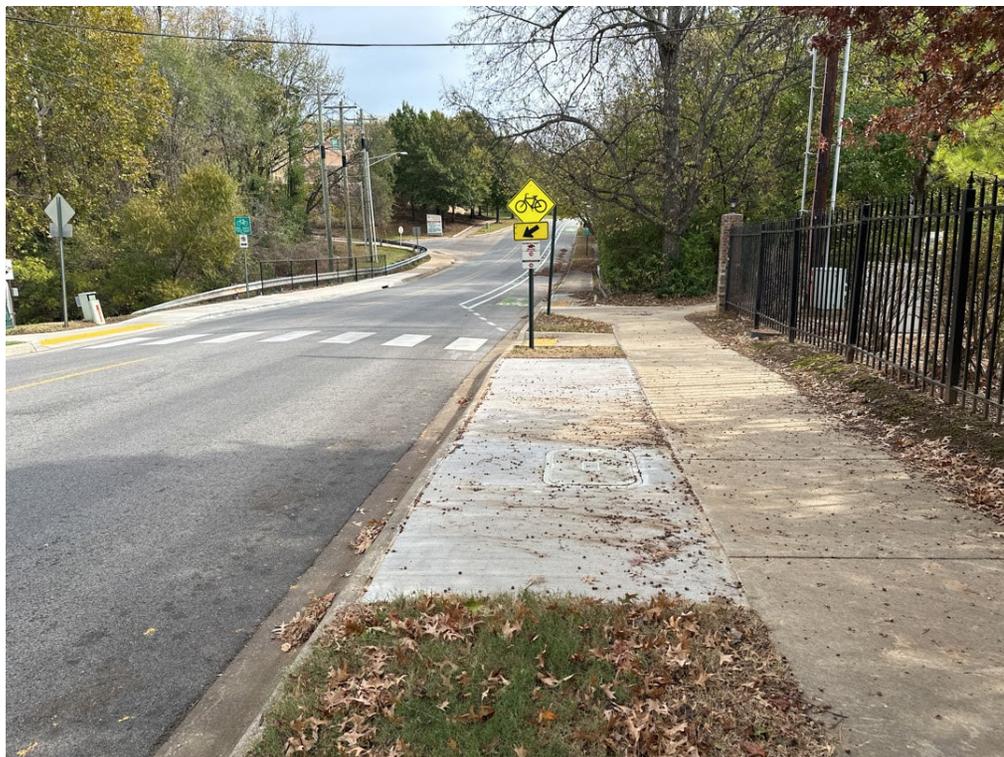
This stop has an adequate landing area, sidewalk connectivity, and existing lighting. No seating is present. The site is shelter-ready. Install bench to improve rider comfort. Add a shelter to provide weather protection and enhance visibility, leveraging the existing infrastructure.

Weekday Activity	
Weekend Activity	
Stop Position	Far-side
Adjacent Property Description	Apartment Building
Landing Area	Concrete
Sidewalk	Yes
Sidewalk Condition	5 = new or cosmetically excellent
Shelter	No
Seating	No
Lighting	Yes
Bicycle Parking	No
Scooter Parking	-

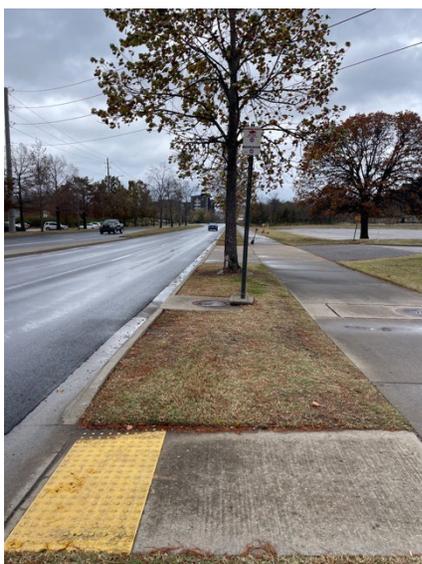
This is a high-impact, moderate-ridership boarding stop located near Baum Stadium, serving multiple peak and non-peak routes. The stop lacks a defined landing area, has no seating, and is partially obstructed by tree roots and uneven surfaces. While lighting is available from an adjacent parking lot, the sidewalk is narrow and borders a sloped grass strip with no formal connection to the nearby Park and Ride. The current location places buses within the crosswalk, posing operational and safety concerns. This stop should be relocated north of the existing driveway to remove the bus from the crosswalk zone. The relocated stop should include an accessible landing area, pedestrian connection to the Park and Ride, and micromobility parking. If space permits, a bench and shelter should be considered to improve comfort and visibility.

Weekday Activity	47.5
Weekend Activity	1.9
Stop Position	Far-side
Adjacent Property Description	University - Sport Center/Stadium
Landing Area	Concrete, Dirt, Grass
Sidewalk	Yes
Sidewalk Condition	3 = Fair - minor root uplifting and breaks
Shelter	No
Seating	No
Lighting	Yes
Bicycle Parking	No
Scooter Parking	Yes

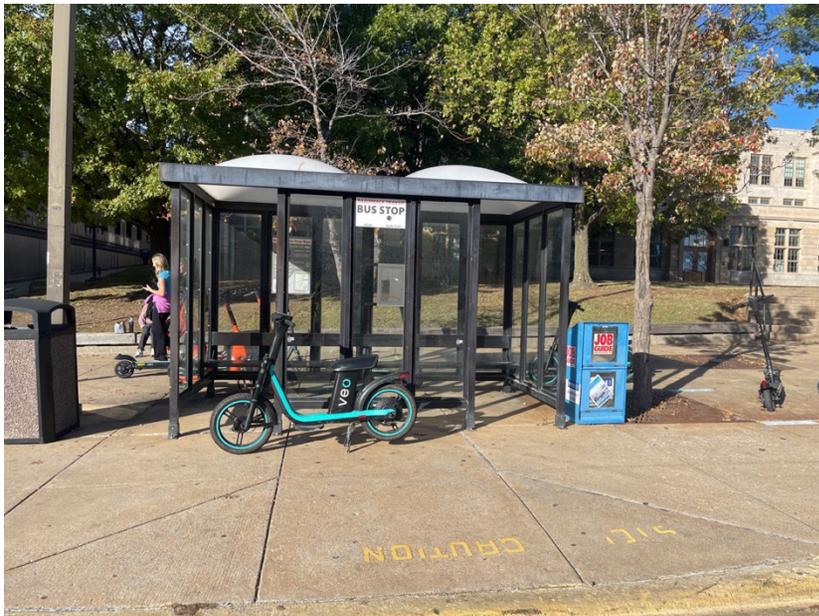
Moderate-ridership stop adjacent to the Bell Engineering building. The site includes a shelter but has limited accessibility for wheelchair users due to shelter orientation and pull-out design. There is no dedicated micromobility parking, and the surrounding area experiences high scooter and bike activity. Upgrade the shelter to improve wheelchair access, particularly when the shelter reaches the end of its useful life. Convert the stop from a pull-out to an in-lane configuration to simplify operations. Add marked micromobility parking and consider covered bike and scooter facilities to support multimodal use. Conduct a deeper site review due to its function as a loading zone.

Weekday Activity	26.5
Weekend Activity	0
Stop Position	Near-side
Adjacent Property Description	School
Landing Area	Concrete
Sidewalk	Yes
Sidewalk Condition	4 = good - No immediate repair
Shelter	Yes
Seating	Yes
Lighting	Yes
Bicycle Parking	Yes
Scooter Parking	Yes

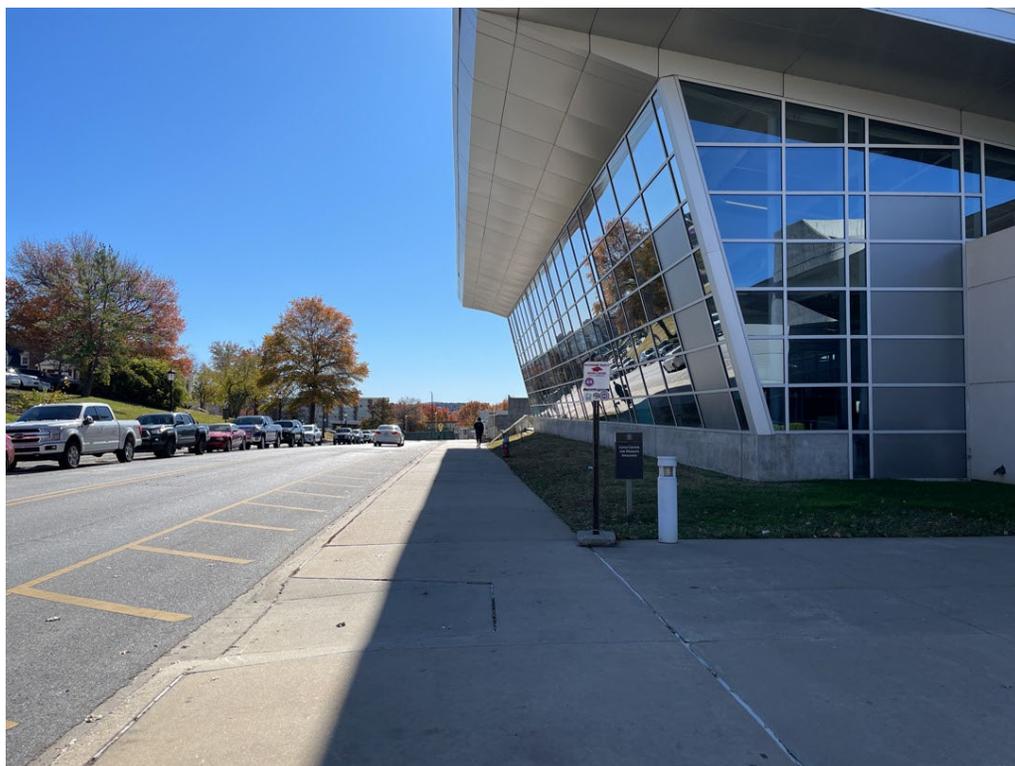
Low-ridership stop near the Bev Lewis Center, currently lacking a defined, accessible boarding area. Boarding occurs directly from the street or grass, which presents safety and accessibility concerns. Construct a landing pad to provide a safe and stable boarding area. Ensure the pad connects to any nearby sidewalk or pathway to support accessibility.

Weekday Activity	1.1
Weekend Activity	0.3
Stop Position	Near-side
Adjacent Property Description	University - Sport Center/Stadium
Landing Area	Concrete
Sidewalk	Yes
Sidewalk Condition	3 = Fair - minor root uplifting and breaks
Shelter	No
Seating	No
Lighting	Yes
Bicycle Parking	No
Scooter Parking	No

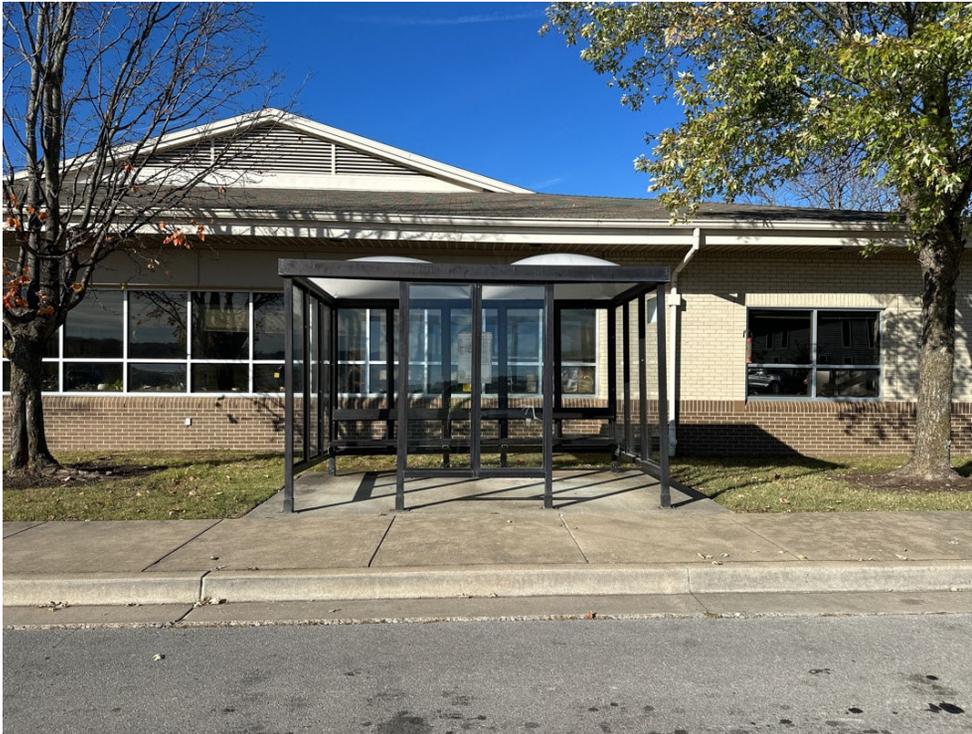
Moderate-ridership stop located near a trail connection, currently lacking a defined landing pad and bike parking. The absence of infrastructure limits accessibility and multimodal integration. Add a bike rack to accommodate trail users and encourage multimodal connections.

Weekday Activity	32
Weekend Activity	1.6
Stop Position	Mid-block
Adjacent Property Description	School
Landing Area	Concrete
Sidewalk	Yes
Sidewalk Condition	4 = good - No immediate repair
Shelter	Yes
Seating	Yes
Lighting	Yes
Bicycle Parking	No
Scooter Parking	No

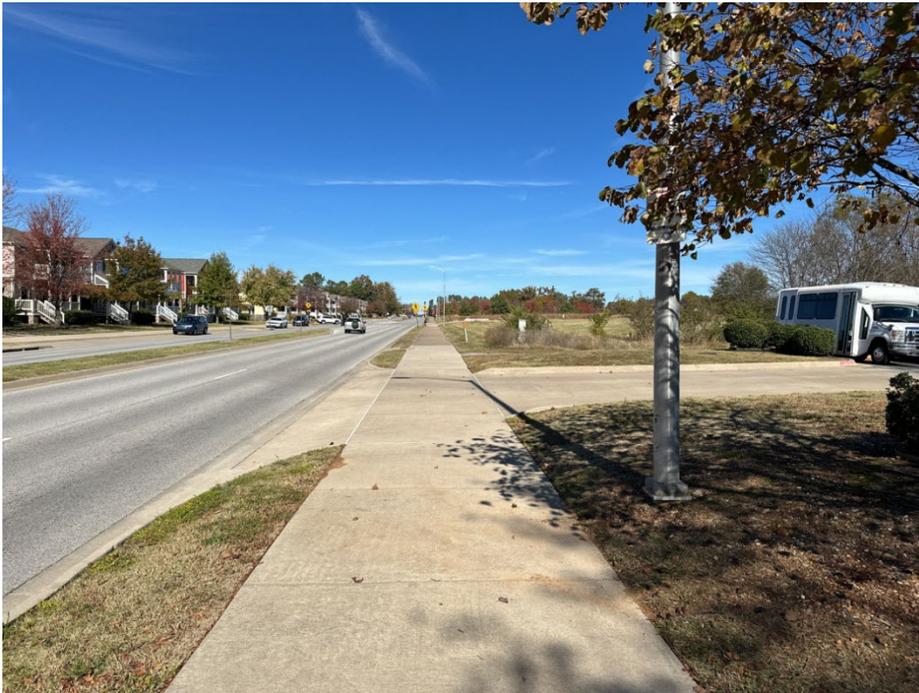
Moderate-ridership outbound stop that serves the Boys & Girls Club. The current location offers limited visibility and is poorly positioned for safe boarding and alighting. The stop lacks a defined landing pad and essential rider amenities. Relocate the stop closer to the Boys & Girls Club entrance to enhance accessibility and rider safety. Construct an accessible landing pad and install basic amenities such as seating, lighting, and micromobility parking to support multimodal access.

Weekday Activity	42.1
Weekend Activity	1.8
Stop Position	Mid-block
Adjacent Property Description	School
Landing Area	Concrete, Grass
Sidewalk	Yes
Sidewalk Condition	5 = new or cosmetically excellent
Shelter	No
Seating	No
Lighting	Yes
Bicycle Parking	No
Scooter Parking	No

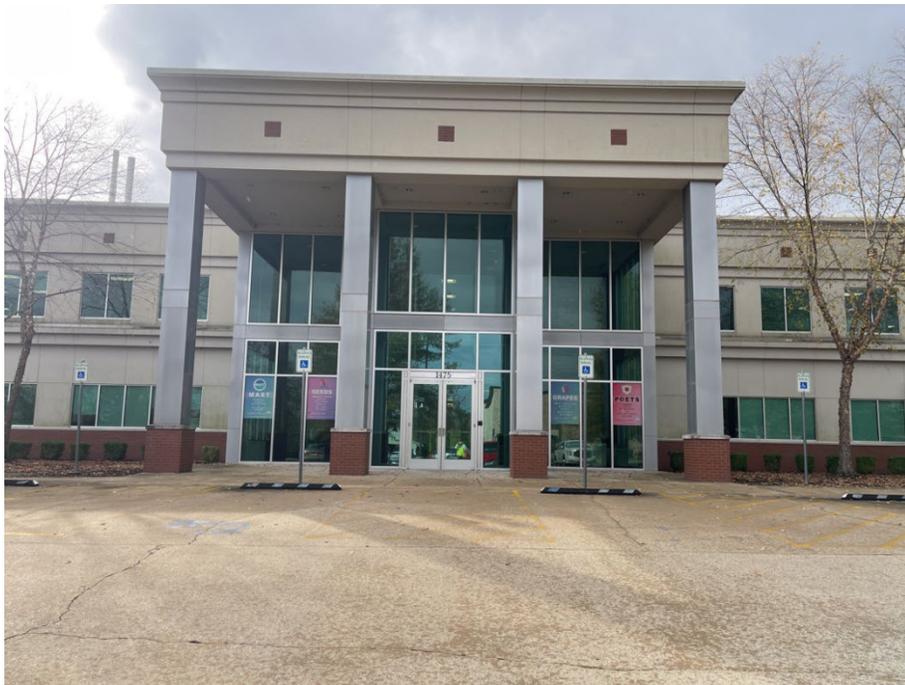
This is a stop with an adequate landing area, sidewalk access, and lighting. No seating is provided, but bike parking is available. The stop serves a low-demand area and is not currently a high-impact location. Install a bench to improve rider comfort. No additional improvements are needed at this time unless ridership increases.

Weekday Activity	No Data Available
Weekend Activity	No Data Available
Stop Position	Near-side
Adjacent Property Description	University Building - Off Campus
Landing Area	Concrete
Sidewalk	Yes
Sidewalk Condition	4 = good - No immediate repair
Shelter	No
Seating	No
Lighting	Yes
Bicycle Parking	Yes
Scooter Parking	No

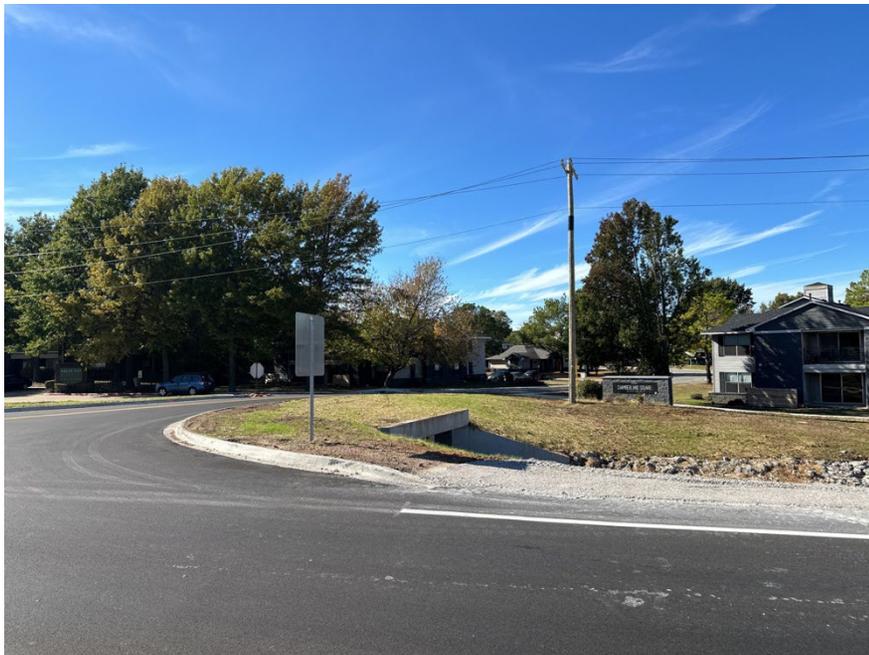
Low-ridership stop in poor condition with no defined landing area and limited passenger protection. Located along a high-speed corridor with inadequate lighting, poor visibility, and no clear connection between the sidewalk and boarding area. Current configuration lacks comfort, safety, and accessibility for regular use. Install a full shelter package with lighting and seating. Construct an accessible landing pad and connect it to the existing sidewalk network. Add bollards for passenger protection from traffic. Install speed limit signage and paint pavement markings (e.g., "SLOW," hatch lines) to calm traffic near the stop. Include placemaking features to improve visibility and encourage use.

Weekday Activity	14.4
Weekend Activity	3.7
Stop Position	Near-side
Adjacent Property Description	Apartment Building
Landing Area	Asphalt, Gravel
Sidewalk	No
Sidewalk Condition	N/A
Shelter	No
Seating	No
Lighting	No
Bicycle Parking	No
Scooter Parking	No

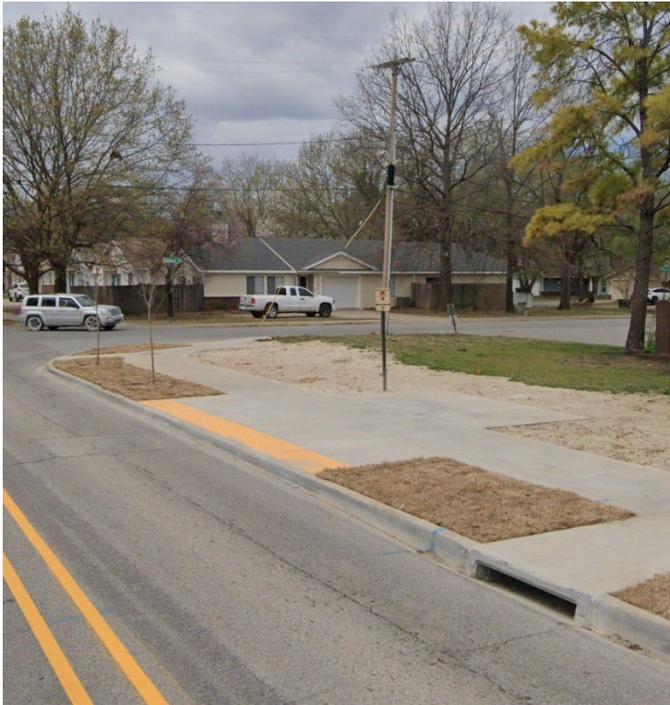
Bus stop recently improved with new sidewalks and addition of landing area adjacent to the curb and shelter pad. Consider adding lighting and shelter and relocating bus stop sign closer to the street to improve visibility. Monitor for any increase in demand that might justify additional amenities.

Weekday Activity	No Data Available
Weekend Activity	No Data Available
Stop Position	Near-side
Adjacent Property Description	Apartment Building
Landing Area	Concrete
Sidewalk	Yes
Sidewalk Condition	5 = new or cosmetically excellent
Shelter	No
Seating	No
Lighting	Yes
Bicycle Parking	No
Scooter Parking	No

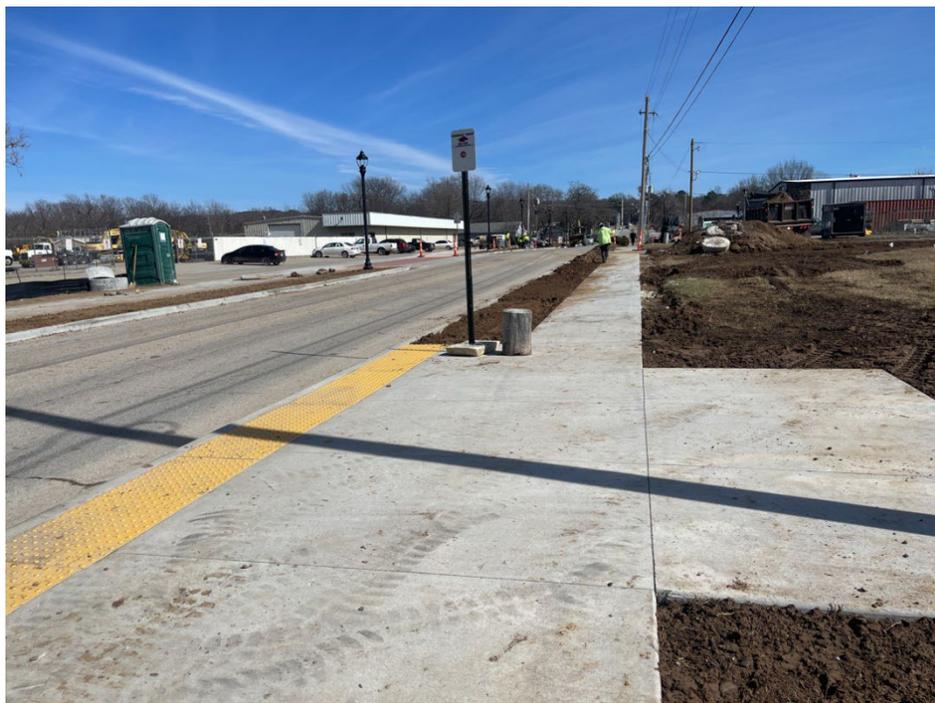
Moderate-ridership balanced stop with new concrete landing area, wide sidewalk, and tactile warning surface. No seating or shelter currently present. Sign is mounted on a permanent base near a utility pole, which may constrain future shelter placement. Lighting appears adequate from adjacent streetlights. Recommend installing a bench to improve comfort. Consider a shelter if space allows or utility relocation becomes feasible.

Weekday Activity	27.5
Weekend Activity	7.7
Stop Position	Far-side
Adjacent Property Description	Apartment Building
Landing Area	Concrete
Sidewalk	Yes
Sidewalk Condition	5 = new or cosmetically excellent
Shelter	No
Seating	No
Lighting	No
Bicycle Parking	No
Scooter Parking	No

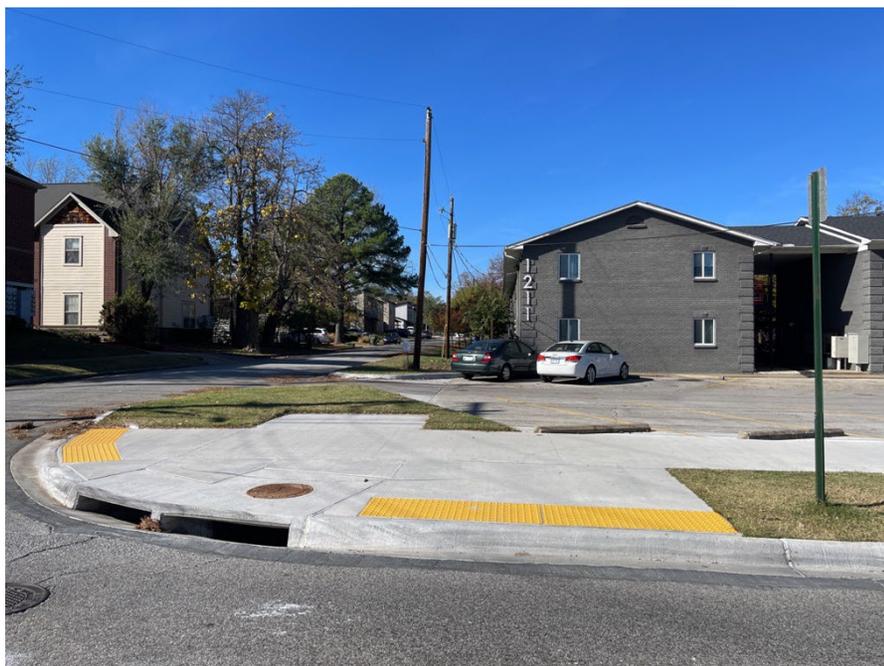
Moderate-ridership inbound stop serving the Colonial Arms apartments. The stop is positioned in a way that limits accessibility and visibility. Although the sidewalk has been recently redone, the pole placement and landing area are not optimized for shelter installation. This stop pairs with outbound stop 149477. Relocate the signpost for improved alignment with the sidewalk and future shelter placement. Construct an accessible landing pad and install a shelter to support rider comfort and visibility. Coordinate improvements with the outbound stop across the street for a consistent experience.

Weekday Activity	48.9
Weekend Activity	10.7
Stop Position	Near-side
Adjacent Property Description	Apartment Building
Landing Area	Concrete
Sidewalk	Yes
Sidewalk Condition	5 = new or cosmetically excellent
Shelter	No
Seating	No
Lighting	Yes
Bicycle Parking	No
Scooter Parking	No

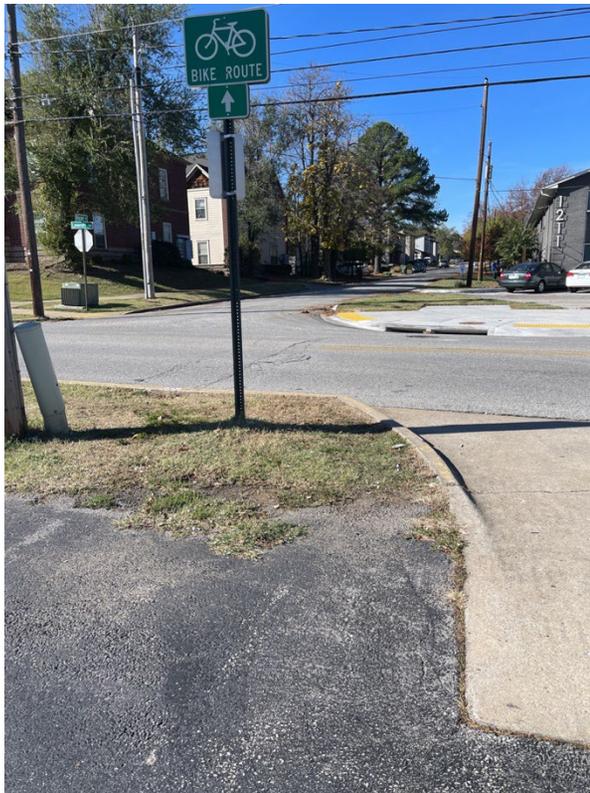
Moderate-ridership outbound stop currently located in a constrained area with limited visibility and poor access. The stop lacks a defined accessible landing pad and other basic amenities. It is the sister stop to 149478 across the street. Relocate the stop in front of the adjacent block wall to improve visibility and access. Construct a landing pad and consider adding a shelter and seating to match improvements at the inbound stop (149478).

Weekday Activity	37.7
Weekend Activity	9.2
Stop Position	N/A
Adjacent Property Description	Place of Worship
Landing Area	Asphalt, Dirt, Grass
Sidewalk	No
Sidewalk Condition	N/A
Shelter	No
Seating	No
Lighting	Yes
Bicycle Parking	No
Scooter Parking	No

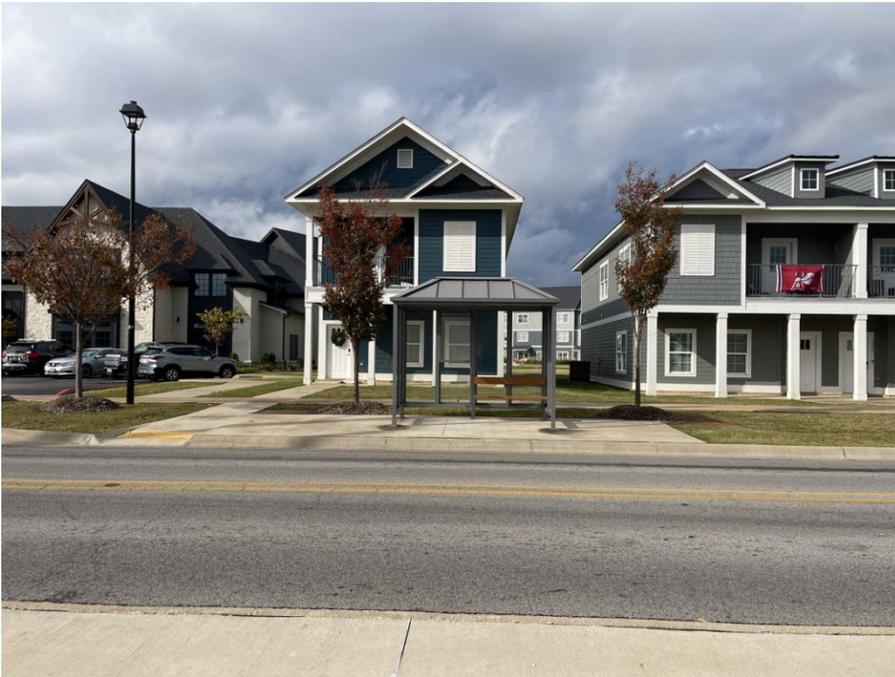
# STOP ID:149480

High-ridership, balanced stop full shelter package in excellent condition, including seating and paved landing area. Lighting is provided by nearby street fixtures but no in-shelter lighting is visible. Sidewalk access is direct and unobstructed. No designated outbound stop exists across the street. Maintain existing infrastructure and evaluate feasibility of formal outbound stop to support bidirectional access and improve network connectivity. Add in-shelter lighting to enhance visibility and nighttime comfort.

Weekday Activity	57.9
Weekend Activity	1.1
Stop Position	Far-side
Adjacent Property Description	Apartment Building, Residence - Townhouse, University Student Housing
Landing Area	Concrete
Sidewalk	Yes
Sidewalk Condition	5 = new or cosmetically excellent
Shelter	Yes
Seating	Yes
Lighting	Yes
Bicycle Parking	No
Scooter Parking	Yes

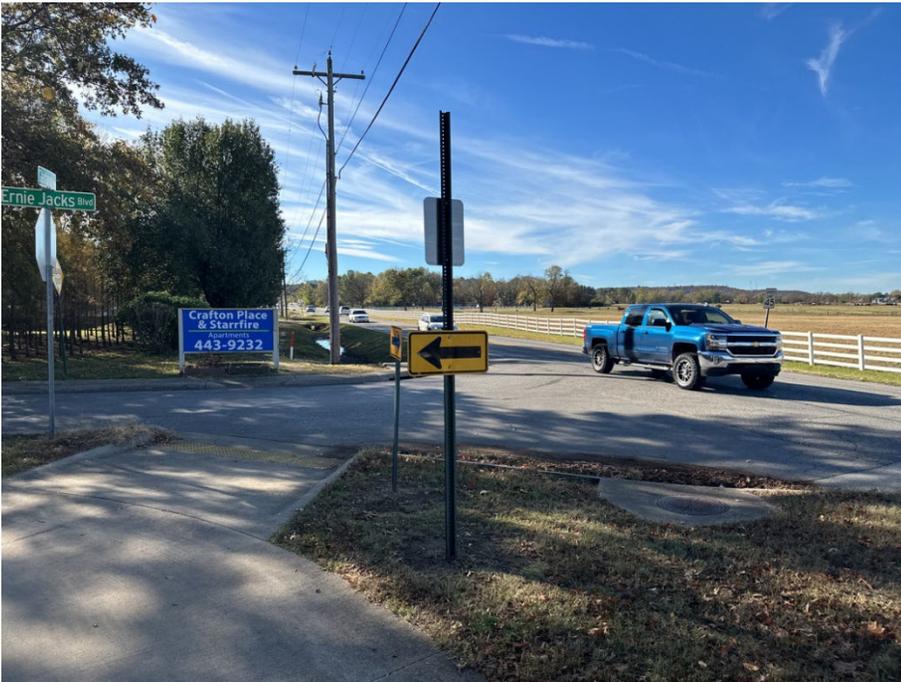
Low-ridership stop located near an active ARDOT project area. The site currently lacks a formal shelter, accessible landing pad, and fully connected sidewalk infrastructure. Trail access is nearby, and coordination with future construction is essential. Coordinate with ARDOT to ensure installation of an ADA-compliant landing pad and shelter as part of planned median and trail improvements. Ensure sidewalk connections are incorporated to support safe and accessible multimodal access.

Weekday Activity	19
Weekend Activity	1.1
Stop Position	Far-side
Adjacent Property Description	Apartment Building, Residence - detached
Landing Area	Asphalt
Sidewalk	Yes
Sidewalk Condition	5 = new or cosmetically excellent
Shelter	No
Seating	No
Lighting	Yes
Bicycle Parking	No
Scooter Parking	No

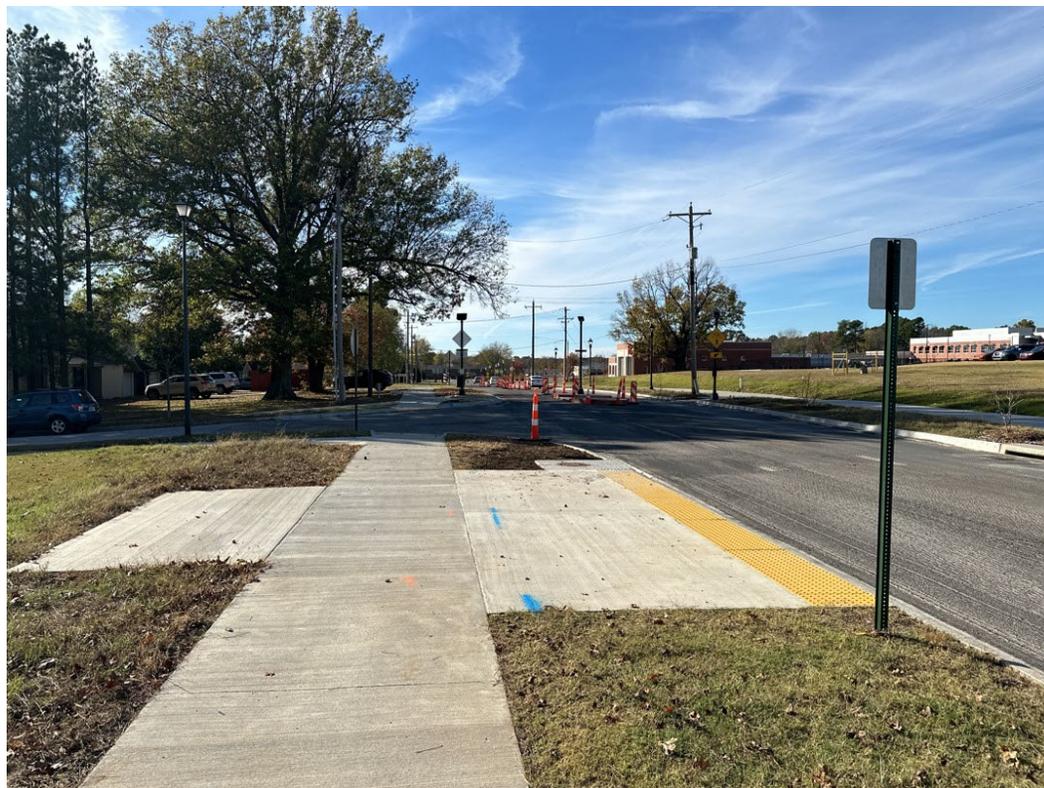
Low-ridership balanced stop with an adequate landing area, sidewalk access, and lighting present. No seating or shelter is currently provided. The site has sufficient space to support additional amenities. If funding, demand, or policy require it: Install a full shelter package with bench and lighting to enhance rider comfort. Add micromobility parking to support scooter and bicycle access.

Weekday Activity	9.5
Weekend Activity	1.2
Stop Position	Far-side
Adjacent Property Description	Apartment Building
Landing Area	Concrete, Tactile, warning strip
Sidewalk	Yes
Sidewalk Condition	5 = new or cosmetically excellent
Shelter	No
Seating	No
Lighting	Yes
Bicycle Parking	No
Scooter Parking	No

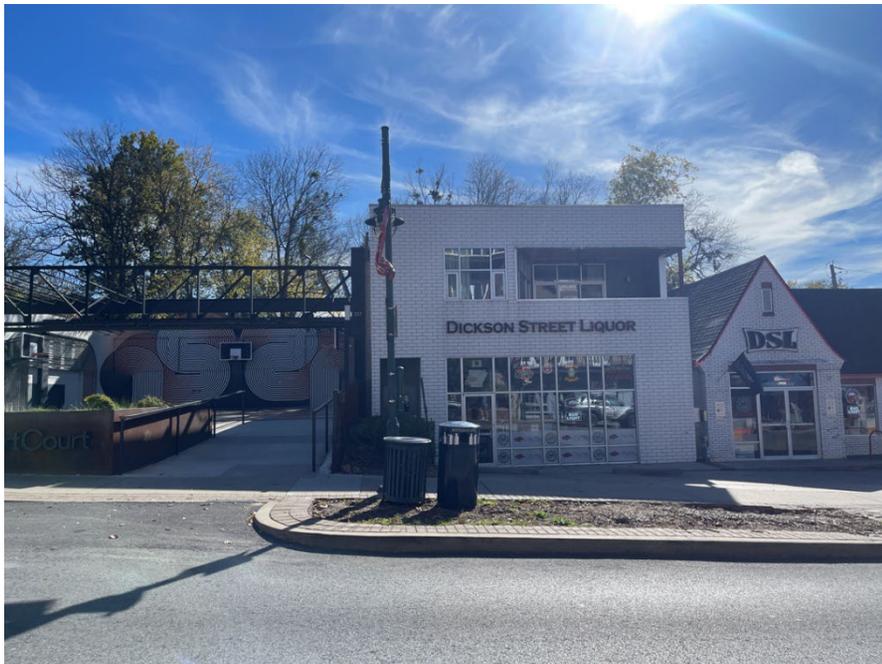
Low-ridership stop located in a busy entertainment district with high pedestrian and micromobility activity. The existing street bulb is surfaced with pavers, and there is no defined landing pad. The site lacks shelter and micromobility parking, limiting functionality and comfort. Replace pavers in the boarding area with concrete to create a landing pad. Install lighting and seating. Add micromobility parking to accommodate bikes and scooters. Improvements should align with similar upgrades at nearby stops like Dickson & School to ensure a consistent rider experience.

Weekday Activity	0.2
Weekend Activity	1.5
Stop Position	Far-side
Adjacent Property Description	Retail Store
Landing Area	Grass, Pavers
Sidewalk	Yes
Sidewalk Condition	3 = Fair - minor root uplifting and breaks
Shelter	No
Seating	No
Lighting	Yes
Bicycle Parking	No
Scooter Parking	No

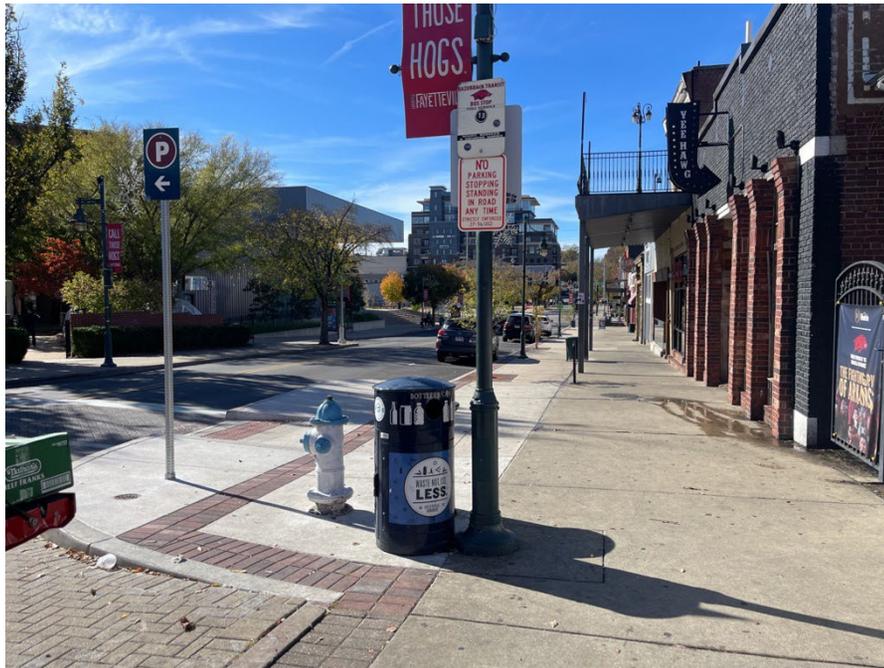
# STOP ID:149487

Low-ridership stop located in the heart of the entertainment district. The site lacks a defined loading zone and has no shelter or seating. Space constraints limit installation options, and pedestrian activity is consistently high. Stripe a formal bus loading zone on the street to improve visibility and operations. Evaluate the potential for seating installation (e.g., knee wall or integrated design) if concerns about loitering can be addressed. Consider adding lighting and shelter where space allows, and coordinate improvements with other nearby high-activity stops for consistency.

Weekday Activity	13.5
Weekend Activity	1.1
Stop Position	N/A
Adjacent Property Description	Bar
Landing Area	Concrete, Pavers
Sidewalk	Yes
Sidewalk Condition	5 = new or cosmetically excellent
Shelter	No
Seating	No
Lighting	Yes
Bicycle Parking	Yes
Scooter Parking	No

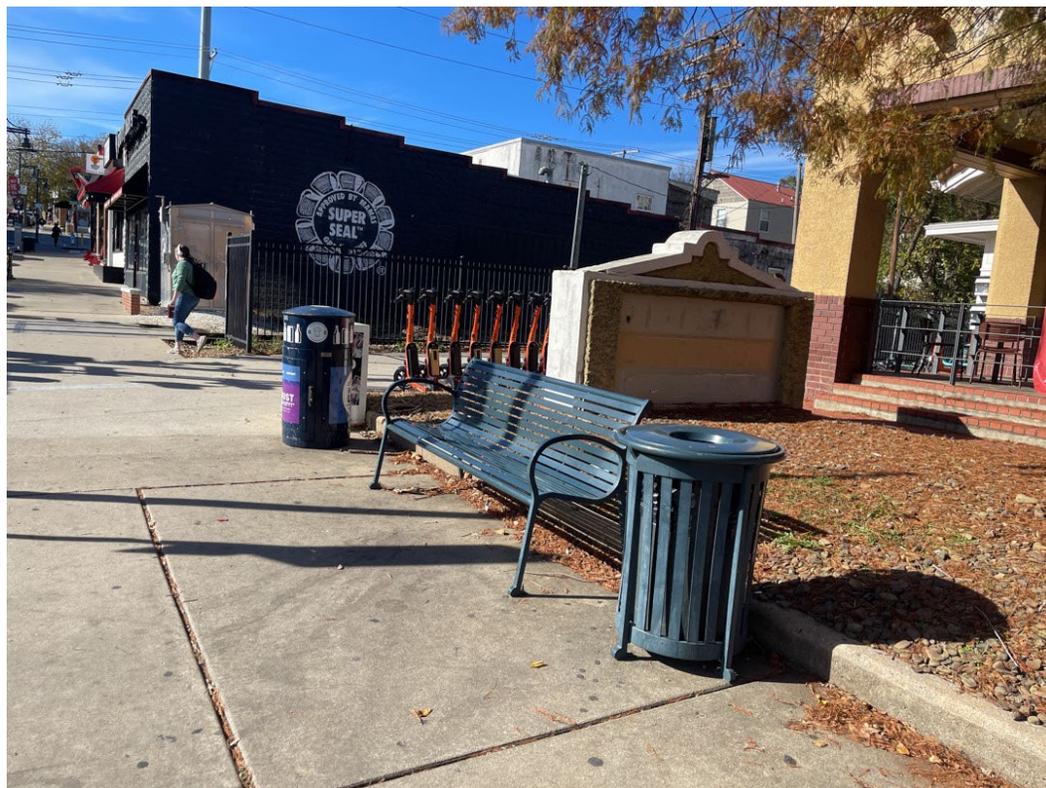
# STOP ID:149489

Moderate-ridership boarding stop located in a high-activity district. The site includes an Accessible landing area, sidewalk access, seating, lighting, bike parking, and scooter parking. Despite this strong foundation, the stop currently lacks a shelter. Install a full shelter package with integrated lighting and seating to enhance comfort and visibility. Leverage existing infrastructure to support a high-quality, multimodal rider experience.

Weekday Activity	33.1
Weekend Activity	1.7
Stop Position	Far-side
Adjacent Property Description	Restaurant
Landing Area	Concrete, Pavers
Sidewalk	Yes
Sidewalk Condition	4 = good - No immediate repair
Shelter	No
Seating	Yes
Lighting	Yes
Bicycle Parking	Yes
Scooter Parking	Yes

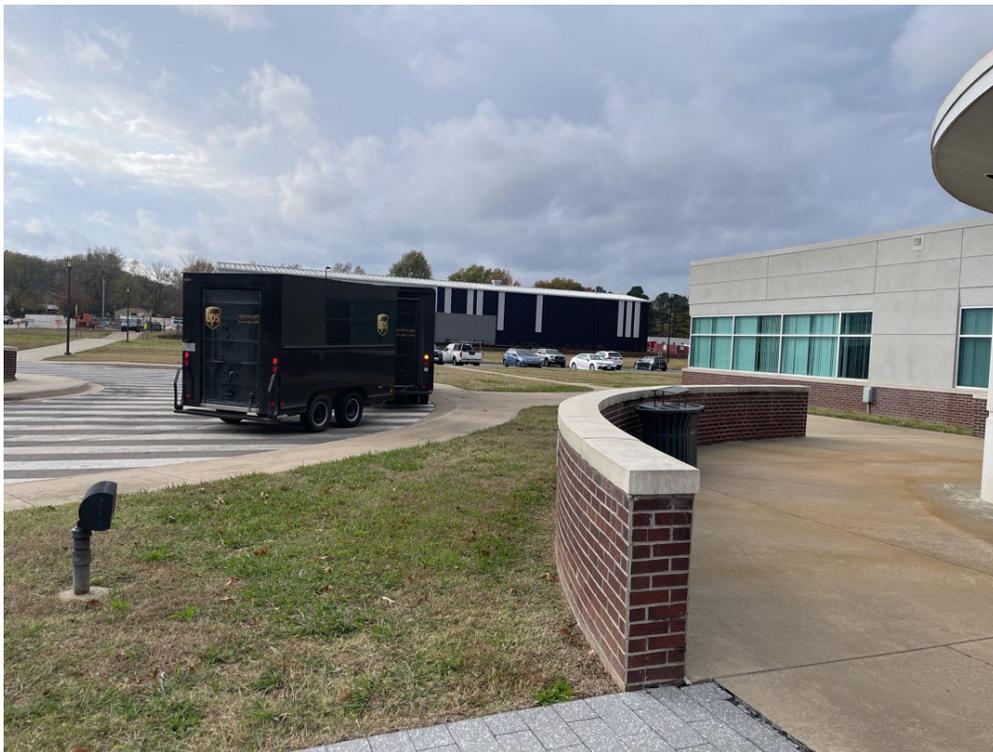
This is a stop serving a specialized university facility. The stop lacks formal signage, making it unclear where boarding occurs. No bike rack or micromobility infrastructure is present, despite frequent use by students traveling by scooter or bike. Install clear bus stop signage and pole to indicate the designated boarding location. Add a bike rack and scooter hub to accommodate multimodal users and reduce sidewalk clutter.

Weekday Activity	No Data Available
Weekend Activity	No Data Available
Stop Position	N/A
Adjacent Property Description	University Building - Off Campus
Landing Area	Concrete
Sidewalk	Yes
Sidewalk Condition	4 = good - No immediate repair
Shelter	No
Seating	No
Lighting	Yes
Bicycle Parking	No
Scooter Parking	No

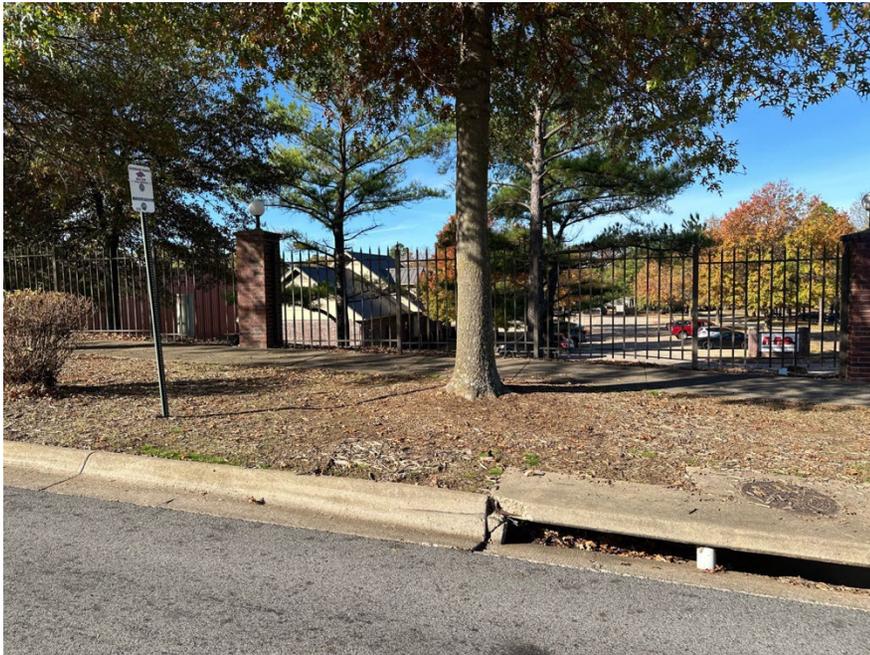
Moderate-ridership balanced stop near UA Athletic facilities, with no defined landing pad, seating, or shelter. Boarding occurs from a grassy strip with no accessible connection to the adjacent apartment complex. Street lighting is present, but there is no dedicated illumination or micromobility support. Construct an accessible landing pad and provide a sidewalk connection through the apartment frontage. Install a full shelter package with lighting, seating, and micromobility parking to support current ridership and improve comfort and visibility.

Weekday Activity	47.1
Weekend Activity	8.5
Stop Position	Far-side
Adjacent Property Description	School
Landing Area	Dirt, Grass
Sidewalk	Yes
Sidewalk Condition	3 = Fair - minor root uplifting and breaks
Shelter	No
Seating	No
Lighting	Yes
Bicycle Parking	No
Scooter Parking	No
