# **NORTHWEST ARKANSAS REGIONAL PLANNING COMMISSION**

## **RAZORBACK TRANSIT BUS STOP ENHANCEMENT PLAN**

October 2025 | FINAL

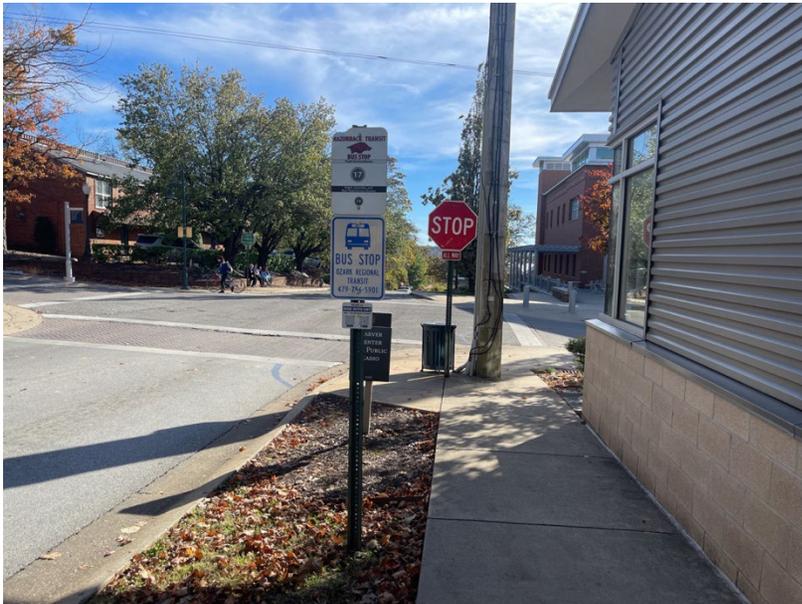
Moderate-ridership balanced stop located on a rolled curb with no defined Accessible landing area. The sidewalk is present but not fully accessible due to grade and lack of a level boarding surface. No seating is provided. Lighting is present, but visibility and pedestrian access are limited. This stop is located near 149531, a midblock location just north of Center Street. Consolidate this stop with nearby Stop 149531 to establish a single, upgraded midblock location. Construct an accessible landing pad with direct sidewalk connection to replace the rolled curb. Install a full shelter package including seating and lighting. Add micromobility parking to support scooter and bike access. Improve sidewalk access and signage for enhanced visibility and safety.

Weekday Activity	32.9
Weekend Activity	7.1
Stop Position	Near-side
Adjacent Property Description	Library
Landing Area	Dirt, Grass
Sidewalk	Yes
Sidewalk Condition	4 = good - No immediate repair
Shelter	No
Seating	No
Lighting	Yes
Bicycle Parking	No
Scooter Parking	No

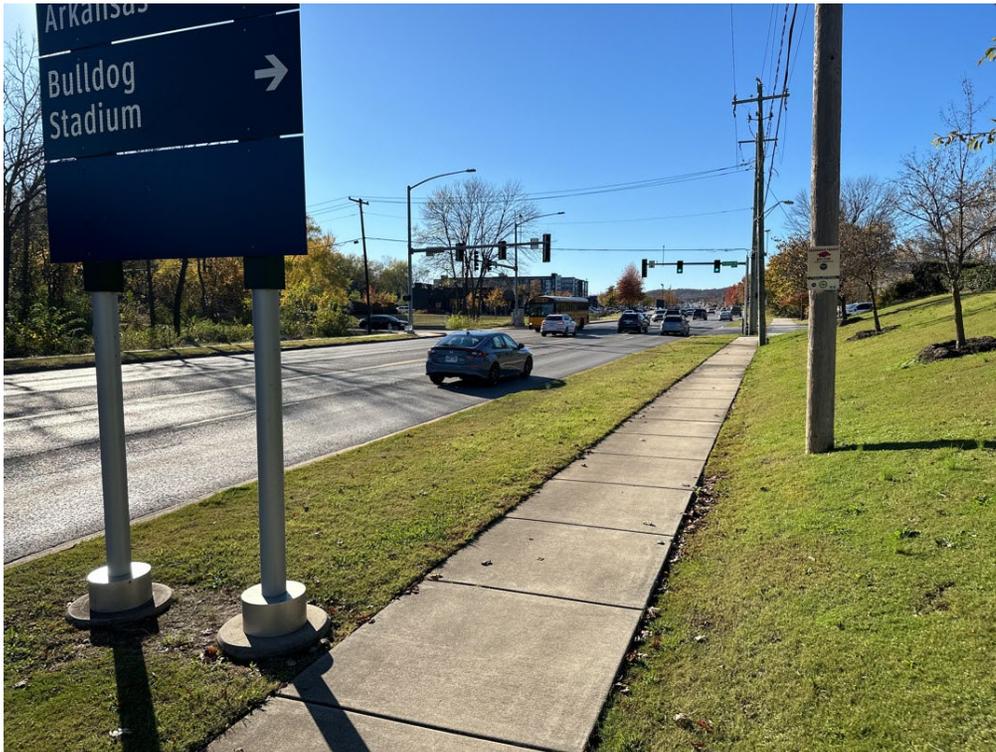
Weekday Activity	10.5
Weekend Activity	1.6
Stop Position	Near-side
Adjacent Property Description	School
Landing Area	Dirt, Grass
Sidewalk	Yes
Sidewalk Condition	4 = good - No immediate repair
Shelter	No
Seating	No
Lighting	No
Bicycle Parking	No
Scooter Parking	No

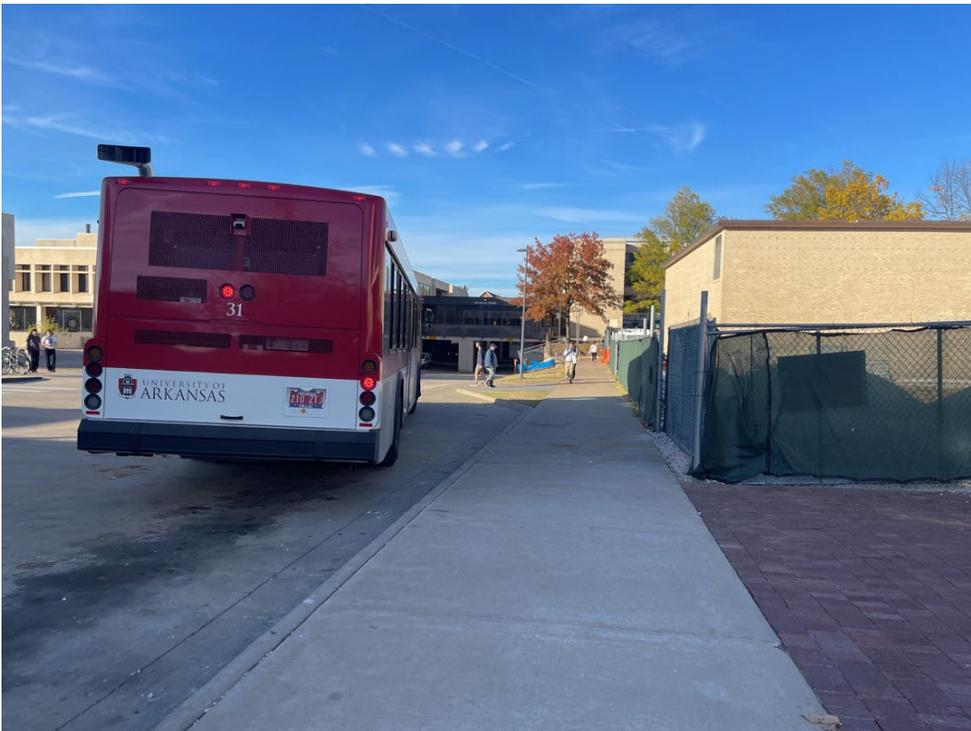
High-ridership balanced stop with adequate landing area, sidewalk present, and no seating, lighting present. full shelter package plus micromobility parking similar to 1021 dining hall, remove pullout and replace with in lane stop, potential bus bulb.

Weekday Activity	129.9
Weekend Activity	0
Stop Position	Far-side
Adjacent Property Description	University Hall
Landing Area	Concrete
Sidewalk	Yes
Sidewalk Condition	4 = good - No immediate repair
Shelter	No
Seating	No
Lighting	Yes
Bicycle Parking	No
Scooter Parking	No

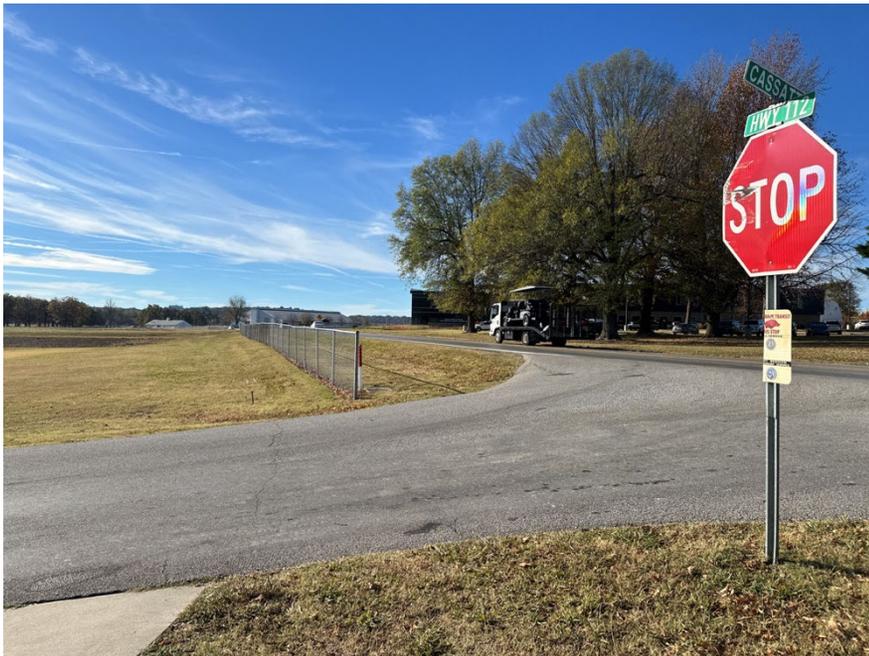
Moderate-ridership balanced stop recently relocated to the corner of Cassatt Street and Highway 112, adjacent to a stop sign. The former shelter near the Food Science facility has been decommissioned. The new stop location lacks a defined landing pad, seating, or lighting and is not clearly visible to approaching operators. Coordinate with ARDOT and UA facilities to establish an accessible boarding area with proper signage and lighting. Consider future shelter installation if demand increases or surrounding development intensifies. Remove or repurpose the old shelter to avoid confusion.

Weekday Activity	43
Weekend Activity	2.5
Stop Position	Near-side
Adjacent Property Description	Empty Lot - Field
Landing Area	Concrete
Sidewalk	Yes
Sidewalk Condition	4 = good - No immediate repair
Shelter	No
Seating	No
Lighting	Yes
Bicycle Parking	No
Scooter Parking	No

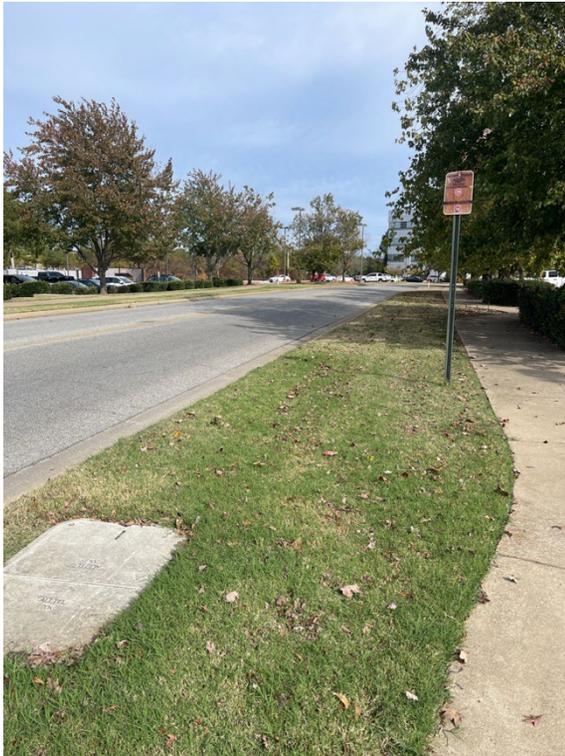
Low-ridership balanced stop located near residential housing and a nearby pharmacy. The stop lacks a defined landing pad, seating, and shelter. Boarding occurs from a grass strip, limiting accessibility and rider comfort. Install an accessible landing pad and add seating to improve functionality. Lighting is present nearby, but site-specific lighting should be evaluated. A shelter may be considered in the future if ridership increases.

Weekday Activity	8.4
Weekend Activity	2.2
Stop Position	Far-side
Adjacent Property Description	Pharmacy
Landing Area	Grass
Sidewalk	Yes
Sidewalk Condition	3 = Fair - minor root uplifting and breaks
Shelter	No
Seating	No
Lighting	Yes
Bicycle Parking	No
Scooter Parking	No

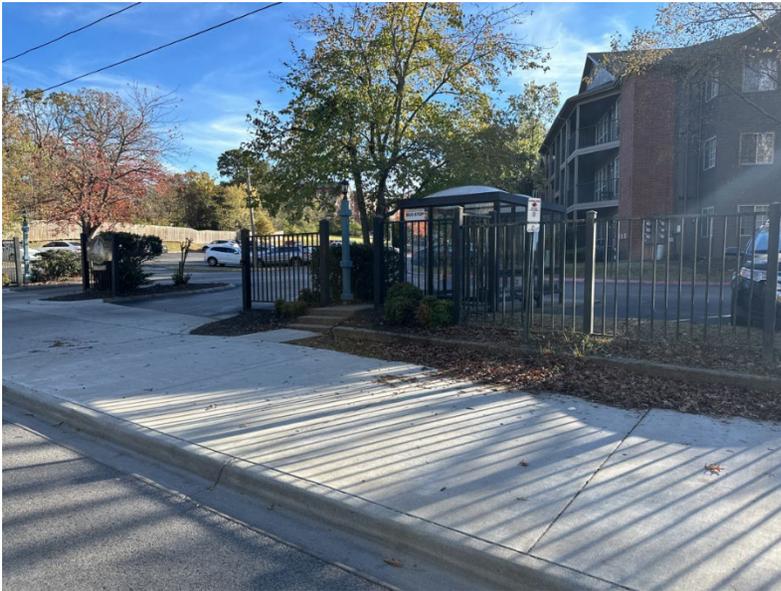
High-ridership boarding stop with adequate landing area, sidewalk present, and seating available. No lighting. The shelter is located behind a fence within a gated apartment complex and is not accessible from the public sidewalk. Passengers in mobility devices cannot reach the curb from the shelter. The current layout creates a physical barrier to boarding and should be addressed to improve accessibility. Relocate or expand the shelter to connect directly to the sidewalk and provide access. Install lighting. Coordinate with property management to ensure the stop remains visible and accessible to the public.

Weekday Activity	59.7
Weekend Activity	2.5
Stop Position	Far-side
Adjacent Property Description	Apartment Building
Landing Area	Concrete
Sidewalk	Yes
Sidewalk Condition	5 = new or cosmetically excellent
Shelter	Yes
Seating	Yes
Lighting	No
Bicycle Parking	No
Scooter Parking	No

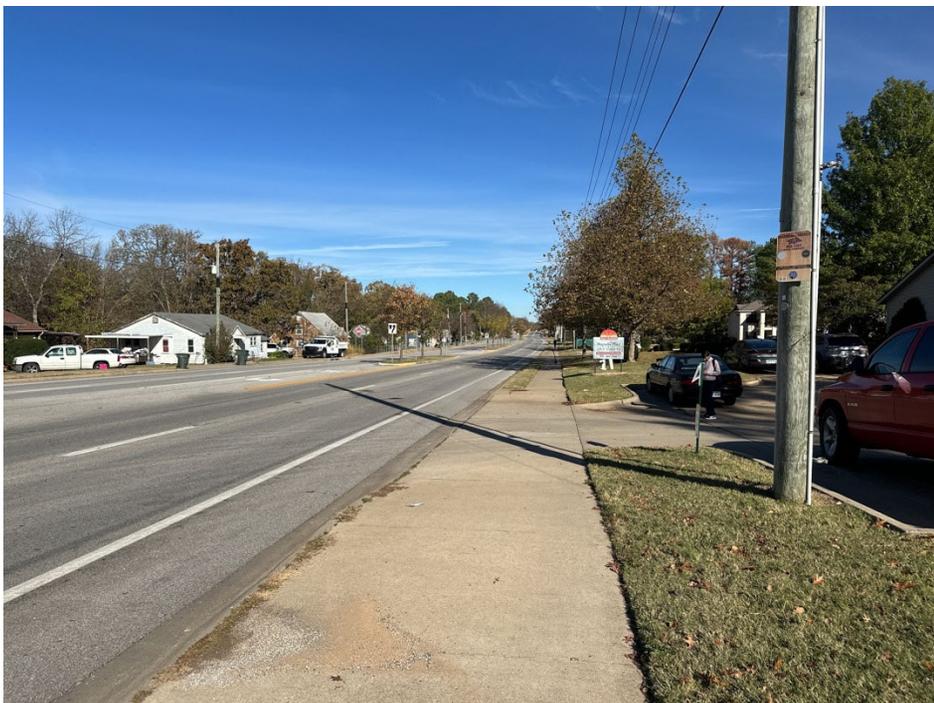
High-ridership alighting stop with a landing area and sidewalk access. The stop currently lacks lighting and seating, and its position near a driveway creates potential conflicts and safety concerns. Relocate the stop just past the adjacent driveway to improve safety and sightlines. Install a full shelter package with seating and lighting to support high passenger volumes and enhance visibility.

Weekday Activity	67.3
Weekend Activity	4.2
Stop Position	Far-side
Adjacent Property Description	Apartment Building, Residence - detached
Landing Area	Concrete
Sidewalk	Yes
Sidewalk Condition	4 = good - No immediate repair
Shelter	No
Seating	No
Lighting	No
Bicycle Parking	No
Scooter Parking	No

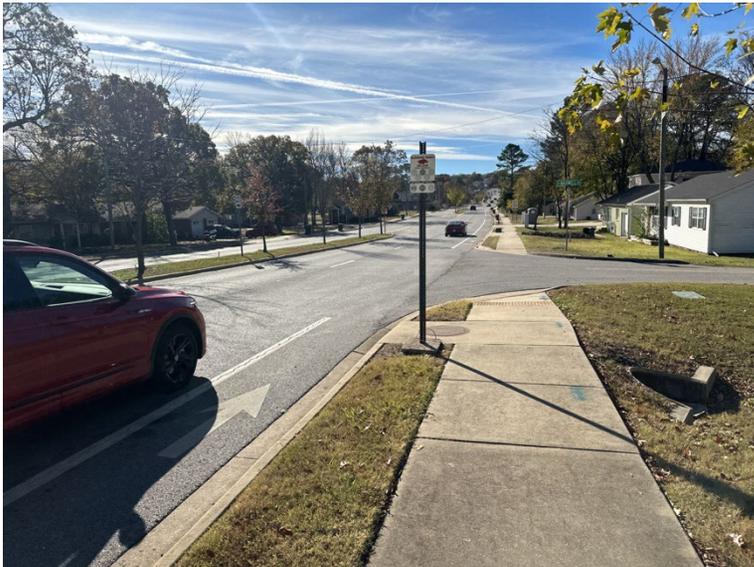
Moderate-ridership boarding stop located at the far side of the intersection with good sidewalk connectivity but no defined landing area, no seating, and no shelter. Lighting is provided by adjacent street infrastructure. The stop is directly adjacent to residential housing, which may limit opportunities for larger infrastructure but is also located near a trail and has potential for micromobility demand. Construct an accessible landing pad to improve boarding safety and functionality. If feasible, engage nearby property owners to determine receptiveness to a full shelter package. Should conditions allow, install a shelter with seating and designated micromobility parking to support heavy ridership and nearby trail connectivity.

Weekday Activity	58.2
Weekend Activity	2.6
Stop Position	Far-side
Adjacent Property Description	Residence - detached
Landing Area	Concrete
Sidewalk	Yes
Sidewalk Condition	4 = good - No immediate repair
Shelter	No
Seating	No
Lighting	Yes
Bicycle Parking	No
Scooter Parking	No

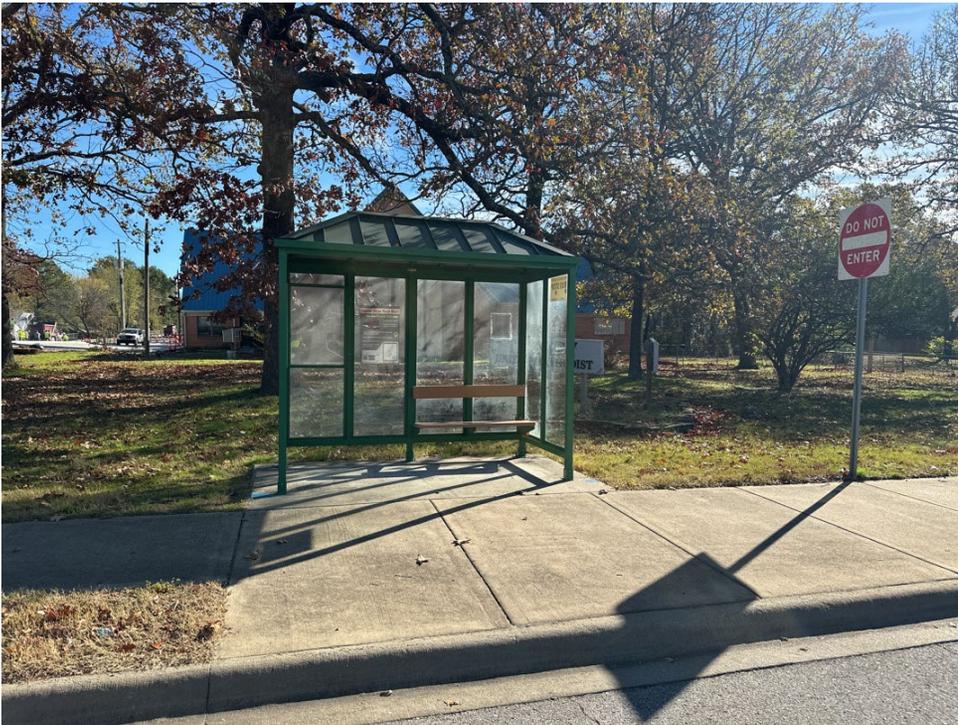
Moderate-ridership balanced stop with an accessible landing area, sidewalk connectivity, a shelter with seating, and street lighting nearby. The shelter lacks dedicated in-shelter lighting, which limits visibility and comfort during low-light conditions. Install in-shelter lighting to improve safety and passenger experience during early mornings and evenings. Maintain all existing infrastructure in good condition.

Weekday Activity	22
Weekend Activity	1.3
Stop Position	Near-side
Adjacent Property Description	Place of Worship
Landing Area	Concrete
Sidewalk	Yes
Sidewalk Condition	4 = good - No immediate repair
Shelter	Yes
Seating	Yes
Lighting	Yes
Bicycle Parking	No
Scooter Parking	No

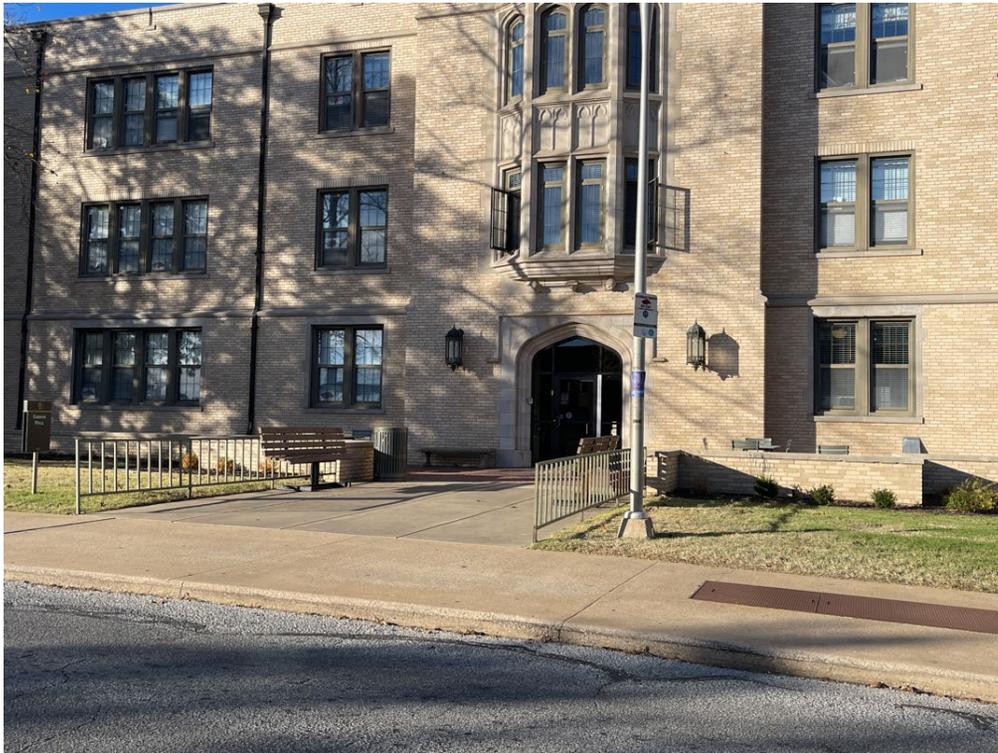
Moderate-ridership stop near Gibson Hall with paved boarding area but no existing seating or shelter. The location has adequate space and conditions to support additional amenities. Install seating to improve passenger comfort. If funding is available, install a shelter either at the current location or at a nearby alternative site that best supports visibility and access.

Weekday Activity	25.4
Weekend Activity	0
Stop Position	Near-side
Adjacent Property Description	University Hall
Landing Area	Concrete
Sidewalk	Yes
Sidewalk Condition	4 = good - No immediate repair
Shelter	No
Seating	No
Lighting	Yes
Bicycle Parking	No
Scooter Parking	No

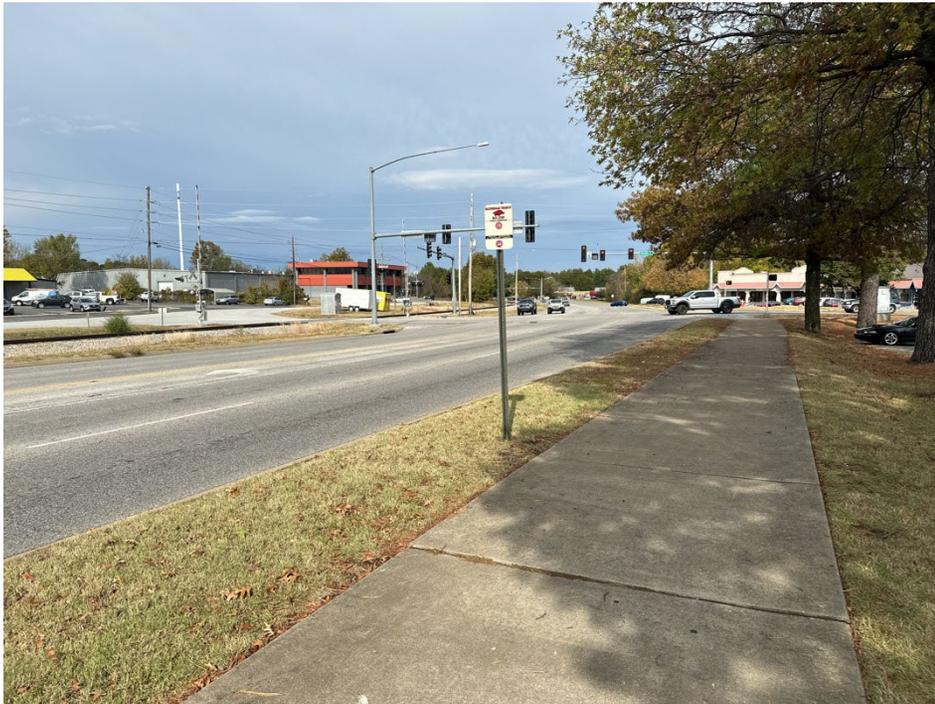
Low-ridership balanced stop located on a key corridor near a commercial area. The stop has sidewalk access and adjacent lighting from a nearby parking lot but lacks a dedicated landing pad, seating, or shelter. Riders currently board from the grass, which provides a poor surface and limits accessibility. Construct an accessible landing pad to create a stable boarding area. Add a bench to improve comfort, and consider installing a shelter if ridership increases in the future.

Weekday Activity	12.7
Weekend Activity	4.4
Stop Position	Near-side
Adjacent Property Description	Mall/Shopping Center
Landing Area	Grass
Sidewalk	Yes
Sidewalk Condition	4 = good - No immediate repair
Shelter	No
Seating	No
Lighting	Yes
Bicycle Parking	No
Scooter Parking	No

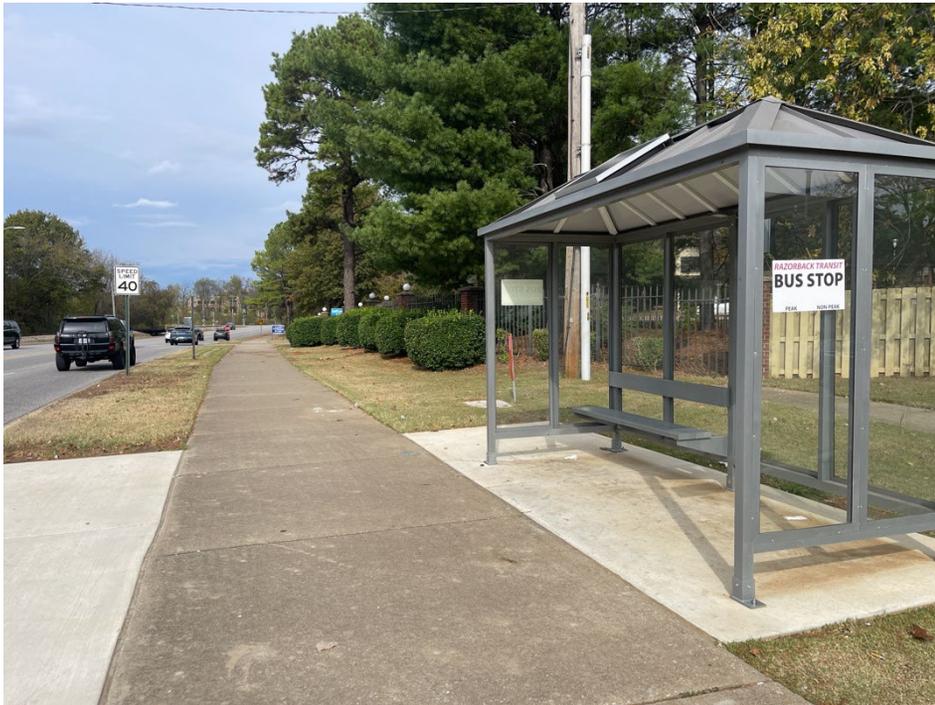
Moderate-ridership balanced stop with an accessible landing area, sidewalk connectivity, shelter with lighting and seating, and a striped on-street bus loading zone. No additional improvements are recommended at this time. Maintain existing infrastructure and monitor conditions as development and ridership evolve.

Weekday Activity	37
Weekend Activity	14.6
Stop Position	Far-side
Adjacent Property Description	Apartment Building
Landing Area	Concrete
Sidewalk	Yes
Sidewalk Condition	4 = good - No immediate repair
Shelter	Yes
Seating	Yes
Lighting	Yes
Bicycle Parking	No
Scooter Parking	No

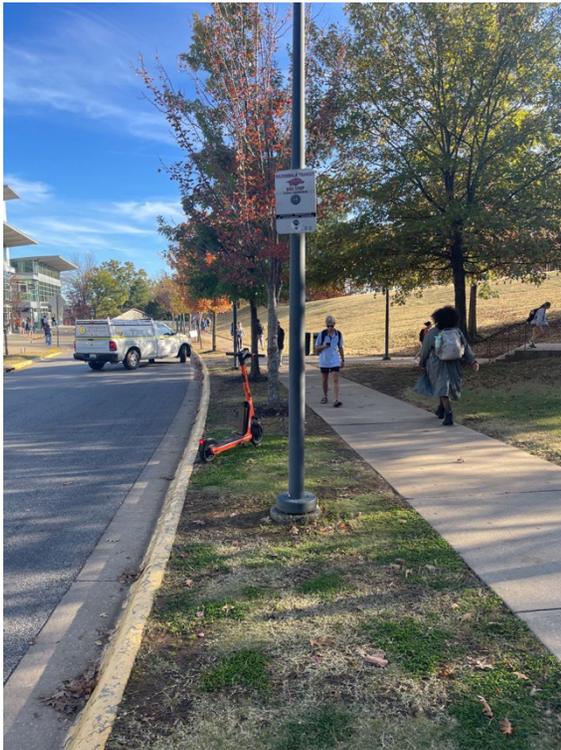
Low-ridership balanced stop adjacent to Willard J. Walker Hall, located in turf beside a wide sidewalk. No defined landing area, seating, or shelter is provided, and the sign is placed just off the path, limiting visibility and accessibility. Street lighting is present nearby, and scooters are frequently observed along the corridor. Relocate the stop slightly north to align with the existing concrete pad. Add an accessible landing pad and micromobility parking. A shelter is not recommended at this time due to ridership levels.

Weekday Activity	1.9
Weekend Activity	1.2
Stop Position	Far-side
Adjacent Property Description	University Hall
Landing Area	Dirt, Grass
Sidewalk	Yes
Sidewalk Condition	4 = good - No immediate repair
Shelter	No
Seating	No
Lighting	Yes
Bicycle Parking	No
Scooter Parking	No

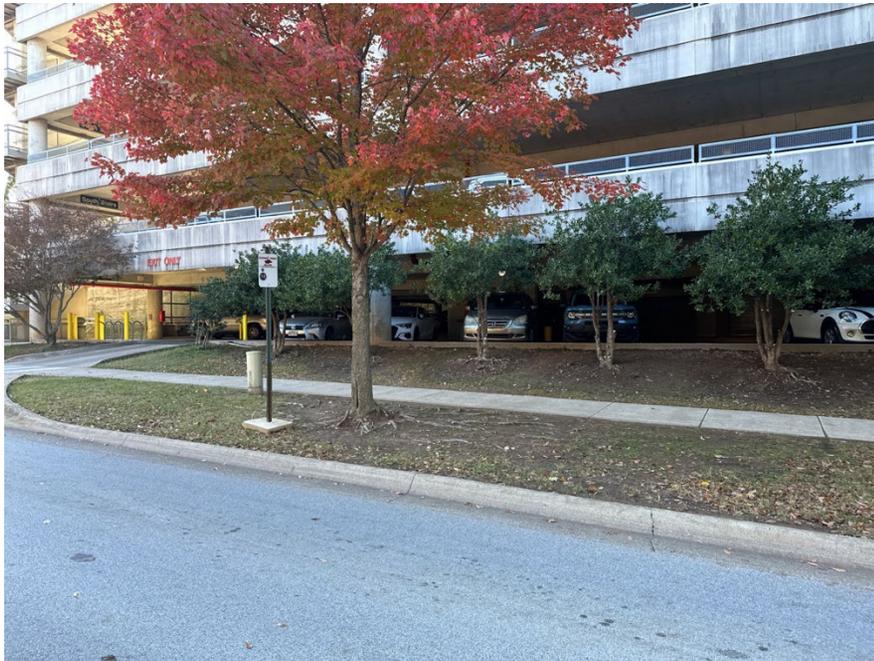
Stop with no defined landing area, sidewalk present, and no seating, lighting present, bike parking. Located midblock with minimal visibility and no boarding area. Signpost is set in a concrete base and partially obscured by a tree. No shelter, seating, or lighting present. Crosswalk and sidewalk connections exist nearby, but the stop lacks a defined landing pad and is set on uneven ground. Consider relocating to a more visible location with improved boarding conditions. Add landing pad and evaluate lighting needs if usage increases.

Weekday Activity	No Data Available
Weekend Activity	No Data Available
Stop Position	Near-side
Adjacent Property Description	Apartment Building
Landing Area	Dirt, Grass
Sidewalk	Yes
Sidewalk Condition	4 = good - No immediate repair
Shelter	No
Seating	No
Lighting	Yes
Bicycle Parking	Yes
Scooter Parking	No

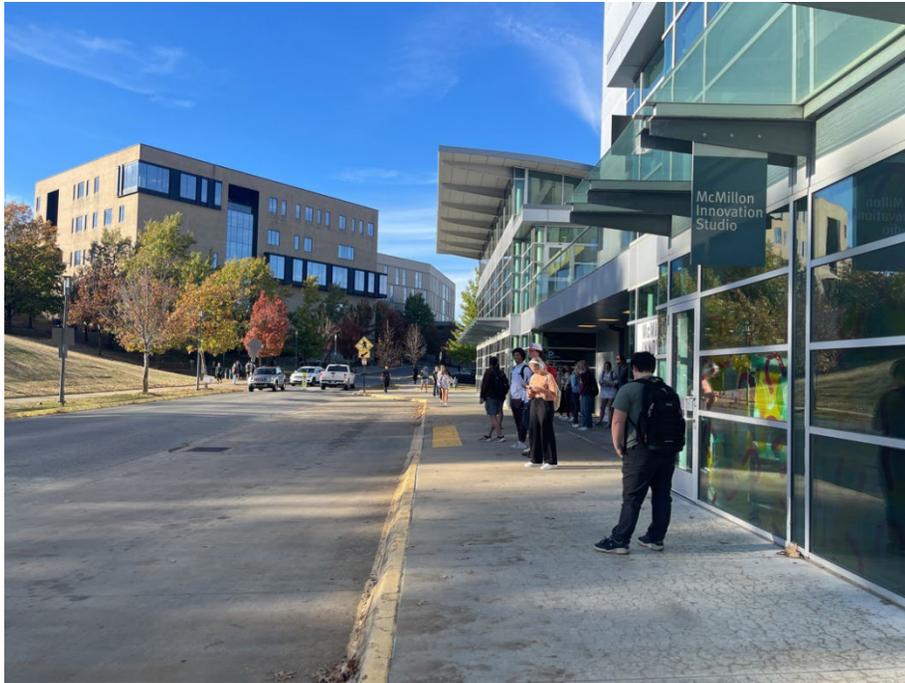
High-ridership balanced stop with adequate landing area, sidewalk present, and no seating, lighting present, bike parking, scooter parking. potential mobility hub, add full shelter package, seating for large numbers, add lighting and micromobility parking (in addition to what is there).

Weekday Activity	307.3
Weekend Activity	1.1
Stop Position	Far-side
Adjacent Property Description	Park and Ride
Landing Area	Concrete
Sidewalk	Yes
Sidewalk Condition	4 = good - No immediate repair
Shelter	No
Seating	No
Lighting	Yes
Bicycle Parking	Yes
Scooter Parking	Yes

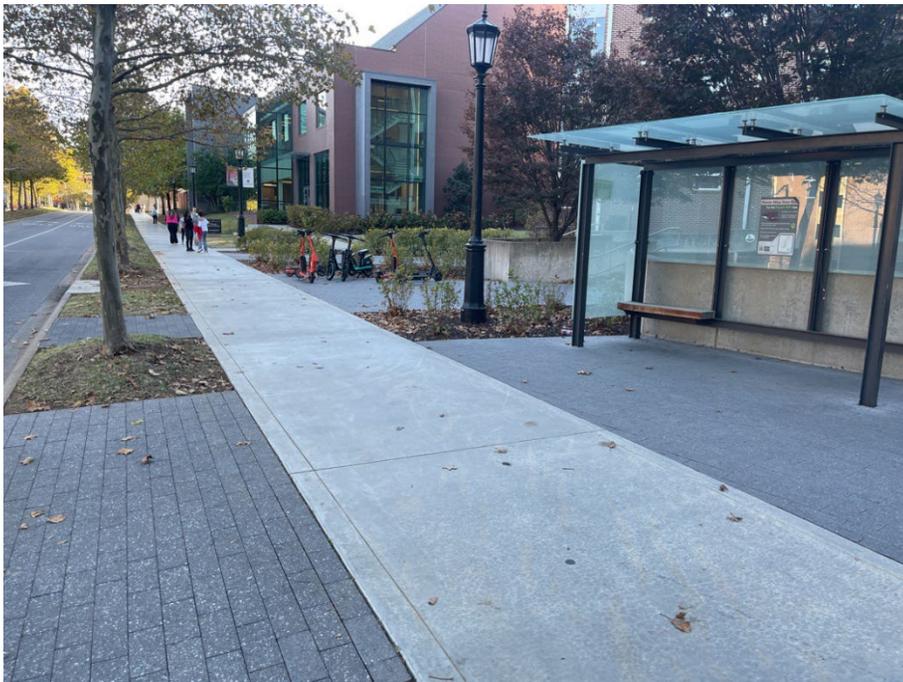
High-ridership alighting stop adjacent to the campus health center with a modern shelter, excellent sidewalk access, and a high-quality paver boarding area. The current shelter is undersized for peak demand and lacks in-shelter lighting. Micromobility devices are staged nearby without a designated parking zone, creating clutter. Expand the existing shelter to accommodate crowding. Add in-shelter lighting to improve safety and comfort, and install formal micromobility parking to support scooter and bike users while keeping walkways clear.

Weekday Activity	183
Weekend Activity	10.4
Stop Position	Mid-block
Adjacent Property Description	School
Landing Area	Pavers
Sidewalk	Yes
Sidewalk Condition	5 = new or cosmetically excellent
Shelter	Yes
Seating	Yes
Lighting	Yes
Bicycle Parking	Yes
Scooter Parking	Yes

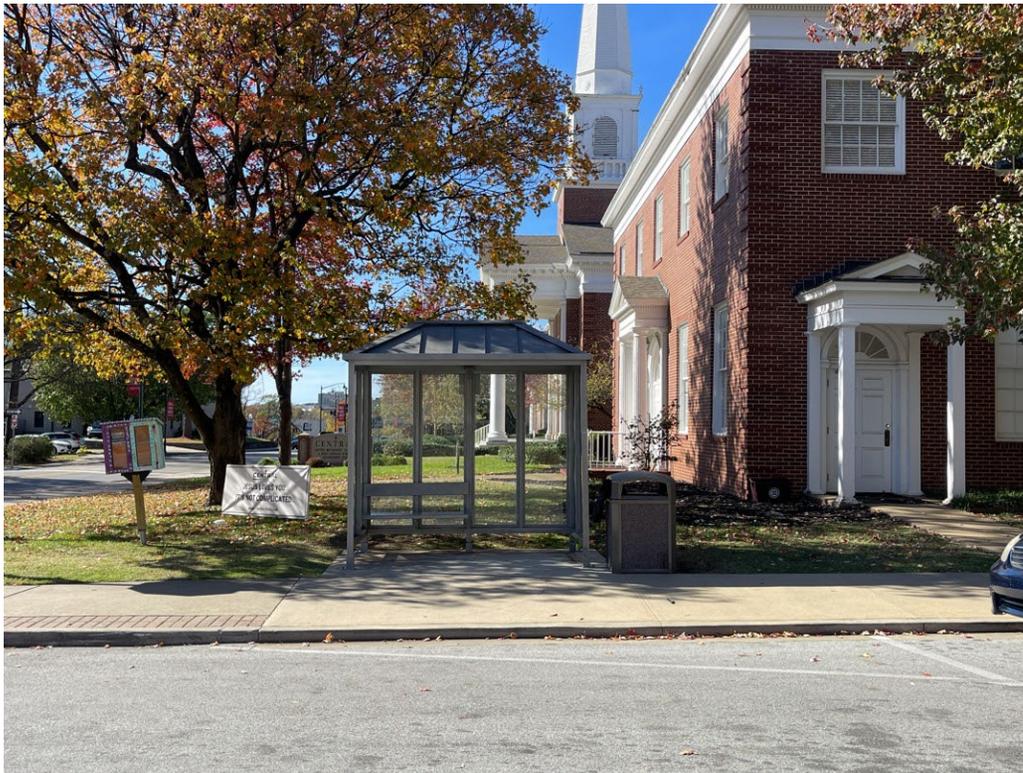
Moderate-ridership stop located at a key intersection near the edge of campus. Its position near on-street parking limits the ability to safely board and alight without infrastructure improvements. Remove one parking space to accommodate a shelter and improve bus alignment. Install a shelter with integrated lighting and a bench. Add micromobility parking to support access for bike and scooter users.

Weekday Activity	34.2
Weekend Activity	2.3
Stop Position	Near-side
Adjacent Property Description	Place of Worship
Landing Area	Concrete
Sidewalk	Yes
Sidewalk Condition	4 = good - No immediate repair
Shelter	Yes
Seating	Yes
Lighting	Yes
Bicycle Parking	No
Scooter Parking	No

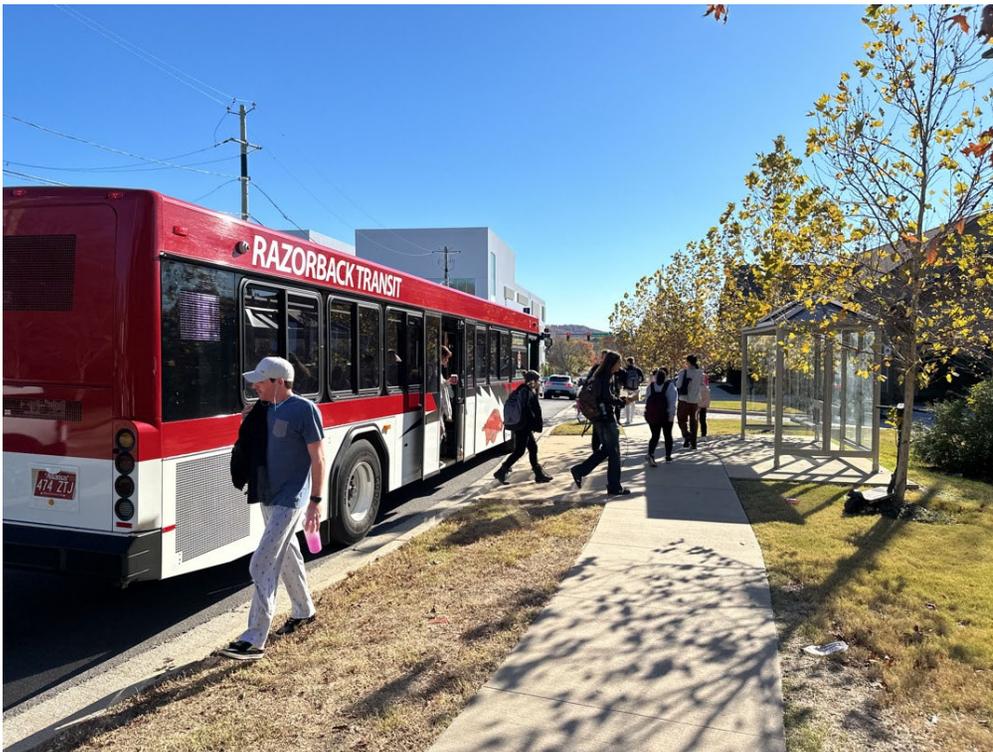
This is a boarding stop in excellent condition with a full shelter, accessible landing pad, sidewalk connectivity, and both in-shelter and adjacent lighting. The shelter is positioned well for queuing but currently lacks a bench, which limits seating capacity. Scooter clutter and occasional trash buildup suggest a need for routine maintenance. Install a bench inside the shelter to support comfort and consider adding a trash receptacle. Continue monitoring for overcrowding during peak academic hours.

Weekday Activity	No Data Available
Weekend Activity	No Data Available
Stop Position	Near-side
Adjacent Property Description	Bank
Landing Area	Concrete
Sidewalk	Yes
Sidewalk Condition	5 = new or cosmetically excellent
Shelter	Yes
Seating	Yes
Lighting	Yes
Bicycle Parking	No
Scooter Parking	No

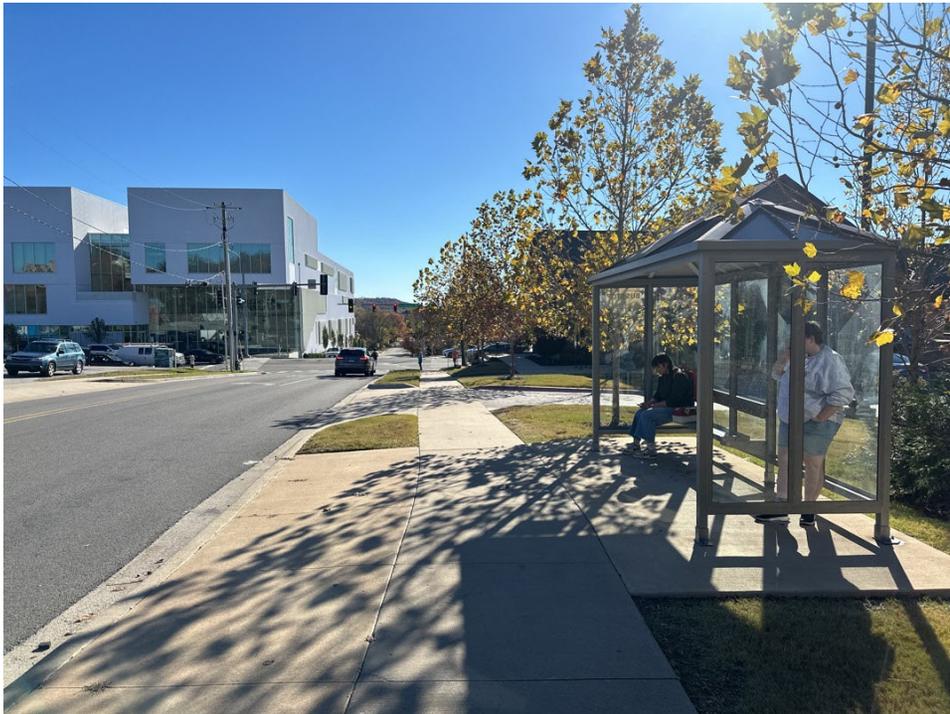
High-ridership stop serving as a primary boarding location along a major corridor. Existing shelter is well-used but undersized for peak demand. No dedicated micromobility parking present. Expand the existing shelter to better accommodate boarding volumes. Add micromobility parking to support bicycle and scooter access and reduce sidewalk clutter.

Weekday Activity	108.2
Weekend Activity	6.6
Stop Position	Far-side
Adjacent Property Description	Bank, Supermarket
Landing Area	Concrete
Sidewalk	Yes
Sidewalk Condition	5 = new or cosmetically excellent
Shelter	Yes
Seating	Yes
Lighting	Yes
Bicycle Parking	No
Scooter Parking	No

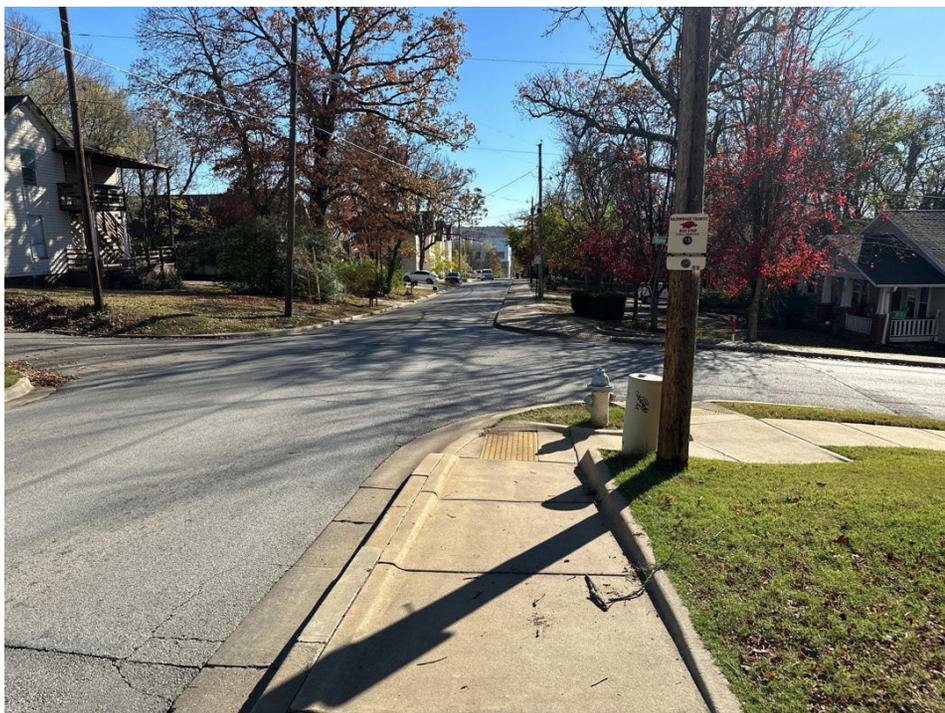
Moderate-ridership alighting stop located along a residential street with no dedicated bus stop pole and minimal nighttime visibility. The sign is mounted to a utility pole, and no lighting, shelter, or seating is present. Sidewalk access is available, but the stop is not well-defined for riders or operators. Install a formal bus stop pole with signage to clearly mark the location. Add lighting if feasible to improve visibility and safety, particularly during early morning or evening hours.

Weekday Activity	54.1
Weekend Activity	0.6
Stop Position	Near-side
Adjacent Property Description	Residence - Townhouse
Landing Area	Concrete
Sidewalk	Yes
Sidewalk Condition	4 = good - No immediate repair
Shelter	No
Seating	No
Lighting	No
Bicycle Parking	No
Scooter Parking	No

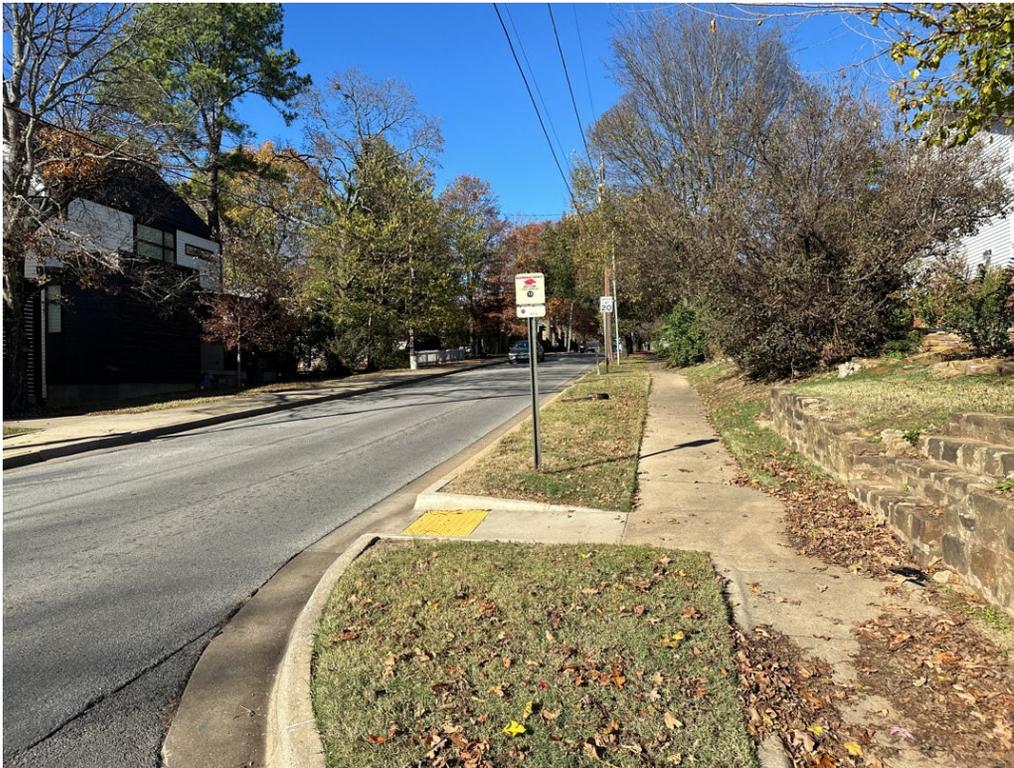
Low-ridership outbound stop with sidewalk access but no defined lighting. The site currently lacks seating and has limited visibility, reducing comfort and safety for waiting passengers. Install lighting to improve visibility and enhance safety. Add a bench to support rider comfort and ensure the stop is clearly marked with a visible signpost.

Weekday Activity	12.2
Weekend Activity	1.8
Stop Position	Far-side
Adjacent Property Description	Apartment Building
Landing Area	Asphalt, Grass
Sidewalk	Yes
Sidewalk Condition	4 = good - No immediate repair
Shelter	No
Seating	Yes
Lighting	No
Bicycle Parking	No
Scooter Parking	No

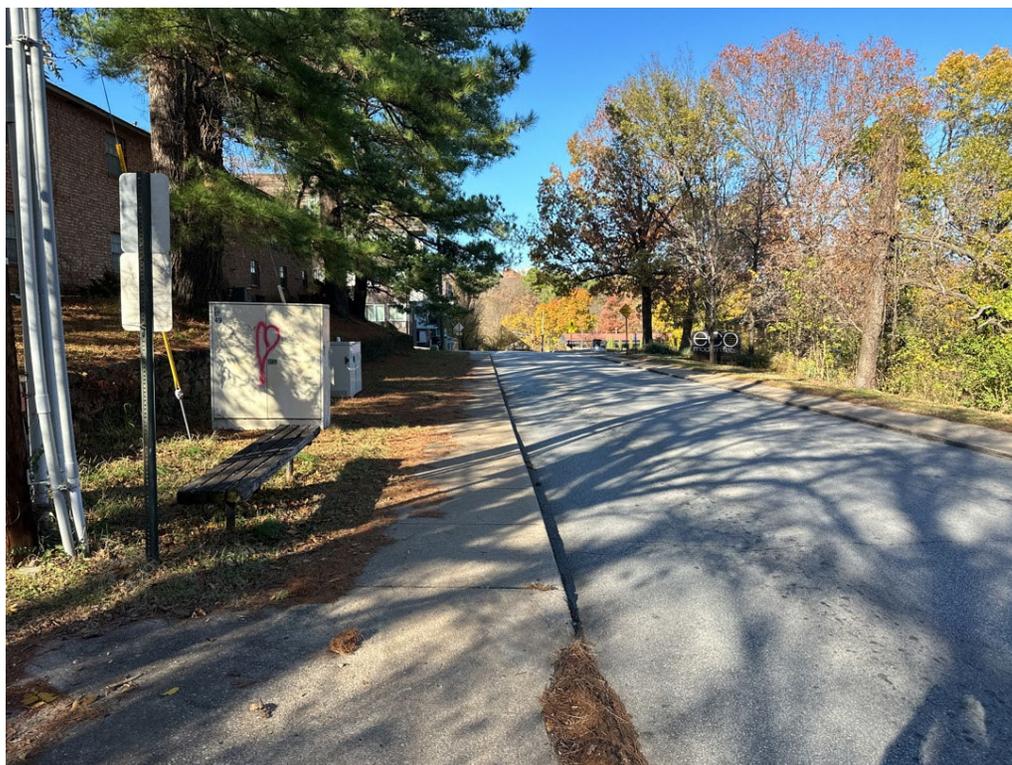
Low-ridership alighting stop with narrow sidewalk and no defined accessible landing pad. Existing seating is in poor condition and not well-suited for an alighting-focused stop. No marked loading zone is present. Expand the sidewalk to construct an accessible landing pad. Remove existing seating due to its condition and limited necessity. Stripe the roadway to establish a formal bus loading zone for improved safety and operations.

Weekday Activity	12.5
Weekend Activity	0.7
Stop Position	Mid-block
Adjacent Property Description	Apartment Building, Residence - detached
Landing Area	Concrete
Sidewalk	Yes
Sidewalk Condition	3 = Fair - minor root uplifting and breaks
Shelter	No
Seating	Yes
Lighting	No
Bicycle Parking	No
Scooter Parking	No

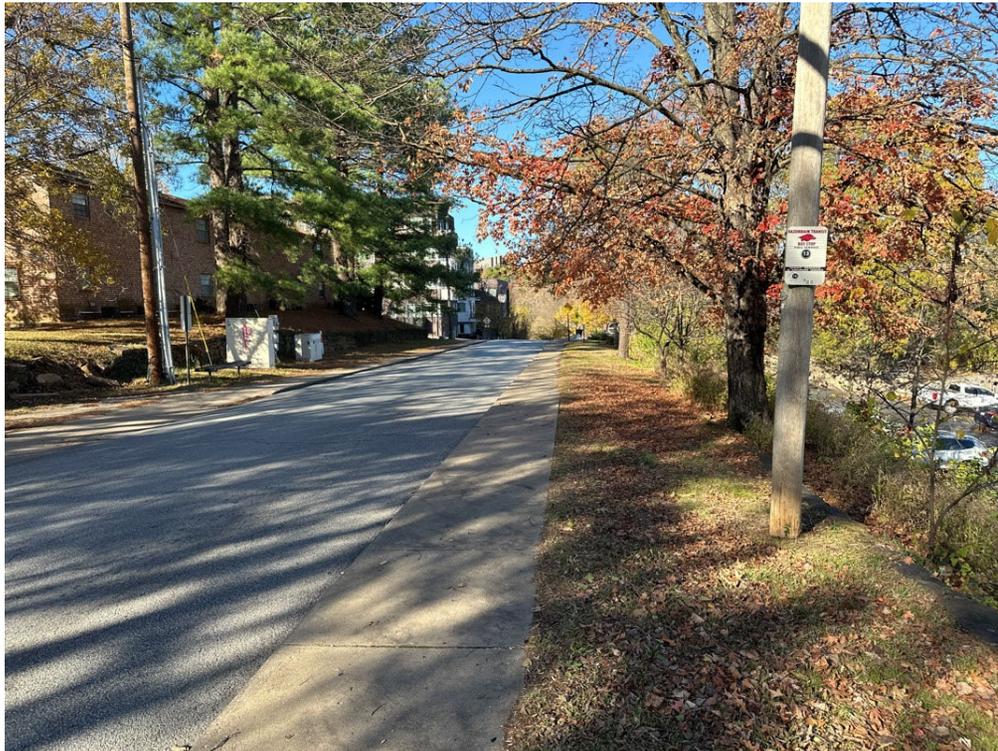
Moderate-ridership outbound stop located on a narrow sidewalk with limited boarding space and no defined landing area. The stop lacks formal identification and amenities, and street conditions pose challenges for safe boarding. Stripe a designated bus loading zone on the street. Expand the sidewalk to construct an accessible landing area. Install a formal bus stop pole and add a shelter to provide weather protection and enhance stop visibility.

Weekday Activity	39.6
Weekend Activity	1.2
Stop Position	Far-side
Adjacent Property Description	Apartment Building
Landing Area	Concrete
Sidewalk	Yes
Sidewalk Condition	3 = Fair - minor root uplifting and breaks
Shelter	No
Seating	No
Lighting	No
Bicycle Parking	No
Scooter Parking	No

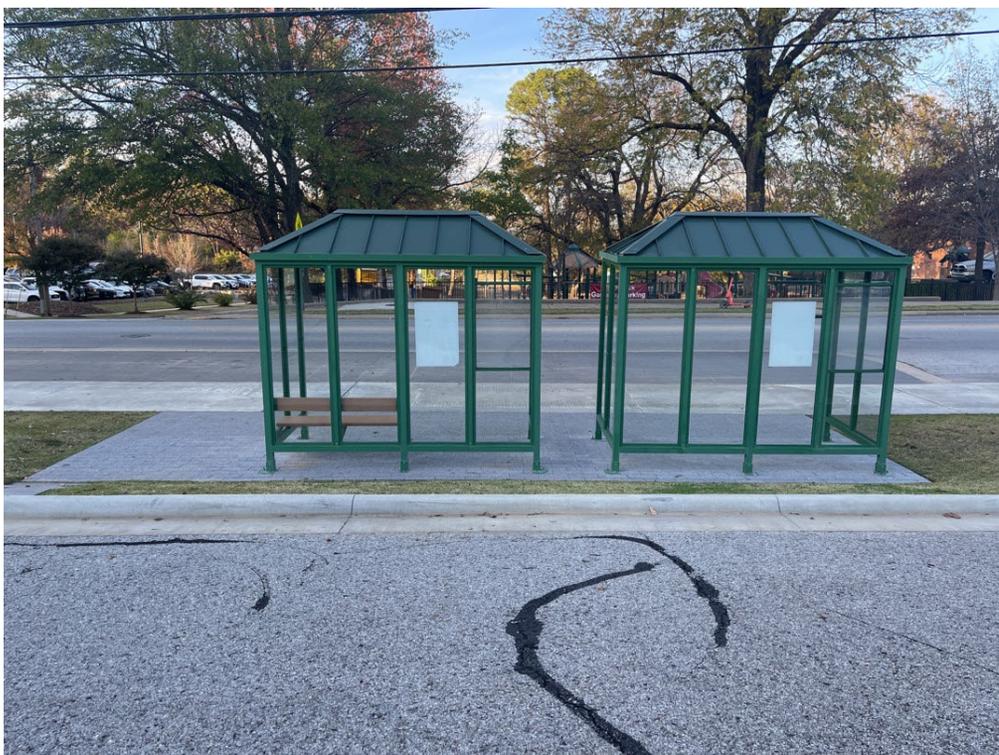
Moderate-ridership balanced stop adjacent to student housing, featuring two high-quality shelters with seating, a decorative paver landing area, sidewalk access, and scooter parking. Lighting is present along the sidewalk, but in-shelter lighting is not provided, limiting visibility during low-light hours. Add in-shelter lighting to enhance comfort and safety. Maintain existing infrastructure and ensure stair access from the adjacent parking lot remains clear and accessible.

Weekday Activity	30.1
Weekend Activity	1.5
Stop Position	Near-side
Adjacent Property Description	University Student Housing
Landing Area	Concrete
Sidewalk	Yes
Sidewalk Condition	5 = new or cosmetically excellent
Shelter	Yes
Seating	Yes
Lighting	Yes
Bicycle Parking	No
Scooter Parking	Yes

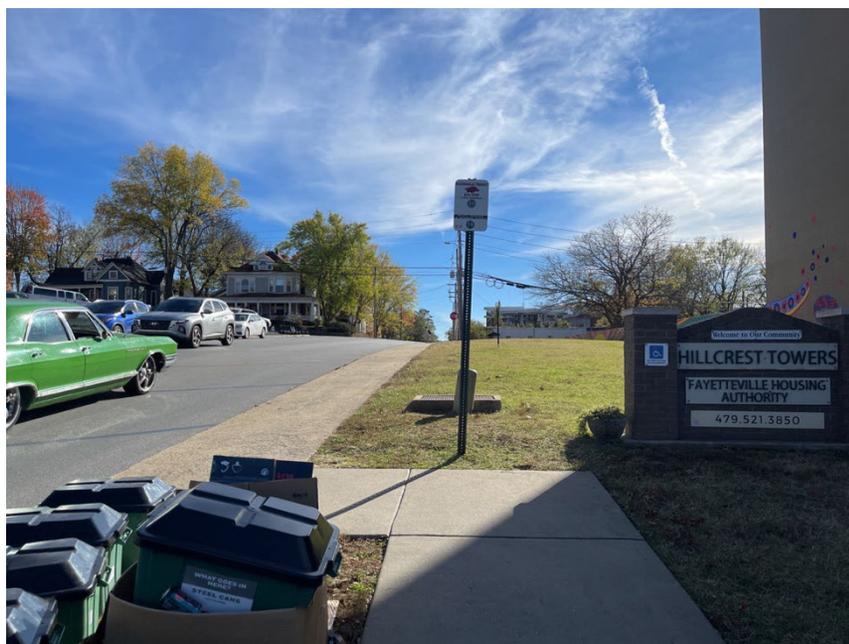
Moderate-ridership balanced stop serving Hillcrest Towers senior housing, located along a narrow sidewalk with a rolled curb and no defined landing area. The stop lacks seating, lighting, shelter, and micromobility accommodations. Trash bins obstruct boarding space, and sidewalk conditions are poor with cracks and uneven surfaces. Combine this stop with nearby Stop 149495 to establish a midblock location north of Center Street. Construct an accessible landing pad, install a full shelter package with lighting and seating, and provide designated micromobility parking. Upgrade sidewalk infrastructure to support safe and inclusive access.

Weekday Activity	39.1
Weekend Activity	11
Stop Position	Mid-block
Adjacent Property Description	Community Center
Landing Area	Concrete, Grass
Sidewalk	Yes
Sidewalk Condition	2 = Poor Shape, some cracks or breaks
Shelter	No
Seating	No
Lighting	No
Bicycle Parking	No
Scooter Parking	No

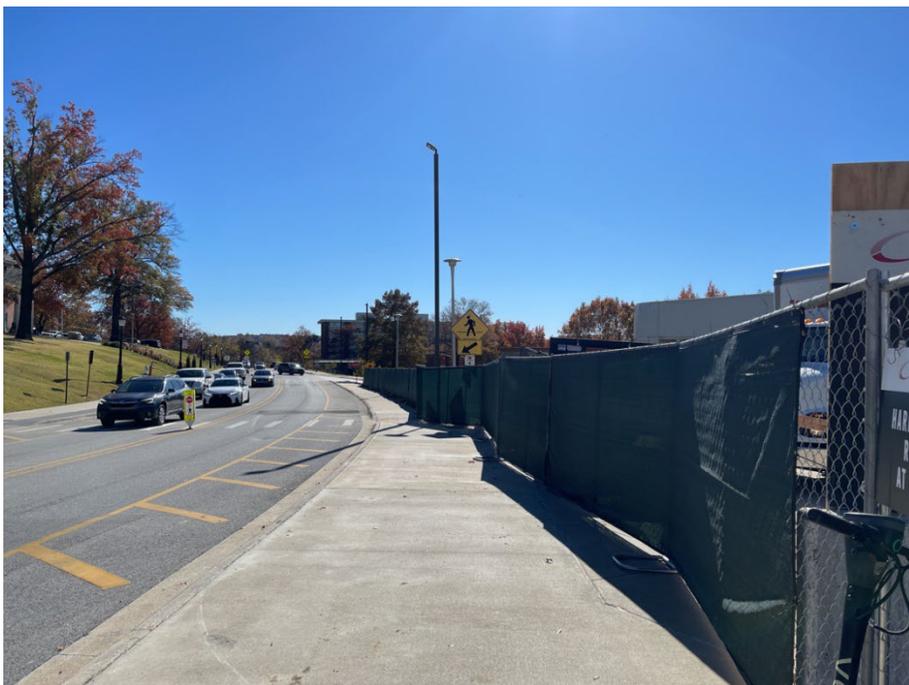
This is a low-ridership balanced stop serving the HPER facility, with an accessible landing area, sidewalk connectivity, lighting from adjacent buildings, and some seating. Scooter parking is present. The stop is currently impacted by adjacent construction, which limits pedestrian access and obscures visibility. Once construction concludes, maintain clear and accessible access to the stop, improve signage placement, and consider adding micromobility parking. A shelter is not recommended at this time due to low ridership.

Weekday Activity	2.8
Weekend Activity	0.4
Stop Position	Near-side
Adjacent Property Description	University - Sport Center/Stadium
Landing Area	Concrete
Sidewalk	Yes
Sidewalk Condition	4 = good - No immediate repair
Shelter	No
Seating	Yes
Lighting	Yes
Bicycle Parking	No
Scooter Parking	Yes

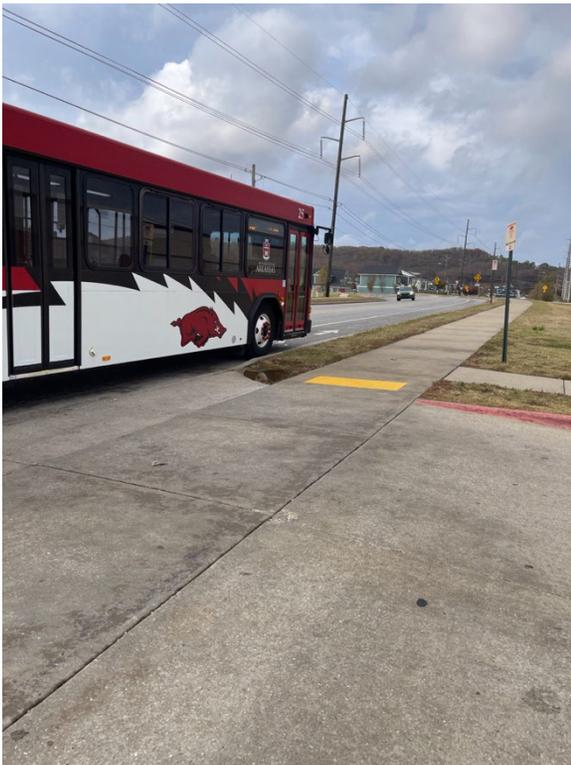
High-ridership alighting stop with sidewalk access and lighting present, but no defined landing area or seating. Riders currently board and alight from an unstructured surface, which reduces accessibility and safety. This stop is closely paired with Stop 149453 across the street. Construct an accessible landing pad and install seating to support comfort and accessibility. Coordinate with Stop 149453 to install a marked pedestrian crosswalk between the two stops to ensure safe street crossing and improve network connectivity.

Weekday Activity	155.1
Weekend Activity	4.9
Stop Position	Near-side
Adjacent Property Description	University - Sport Center/Stadium
Landing Area	Concrete, Grass
Sidewalk	Yes
Sidewalk Condition	4 = good - No immediate repair
Shelter	No
Seating	No
Lighting	Yes
Bicycle Parking	No
Scooter Parking	No
