# **NORTHWEST ARKANSAS REGIONAL PLANNING COMMISSION**

## **RAZORBACK TRANSIT BUS STOP ENHANCEMENT PLAN**

October 2025 | FINAL

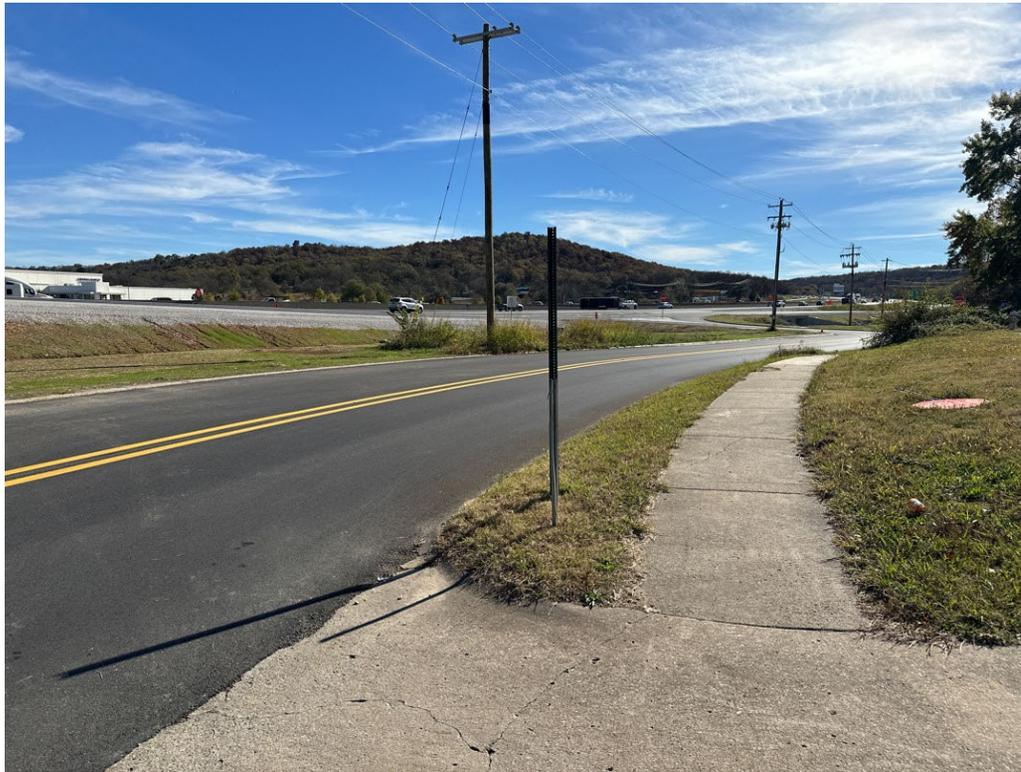
Low-ridership stop with no visible sign or pole, making it difficult for riders to identify the stop location. No defined landing pad or accessible boarding surface is present. Install a new bus stop sign and pole in a visible, accessible location. Construct an accessible landing pad to support safe boarding and ensure the stop meets basic accessibility standards.

Weekday Activity	2.1
Weekend Activity	0.9
Stop Position	Mid-block
Adjacent Property Description	Mall/Shopping Center
Landing Area	Concrete, Grass
Sidewalk	Yes
Sidewalk Condition	3 = Fair - minor root uplifting and breaks
Shelter	No
Seating	No
Lighting	No
Bicycle Parking	No
Scooter Parking	No

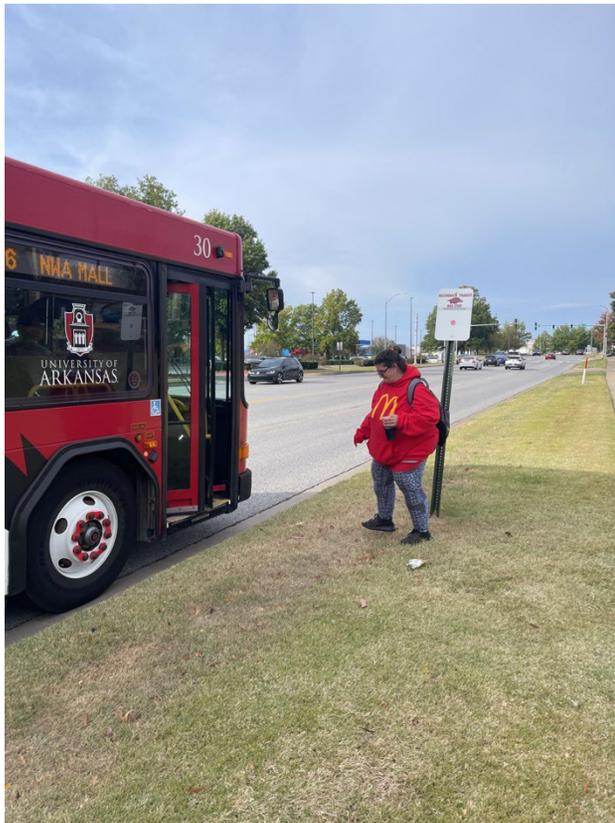
Moderate-ridership stop located near commercial destinations with no defined accessible landing pad. The site lacks seating, shelter, and dedicated lighting, limiting accessibility and comfort for riders. Construct an accessible landing pad. Add lighting for safety and visibility, and install a bench to improve comfort. Consider a shelter if ridership demand increases.

Weekday Activity	33.3
Weekend Activity	19.7
Stop Position	Mid-block
Adjacent Property Description	Retail Store
Landing Area	Grass
Sidewalk	Yes
Sidewalk Condition	4 = good - No immediate repair
Shelter	No
Seating	No
Lighting	Yes
Bicycle Parking	No
Scooter Parking	No

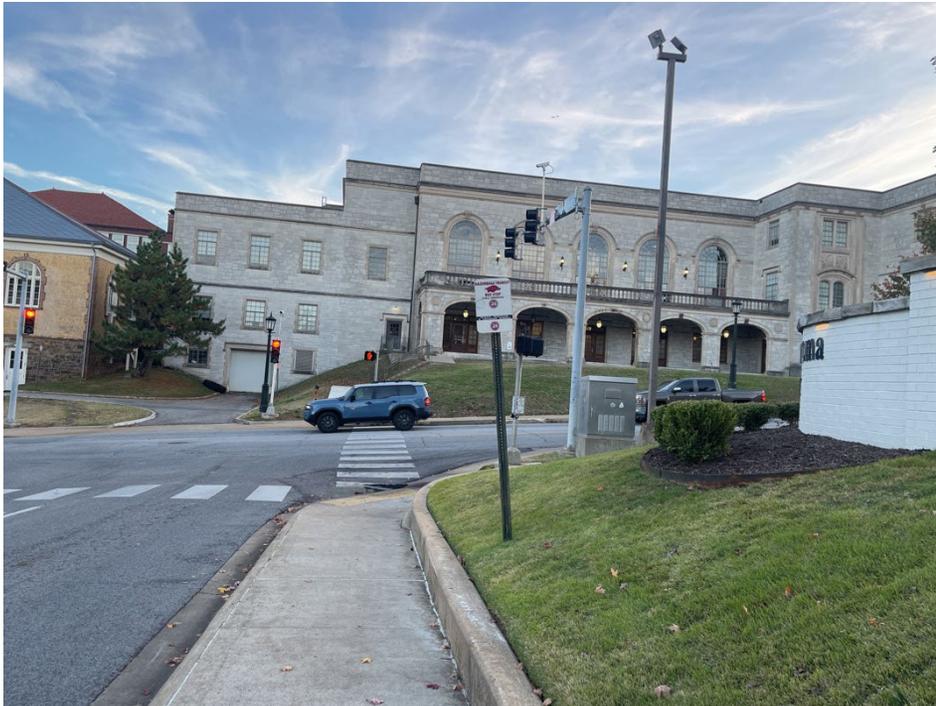
High-ridership stop with existing sign and pole but without an accessible landing pad. The current location provides limited visibility and access, making boarding conditions suboptimal. Relocate the stop slightly south to improve visibility and sidewalk access. Construct an accessible landing pad and add seating or shelter if space allows to enhance comfort and accessibility.

Weekday Activity	105.1
Weekend Activity	8.4
Stop Position	Near-side
Adjacent Property Description	Student Living
Landing Area	Concrete
Sidewalk	Yes
Sidewalk Condition	4 = good - No immediate repair
Shelter	No
Seating	No
Lighting	Yes
Bicycle Parking	No
Scooter Parking	No

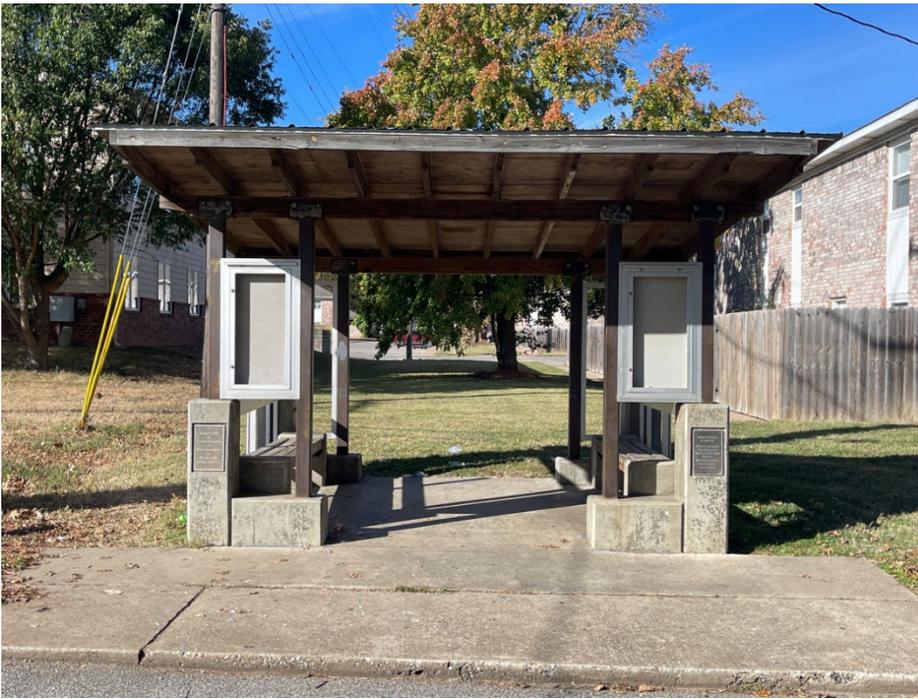
High-ridership inbound stop with existing shelter and seating. While sidewalk access is available, the current landing pad is too narrow to support safe and accessible boarding, particularly for riders using mobility devices. Widen the landing area to meet accessibility standards and ensure safe boarding. Coordinate improvements with the outbound stop across the street to provide a consistent and accessible passenger experience.

Weekday Activity	70
Weekend Activity	16.6
Stop Position	Mid-block
Adjacent Property Description	Apartment Building
Landing Area	Concrete
Sidewalk	Yes
Sidewalk Condition	2 = Poor Shape, some cracks or breaks
Shelter	Yes
Seating	Yes
Lighting	Yes
Bicycle Parking	No
Scooter Parking	No

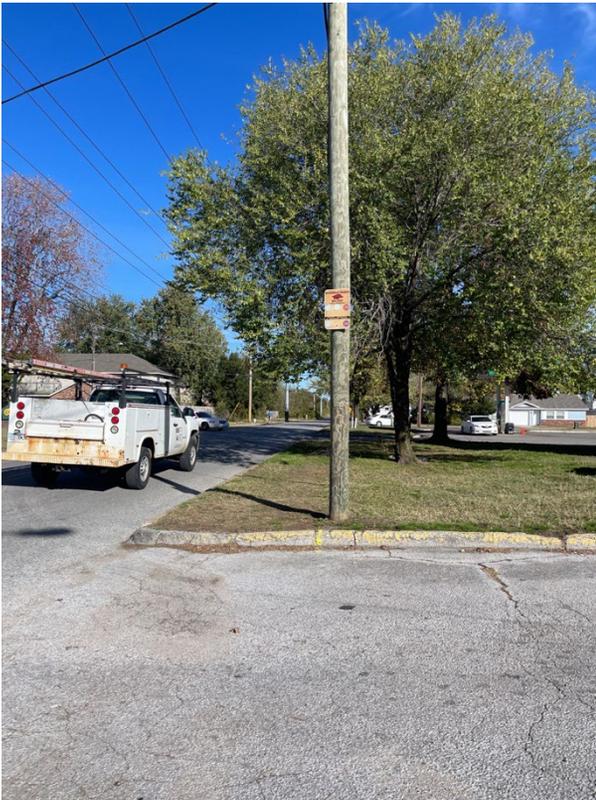
Moderate-ridership outbound stop located mid-block in the travel lane with no safe waiting area. The stop lacks a defined landing pad and shelter, and the sign is in poor condition, reducing visibility and accessibility. Relocate the stop to a safer location that improves visibility and rider access. Install an Accessible landing pad and add a shelter to match the inbound stop across the street. Replace the existing sign and pole to clearly identify the stop.

Weekday Activity	52.1
Weekend Activity	15.8
Stop Position	Mid-block
Adjacent Property Description	Apartment Building
Landing Area	Asphalt, Grass
Sidewalk	No
Sidewalk Condition	N/A
Shelter	No
Seating	No
Lighting	Yes
Bicycle Parking	No
Scooter Parking	No

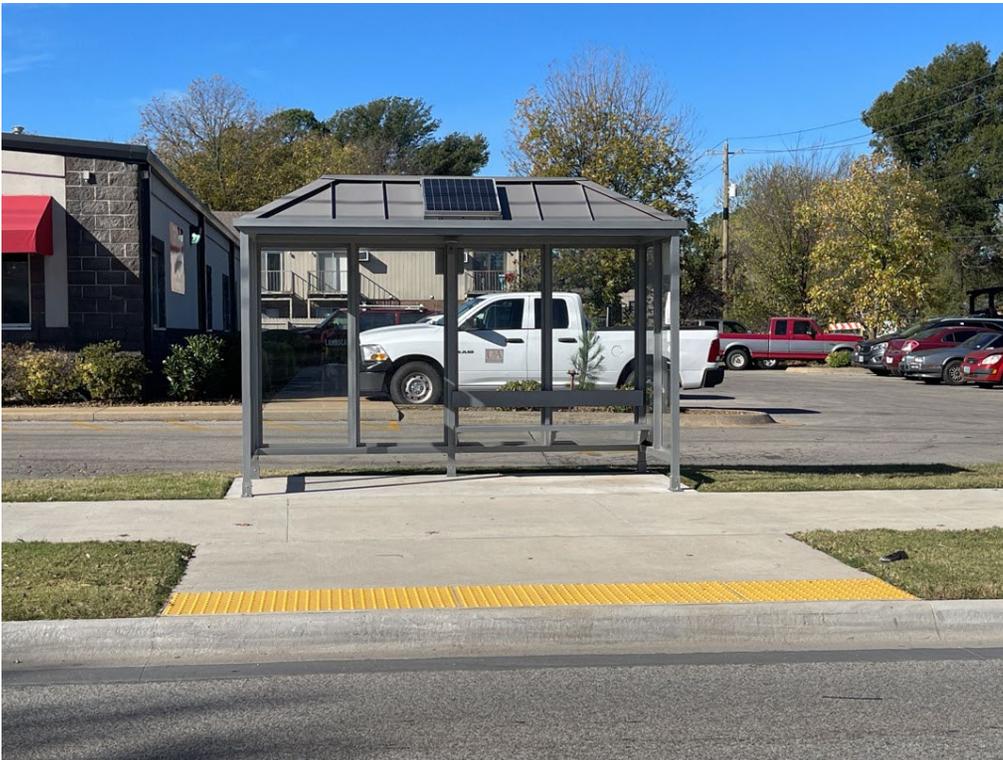
High-ridership stop in excellent condition with a new shelter, accessible landing pad, and clear, accessible connections to the sidewalk network. Lighting is present and functional. Stop needs parking for micromobility devices. Continue routine maintenance to preserve shelter quality and visibility.

Weekday Activity	70
Weekend Activity	10.2
Stop Position	Far-side
Adjacent Property Description	Auto Repair
Landing Area	Concrete
Sidewalk	Yes
Sidewalk Condition	5 = new or cosmetically excellent
Shelter	Yes
Seating	Yes
Lighting	Yes
Bicycle Parking	No
Scooter Parking	No

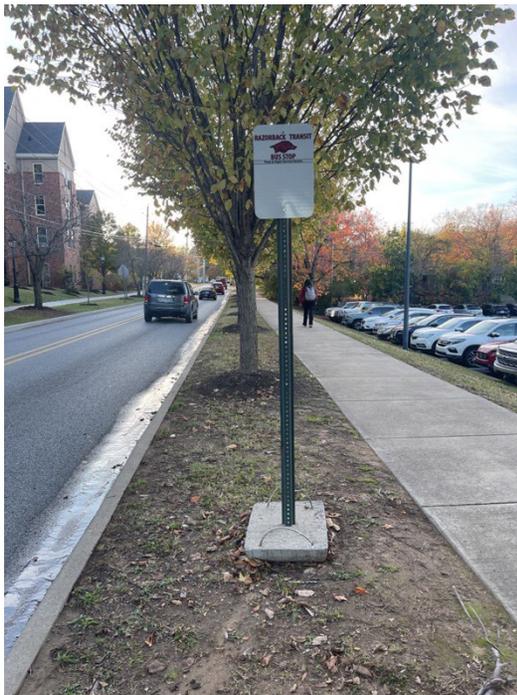
This is a low-ridership balanced stop adjacent to a large surface parking lot. The stop has sidewalk access but no defined landing area, no seating, and a temporary signpost mounted in turf. Lighting is available from the adjacent lot but not directly over the stop, and boarding occurs from a grass strip with no paved surface. Install an accessible landing pad to provide a safe, stable boarding area. Replace the temporary signpost with a permanent, properly positioned mount. Consider adding a bench to support comfort given moderate activity levels tied to nearby parking demand.

Weekday Activity	15.2
Weekend Activity	0.7
Stop Position	Far-side
Adjacent Property Description	Parking Lot
Landing Area	Dirt, Grass
Sidewalk	Yes
Sidewalk Condition	4 = good - No immediate repair
Shelter	No
Seating	No
Lighting	Yes
Bicycle Parking	No
Scooter Parking	No

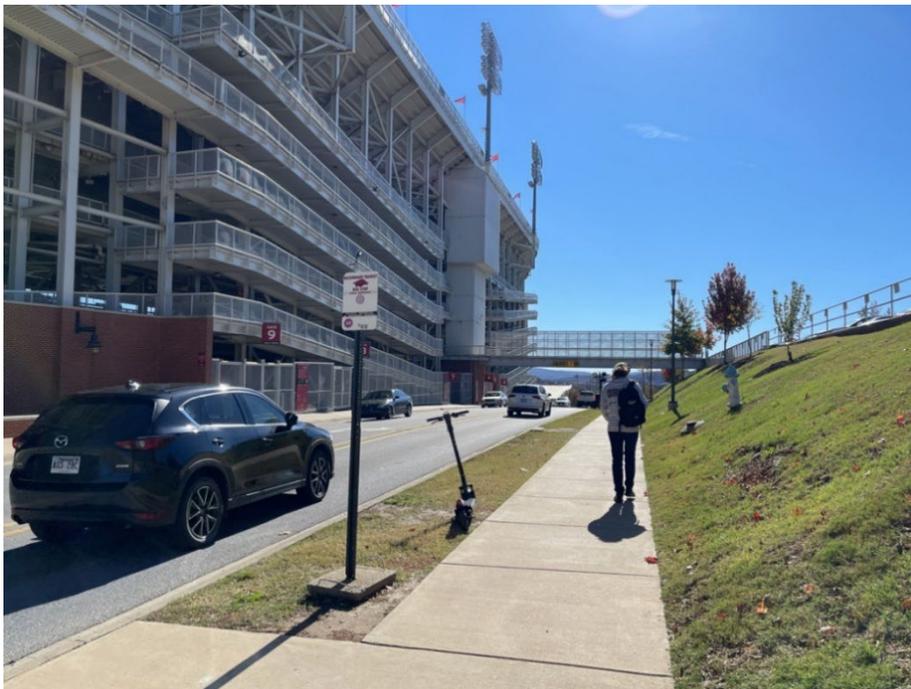
Moderate-ridership balanced stop adjacent to Razorback Stadium with sidewalk access but no defined landing area, seating, or shelter. The site is not currently shelter-ready due to a narrow hardscape zone and adjacent slope, though installation could be feasible with expanded concrete. Street lighting is present, and scooter clutter was observed. Construct an accessible landing pad and install designated micromobility parking to reduce obstruction. Reorient the sign for better visibility along the travel path.

Weekday Activity	22
Weekend Activity	1
Stop Position	Far-side
Adjacent Property Description	University - Sport Center/Stadium
Landing Area	Concrete
Sidewalk	Yes
Sidewalk Condition	4 = good - No immediate repair
Shelter	No
Seating	No
Lighting	Yes
Bicycle Parking	No
Scooter Parking	No

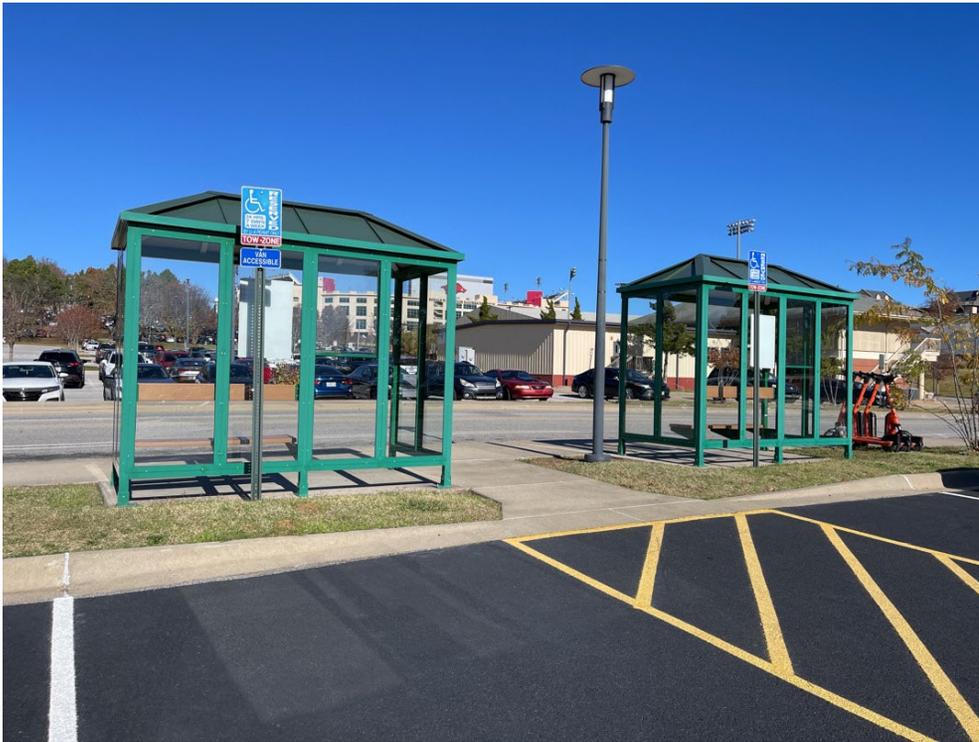
High-ridership, boarding-oriented stop in good condition with two full shelters, benches, sidewalk-level boarding, and adjacent micromobility parking. Lightpole nearby provides ambient lighting, but shelters lack in-unit lighting. Monitor crowding and explore shelter lighting retrofit if usage continues to grow.

Weekday Activity	362
Weekend Activity	1.6
Stop Position	Near-side
Adjacent Property Description	Parking Lot
Landing Area	Concrete
Sidewalk	Yes
Sidewalk Condition	4 = good - No immediate repair
Shelter	Yes
Seating	Yes
Lighting	Yes
Bicycle Parking	No
Scooter Parking	Yes

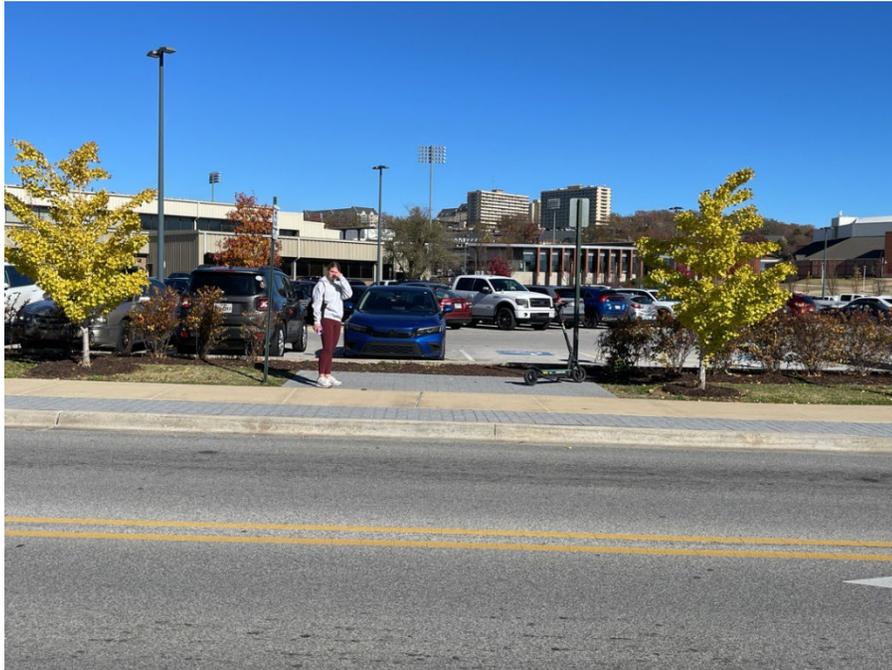
High-ridership inbound stop with a paved waiting area but no passenger amenities. Riders regularly wait in this area, and the absence of seating, shelter, and micromobility accommodations limits comfort and contributes to sidewalk clutter. Install a shelter and bench to support passenger comfort and accommodate high boarding volumes. Add micromobility parking to manage scooter storage and maintain clear pedestrian pathways.

Weekday Activity	249.9
Weekend Activity	2.3
Stop Position	Far-side
Adjacent Property Description	Park and Ride
Landing Area	Pavers
Sidewalk	Yes
Sidewalk Condition	4 = good - No immediate repair
Shelter	No
Seating	No
Lighting	Yes
Bicycle Parking	No
Scooter Parking	Yes

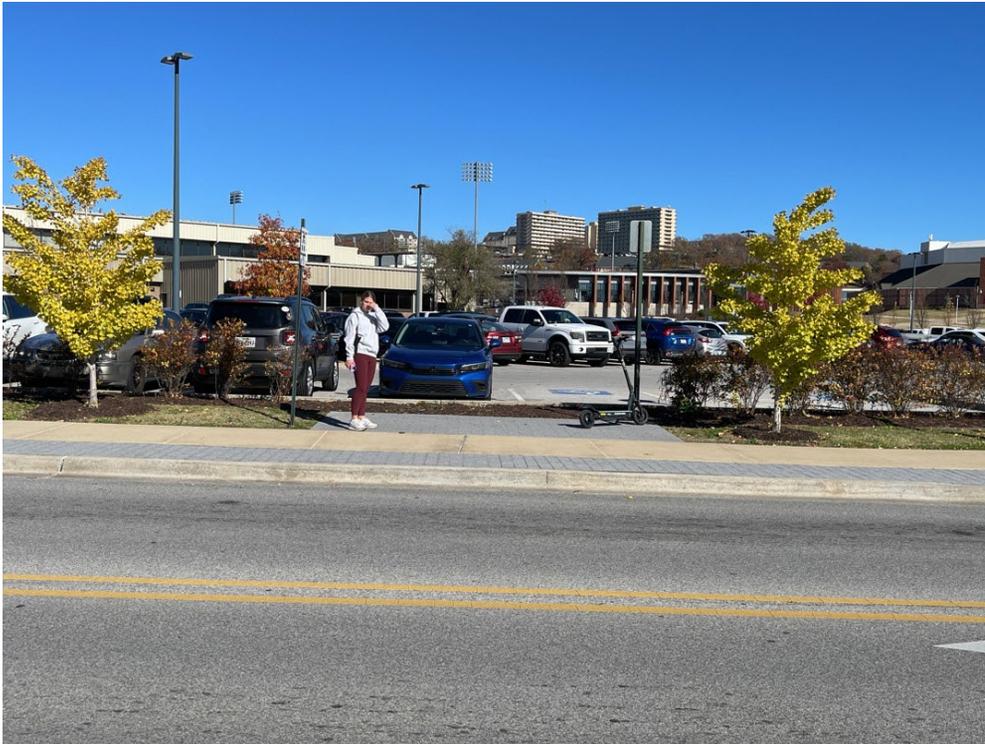
High-ridership alighting stop with a paved waiting area and good visibility. While the site is shelter-ready, current usage patterns do not justify a shelter. No seating or micromobility accommodations are currently provided. Install a bench to support comfort for waiting passengers. Add micromobility parking to organize bike and scooter use. Reevaluate shelter need if boarding activity increases.

Weekday Activity	72.1
Weekend Activity	3.6
Stop Position	Near-side
Adjacent Property Description	University - Sport Center/Stadium
Landing Area	Pavers
Sidewalk	Yes
Sidewalk Condition	4 = good - No immediate repair
Shelter	No
Seating	No
Lighting	Yes
Bicycle Parking	No
Scooter Parking	No

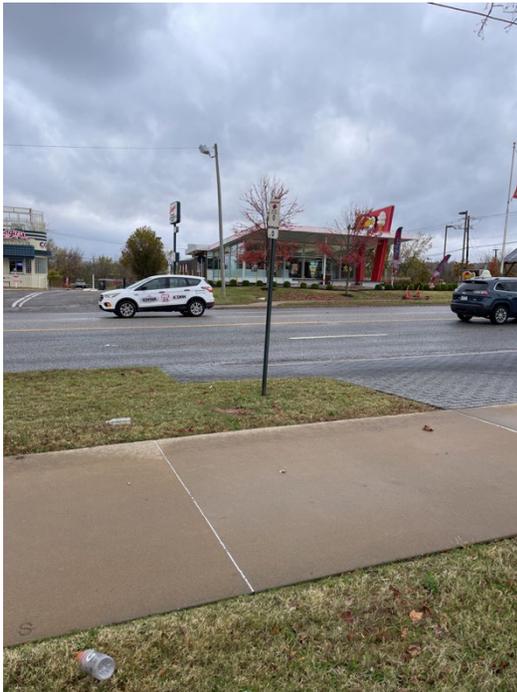
Low-ridership stop with a leaning signpost and no defined landing pad or seating. The site is not currently shelter ready due to a lack of concrete and a nearby driveway that limits available space. Reset the leaning signpost and install an accessible landing pad. Add a bench to improve rider comfort. Monitor site conditions for future shelter feasibility if infrastructure constraints are resolved.

Weekday Activity	13.4
Weekend Activity	6
Stop Position	Far-side
Adjacent Property Description	University Administration Building
Landing Area	Dirt, Grass, Pavers
Sidewalk	Yes
Sidewalk Condition	5 = new or cosmetically excellent
Shelter	No
Seating	No
Lighting	No
Bicycle Parking	No
Scooter Parking	No

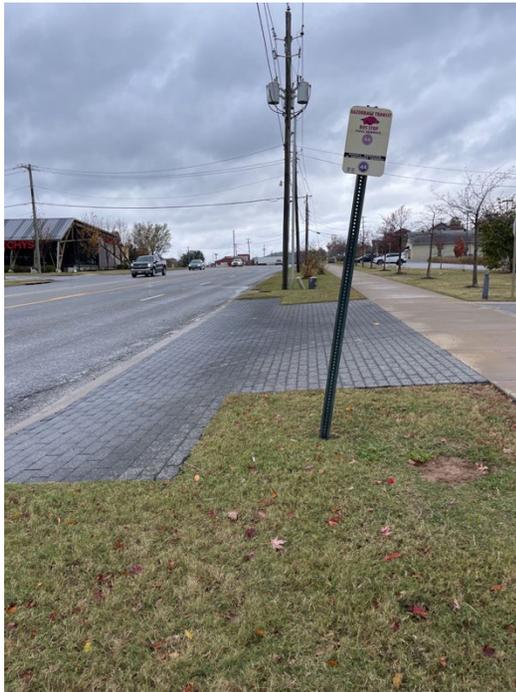
Low-ridership stop with a leaning signpost and no defined, concrete landing pad or seating. The site is not currently shelter ready due to a lack of concrete and a nearby driveway that limits available space. Reset the leaning signpost and install an accessible, concrete landing pad. Add a bench to improve rider comfort. Monitor site conditions for future shelter feasibility if infrastructure constraints are resolved.

Weekday Activity	13.4
Weekend Activity	6
Stop Position	Far-side
Adjacent Property Description	University Administration Building
Landing Area	Dirt, Grass, Pavers
Sidewalk	Yes
Sidewalk Condition	5 = new or cosmetically excellent
Shelter	No
Seating	No
Lighting	No
Bicycle Parking	No
Scooter Parking	No

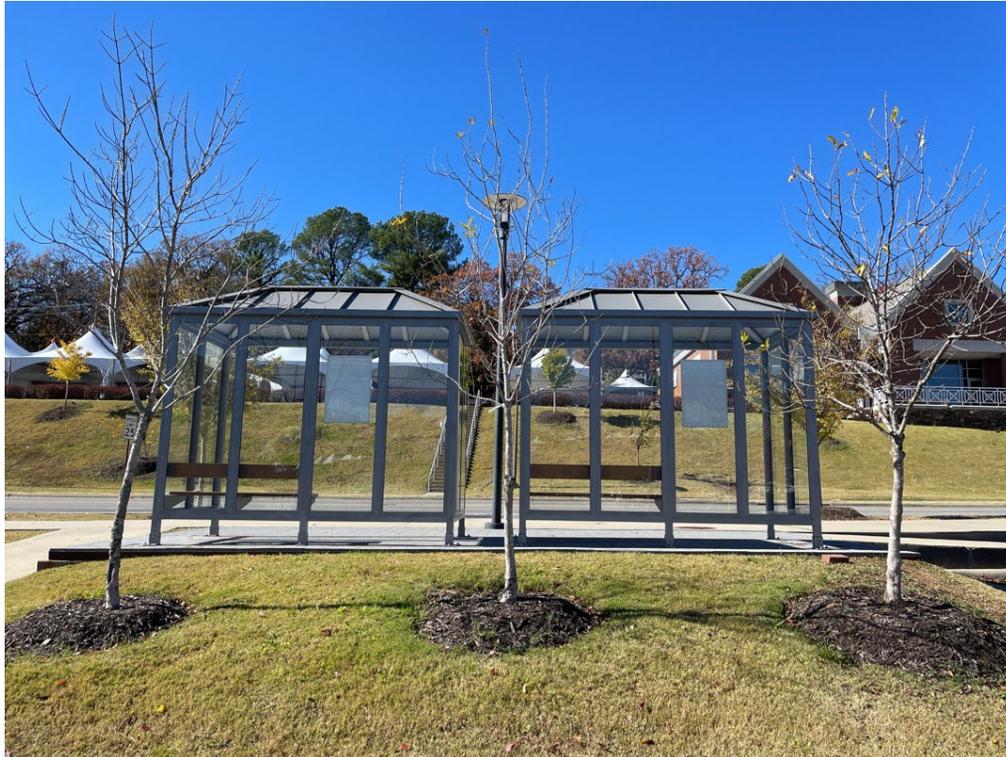
High-ridership stop with a full shelter, adequate lighting, and a wide, accessible landing area. All infrastructure is in excellent condition and supports safe, comfortable boarding. No improvements needed at this time. Continue routine maintenance to preserve existing stop quality.

Weekday Activity	90.6
Weekend Activity	1.3
Stop Position	Near-side
Adjacent Property Description	University - Sport Center/Stadium
Landing Area	Pavers
Sidewalk	Yes
Sidewalk Condition	5 = new or cosmetically excellent
Shelter	Yes
Seating	Yes
Lighting	Yes
Bicycle Parking	No
Scooter Parking	No

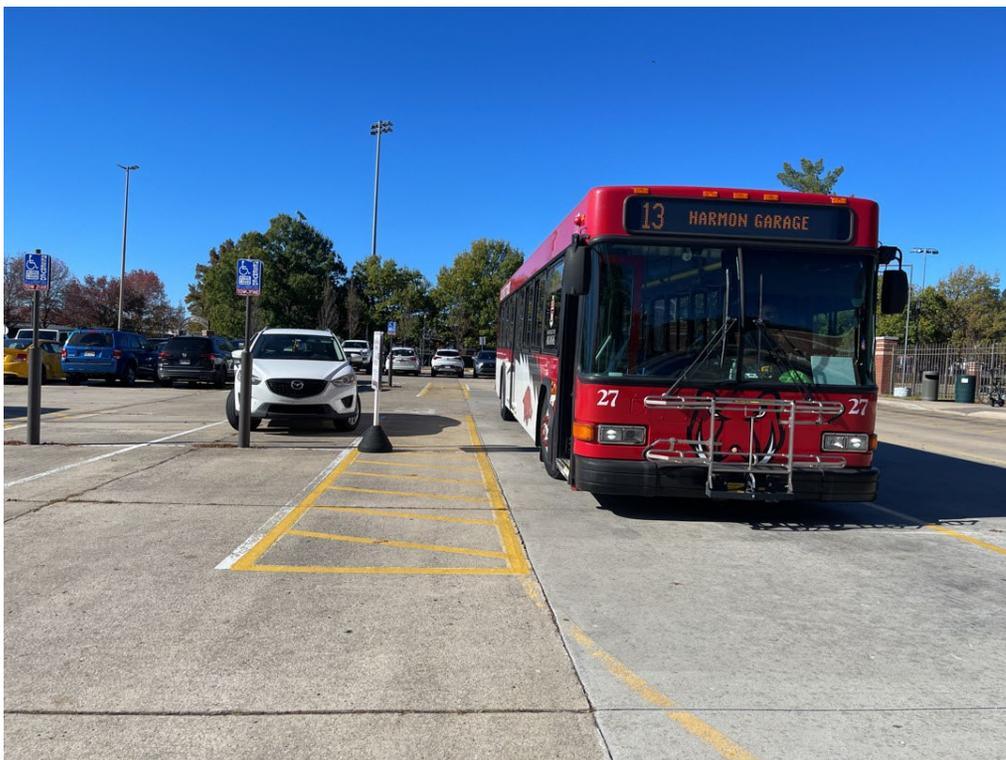
High-ridership balanced stop in good condition with paved surface and accessible boarding area. No shelter present at this post, but site is shelter-ready and adjacent to shelter-equipped stop 149556. Recommend coordinated improvements and signage with nearby stops. Good lighting and parking nearby; monitor for clarity and access during events.

Weekday Activity	290.5
Weekend Activity	2.7
Stop Position	Far-side
Adjacent Property Description	Park and Ride
Landing Area	Asphalt
Sidewalk	No
Sidewalk Condition	N/A
Shelter	No
Seating	No
Lighting	Yes
Bicycle Parking	No
Scooter Parking	No

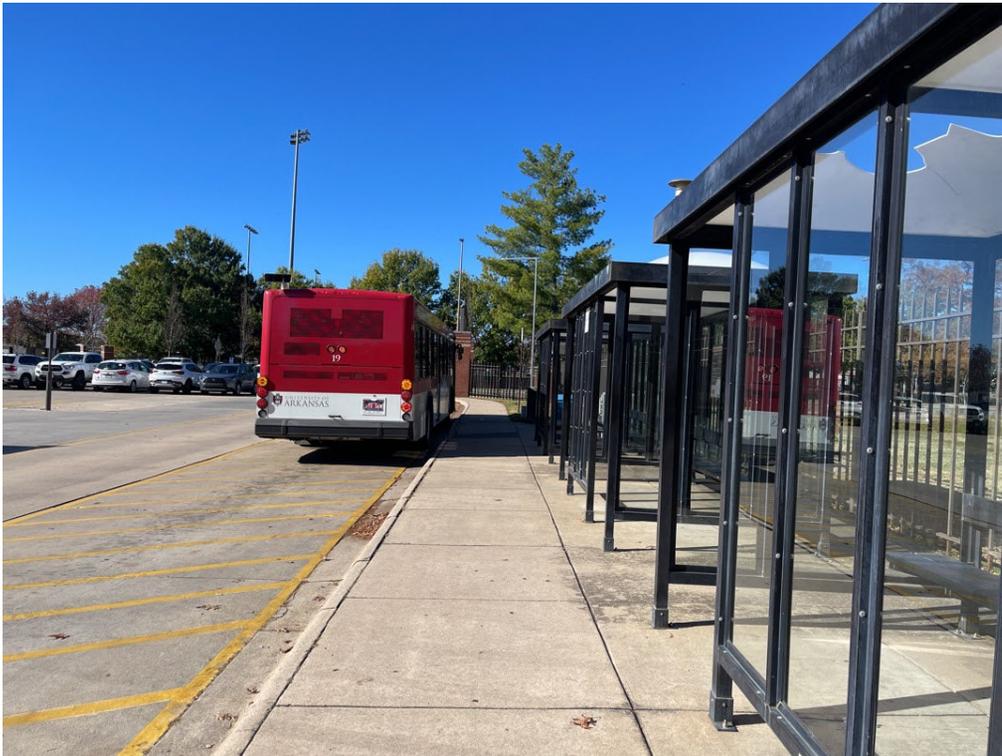
High-ridership balanced stop in good condition with full shelter, seating, trash receptacles, lighting, and clear boarding area. One shelter has visible roof damage, repair recommended. Micromobility parking area exists but clutter persists; consider delineation or signage to better organize parking. Monitor for crowding during peak times.

Weekday Activity	667.1
Weekend Activity	0
Stop Position	Near-side
Adjacent Property Description	Park and Ride
Landing Area	Concrete
Sidewalk	Yes
Sidewalk Condition	4 = good - No immediate repair
Shelter	Yes
Seating	Yes
Lighting	Yes
Bicycle Parking	Yes
Scooter Parking	Yes

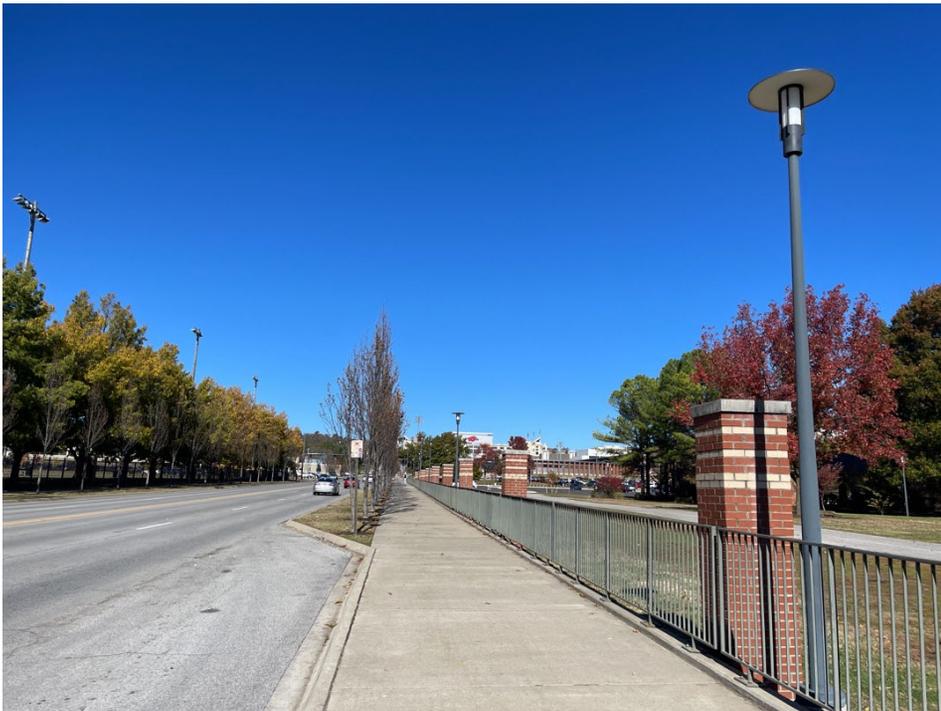
Moderate-ridership balanced stop located in a bus cutout adjacent to a wide sidewalk and open space near Razorback Road. The stop has no seating or shelter, and the posted sign is faded and difficult to see. The site is shelter-ready but does not currently warrant one based on use. Replace the sign to improve visibility and install an accessible landing pad and bench to enhance comfort. Coordinate with Razorback Transit if future removal of the bus cutout is pursued.

Weekday Activity	21.6
Weekend Activity	5
Stop Position	Near-side
Adjacent Property Description	Park
Landing Area	Concrete
Sidewalk	Yes
Sidewalk Condition	4 = good - No immediate repair
Shelter	No
Seating	No
Lighting	Yes
Bicycle Parking	No
Scooter Parking	No

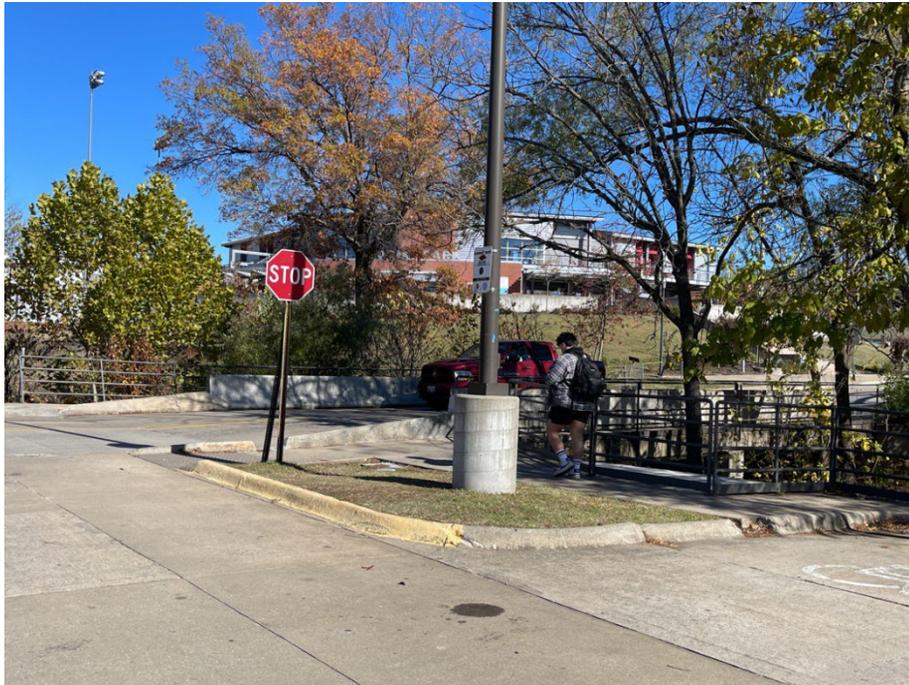
High-ridership boarding stop adjacent to a Park and Ride lot, with boarding occurring from a narrow strip along a driveway. The current sign is mounted on a shared pole and partially obscured, and there is no accessible landing pad, seating, or micromobility parking. The site is not currently shelter ready but could be upgraded with modest improvements. Construct an accessible landing pad with a clear sidewalk connection and install a bench. Add micromobility parking to manage scooters and reduce clutter. Coordinate improvements with nearby stops 149553 and 149556 to ensure a consistent and accessible experience along this segment.

Weekday Activity	68.9
Weekend Activity	0.1
Stop Position	Near-side
Adjacent Property Description	Park and Ride
Landing Area	Concrete, Grass
Sidewalk	Yes
Sidewalk Condition	4 = good - No immediate repair
Shelter	No
Seating	No
Lighting	Yes
Bicycle Parking	No
Scooter Parking	No

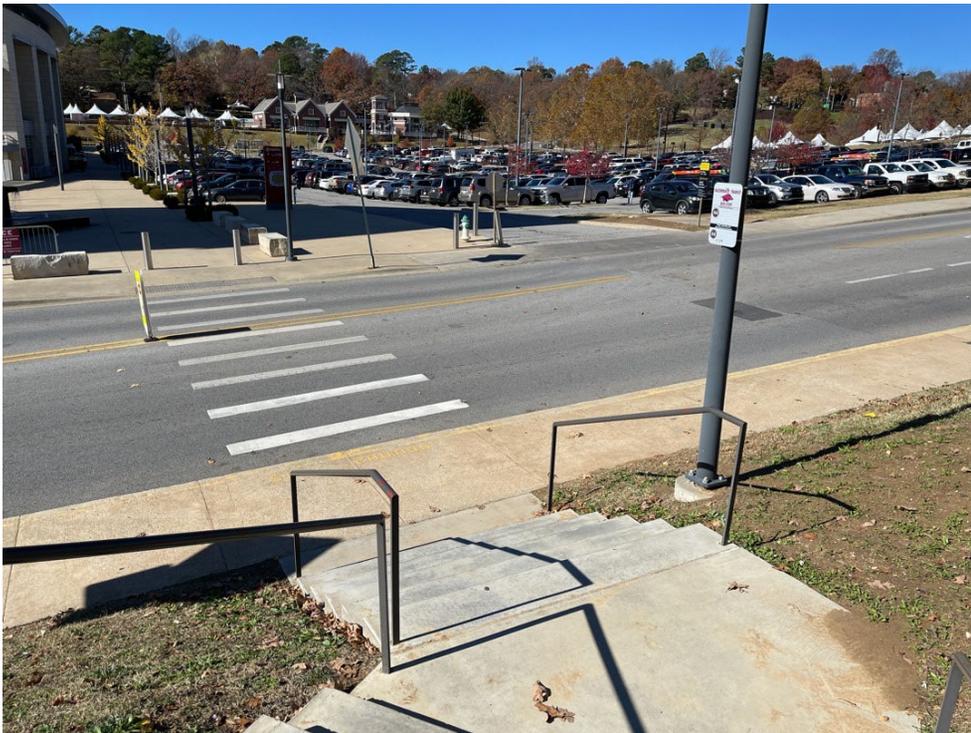
Low-ridership alighting stop with sidewalk present and no seating available. The sign is mounted to a light pole at the top of a stairway, creating a steep and inaccessible connection to the street. This location limits use by passengers with mobility challenges and offers no level access from adjacent paths. Evaluate relocation of the stop to a more accessible location with a direct sidewalk connection and level boarding area.

Weekday Activity	3.3
Weekend Activity	0.3
Stop Position	Far-side
Adjacent Property Description	University - Sport Center/Stadium
Landing Area	Concrete
Sidewalk	Yes
Sidewalk Condition	3 = Fair - minor root uplifting and breaks
Shelter	No
Seating	No
Lighting	Yes
Bicycle Parking	No
Scooter Parking	No

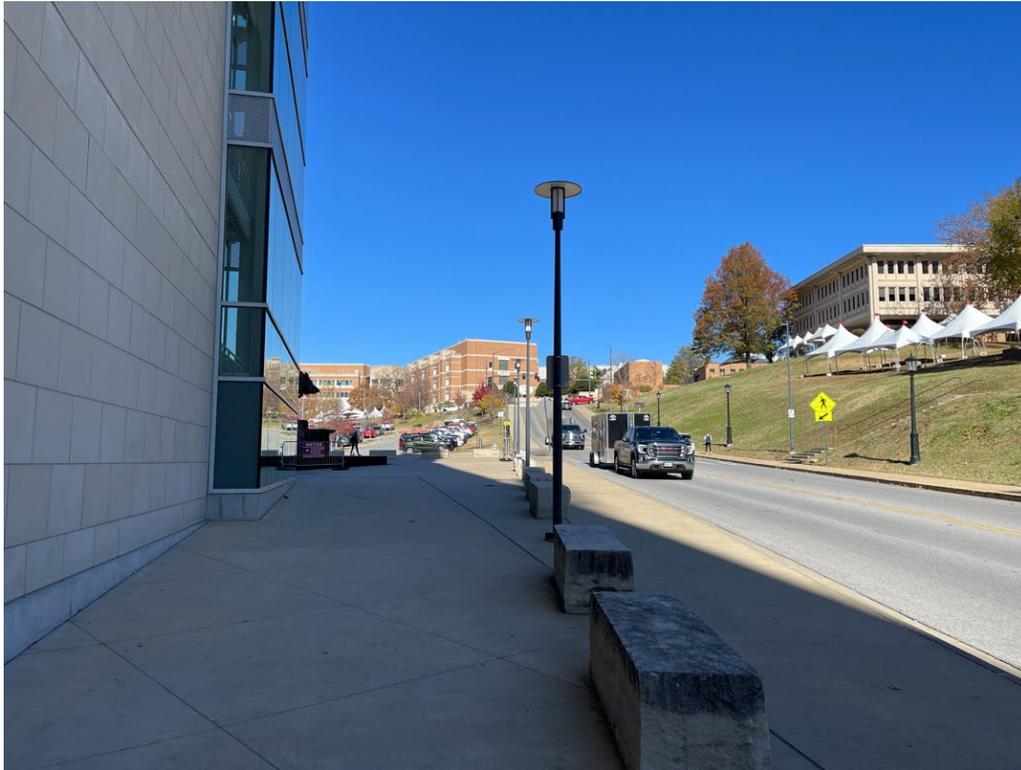
Low-ridership balanced stop with adequate landing area, sidewalk, seating and lighting present. Sign mounted on light pole with wide, paved waiting area. Stop is shelter-ready, consider adding shelter if demand increases.

Weekday Activity	3
Weekend Activity	0.3
Stop Position	Far-side
Adjacent Property Description	University - Sport Center/Stadium
Landing Area	Concrete
Sidewalk	Yes
Sidewalk Condition	4 = good - No immediate repair
Shelter	No
Seating	Yes
Lighting	Yes
Bicycle Parking	No
Scooter Parking	No

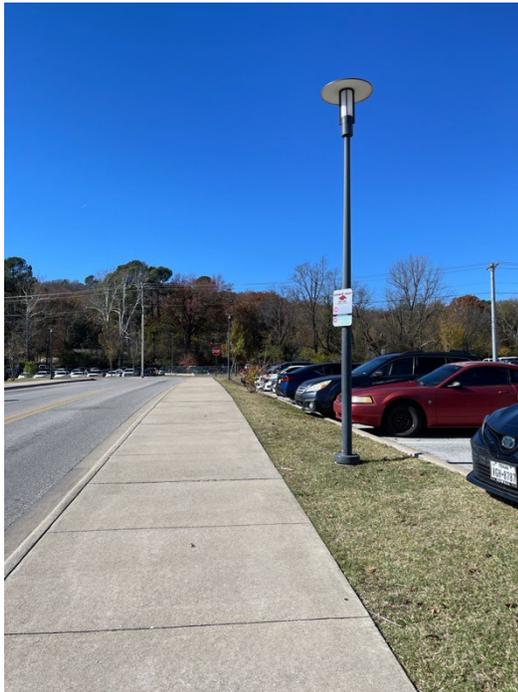
High-ridership alighting stop in good condition, located directly across from the high-ridership boarding stop at 149564. Currently signed only with a pole; no boarding pad or amenities are provided. While shelter is not recommended due to stop function, the site has adequate space to accommodate a landing pad and potentially a shelter in the future if boarding demand increases. Consider coordinating improvements with 149564 for visual and functional consistency.

Weekday Activity	69
Weekend Activity	1.5
Stop Position	Far-side
Adjacent Property Description	University Administration Building
Landing Area	Concrete
Sidewalk	Yes
Sidewalk Condition	4 = good - No immediate repair
Shelter	No
Seating	No
Lighting	Yes
Bicycle Parking	No
Scooter Parking	No

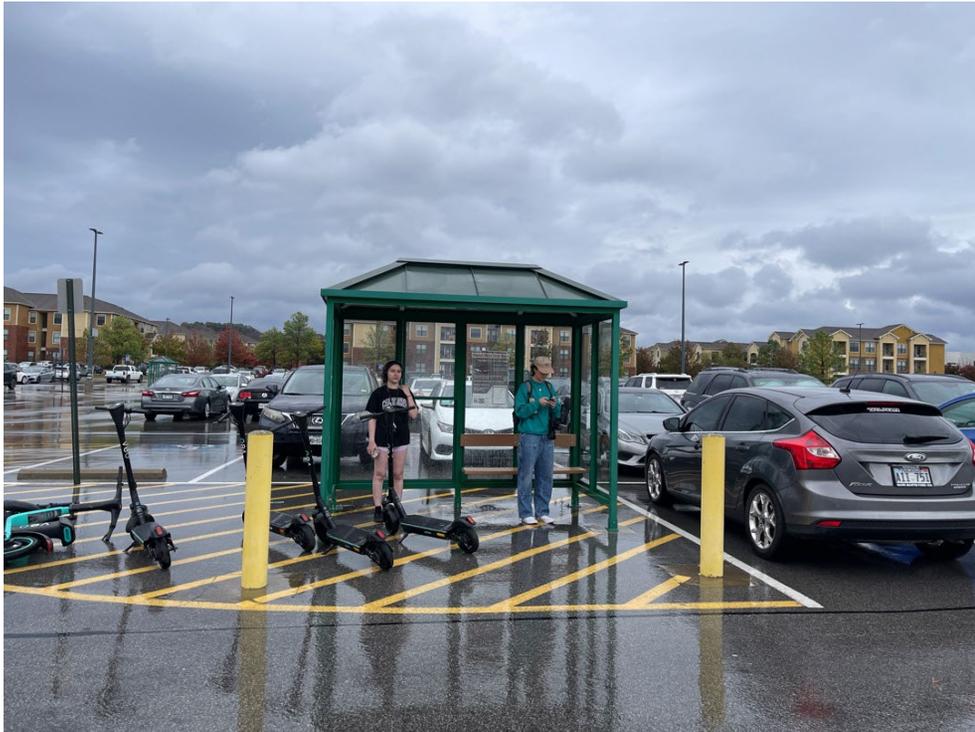
High-ridership balanced stop serving Economy Parking with existing shelter and sidewalk access. Recommend expanding shelter capacity to accommodate peak demand. No dedicated lighting in shelter, add lighting for safety and visibility. Scooter presence observed, add micromobility parking to reduce clutter and maintain clear boarding area. Stop is in good condition and not a relocation candidate.

Weekday Activity	331.2
Weekend Activity	7.8
Stop Position	Not Near an Intersection
Adjacent Property Description	Apartment Building, University Student Housing
Landing Area	Asphalt
Sidewalk	No
Sidewalk Condition	N/A
Shelter	Yes
Seating	Yes
Lighting	Yes
Bicycle Parking	No
Scooter Parking	Yes

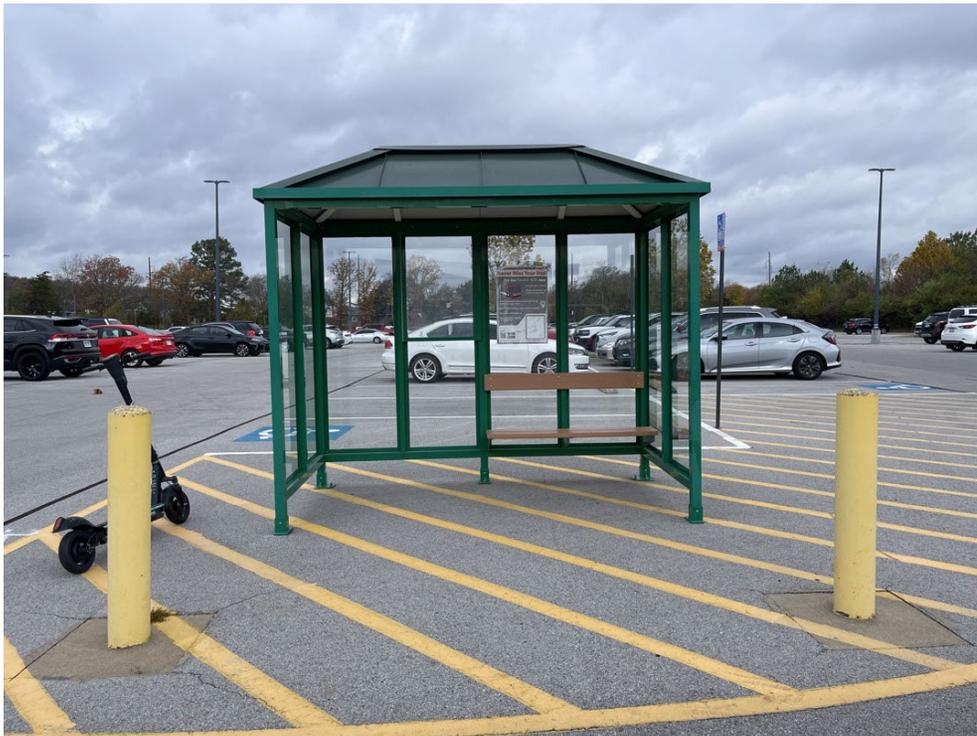
High-ridership balanced stop across from 149567 serving Economy Parking. Existing shelter is well-used, recommend expansion to better support demand. Scooter presence noted, add micromobility parking to manage clutter. Coordinate improvements with sister stop 149567 to maintain consistency across the pair. Site is in good condition with accessible boarding.

Weekday Activity	291.8
Weekend Activity	11.7
Stop Position	Not Near an Intersection
Adjacent Property Description	Apartment Building, University Student Housing
Landing Area	Asphalt
Sidewalk	No
Sidewalk Condition	N/A
Shelter	Yes
Seating	Yes
Lighting	Yes
Bicycle Parking	No
Scooter Parking	Yes

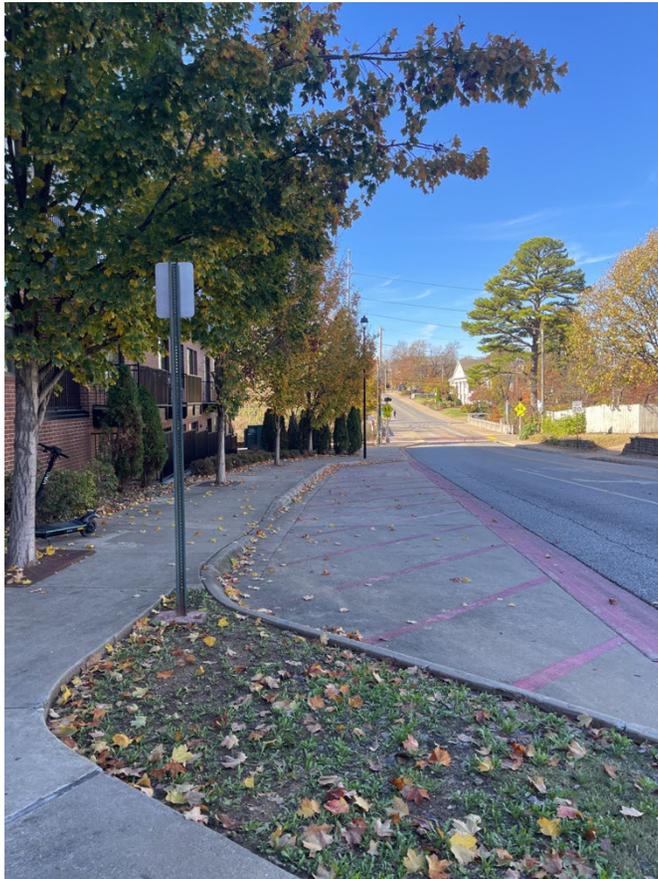
Low-ridership balanced stop with signpost in grass and existing bus cutout. No shelter or lighting currently present. Recommend evaluating removal of cutout, improving lighting, and adding shelter if future ridership growth supports investment. Site lacks paved boarding area and is not currently shelter ready.

Weekday Activity	7.5
Weekend Activity	0
Stop Position	N/A
Adjacent Property Description	Apartment Building
Landing Area	Concrete
Sidewalk	Yes
Sidewalk Condition	1 = Hazardous - large brakes, cracks, root uplifting, risk of injury from Normal use
Shelter	No
Seating	No
Lighting	Yes
Bicycle Parking	No
Scooter Parking	No

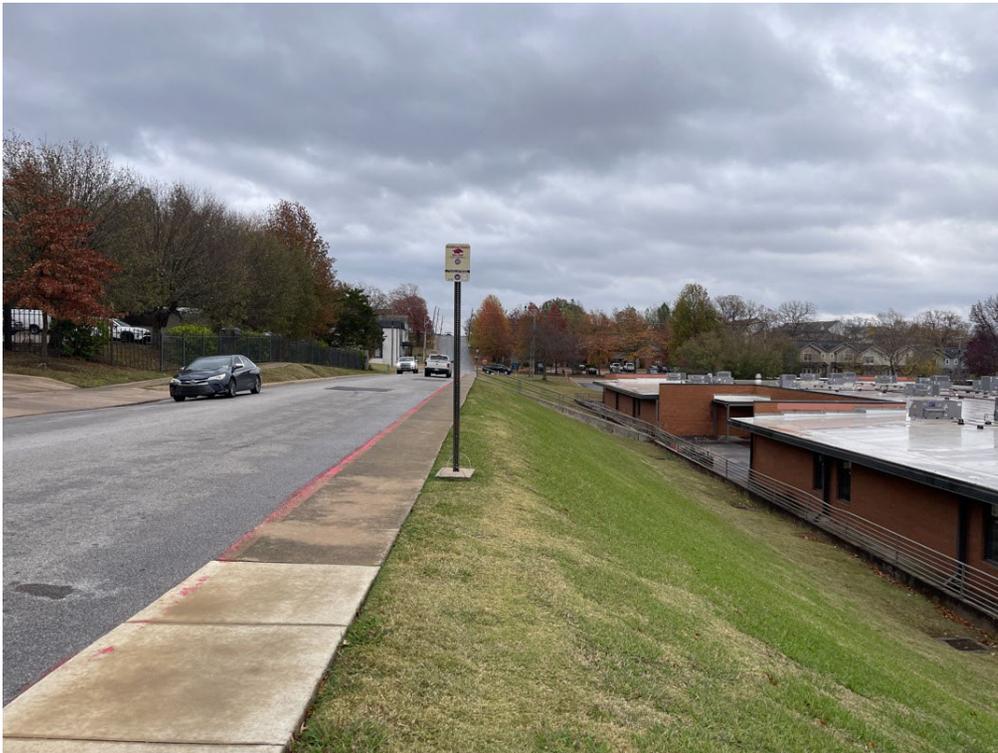
Low-ridership balanced stop located on temporary concrete pad in grassy area with sloped terrain. Sidewalk is too narrow for shelter and site is not shelter ready. Stop is slated for relocation to the east where terrain allows for the addition of a loading platform.

Weekday Activity	7.3
Weekend Activity	1.3
Stop Position	Near-side
Adjacent Property Description	Apartment Building
Landing Area	Concrete
Sidewalk	Yes
Sidewalk Condition	3 = Fair - minor root uplifting and breaks
Shelter	No
Seating	No
Lighting	Yes
Bicycle Parking	No
Scooter Parking	No

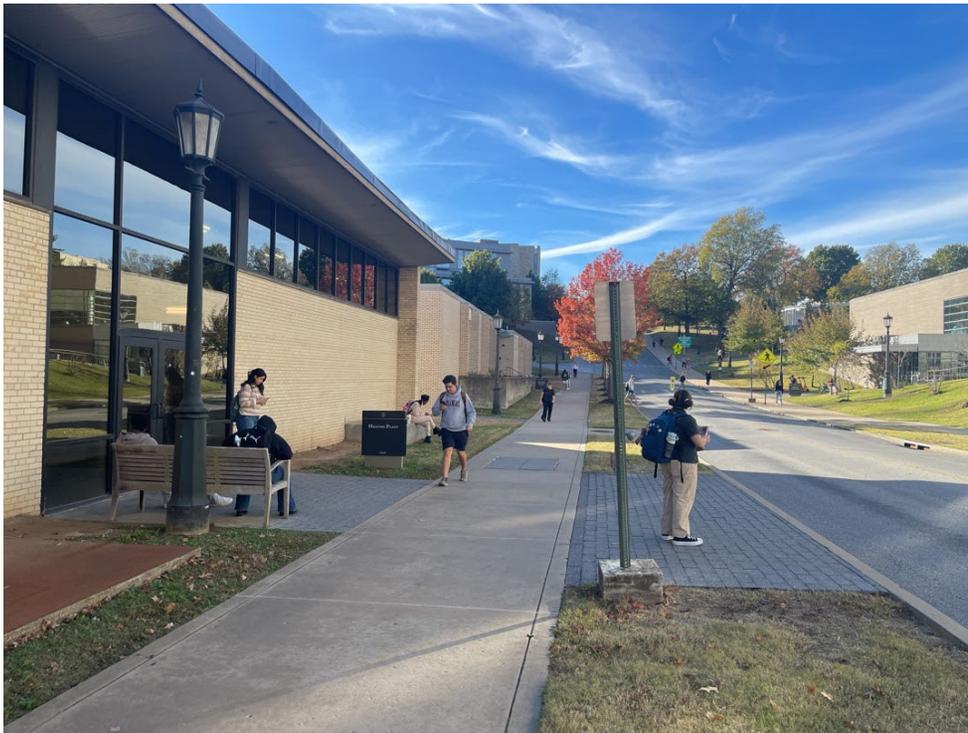
High-ridership balanced stop directly across from 149602. Signpost is placed in a concrete block and lacks visibility. Amenities include a nearby bench, but no shelter or lighting directly at the stop. Landing surface is paved with unit pavers and connects to sidewalk. Recommend replacing the temporary signpost with a permanent installation, adding a trash receptacle, and installing a shelter due to its boarding function. Consider adding lighting and improved signage visibility. Upgrades should align with improvements at 149602 to ensure consistency.

Weekday Activity	151.3
Weekend Activity	1.6
Stop Position	Mid-block
Adjacent Property Description	School
Landing Area	Pavers
Sidewalk	Yes
Sidewalk Condition	4 = good - No immediate repair
Shelter	No
Seating	Yes
Lighting	Yes
Bicycle Parking	No
Scooter Parking	No

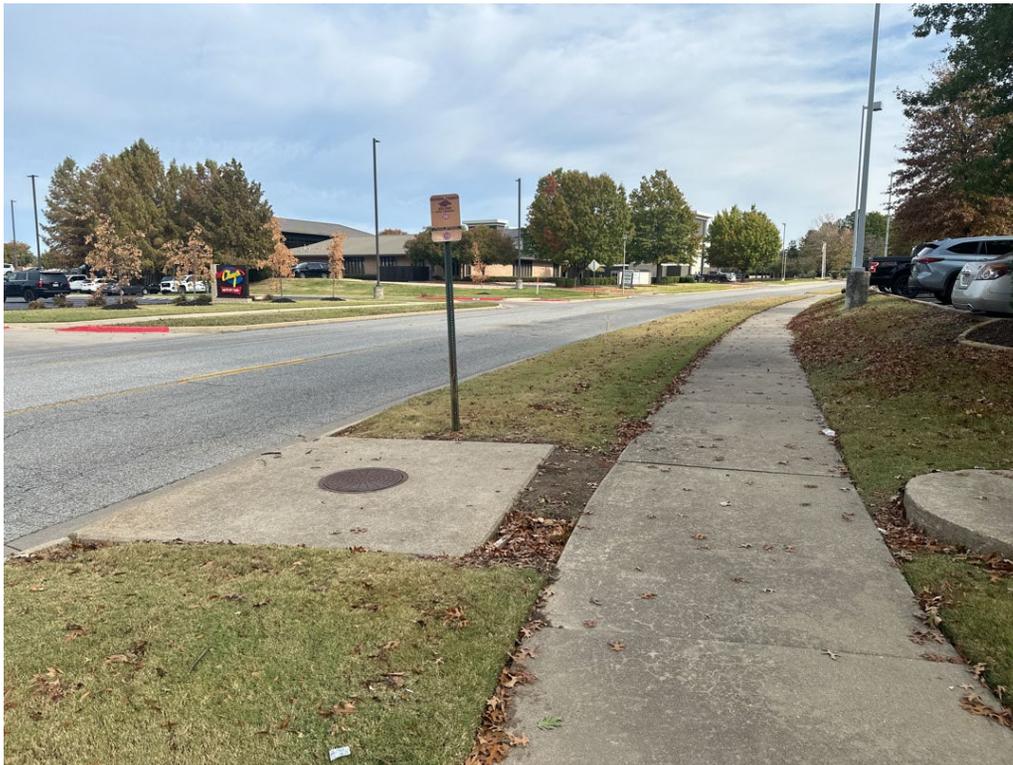
Moderate-ridership balanced stop located on a curve with incomplete boarding infrastructure. Landing pad contains a manhole cover and is not connected to the nearby sidewalk. Stop sign and pole are weathered and should be replaced. Recommend adding a sidewalk connection and upgrading the pad surface to improve safety and accessibility. Evaluate sightlines due to curve.

Weekday Activity	21.8
Weekend Activity	7
Stop Position	Far-side
Adjacent Property Description	Office Building
Landing Area	Concrete, Grass
Sidewalk	Yes
Sidewalk Condition	4 = good - No immediate repair
Shelter	No
Seating	No
Lighting	Yes
Bicycle Parking	No
Scooter Parking	No
