# **NORTHWEST ARKANSAS REGIONAL PLANNING COMMISSION**

## **RAZORBACK TRANSIT BUS STOP ENHANCEMENT PLAN**

October 2025 | FINAL

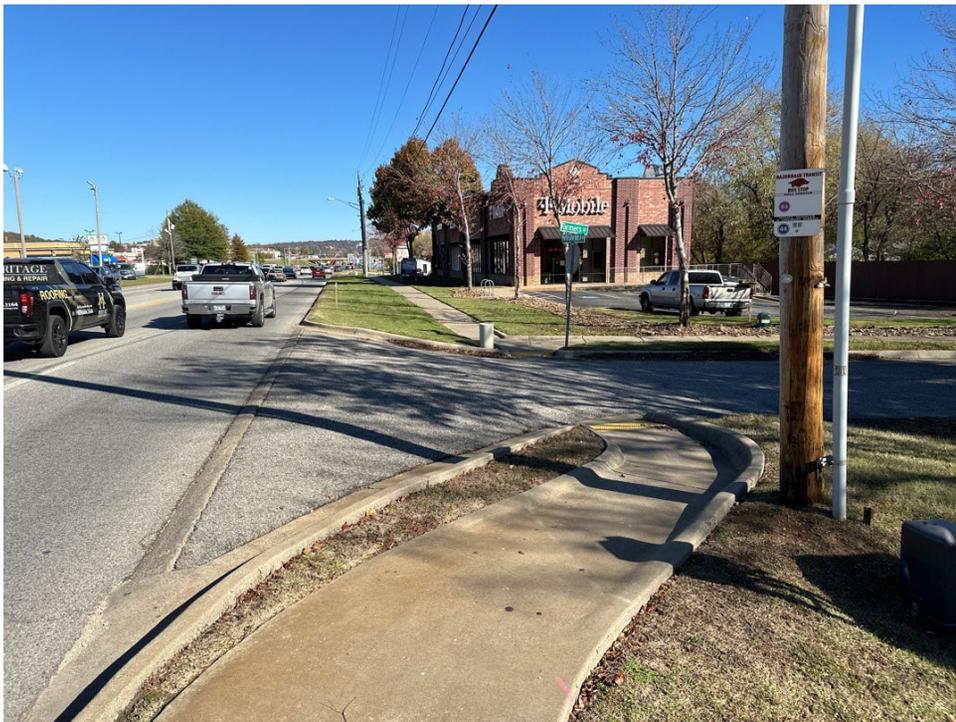
Weekday Activity	14.4
Weekend Activity	2
Stop Position	Near-side
Adjacent Property Description	Retail Store
Landing Area	Concrete
Sidewalk	Yes
Sidewalk Condition	2 = Poor Shape, some cracks or breaks
Shelter	No
Seating	No
Lighting	Yes
Bicycle Parking	No
Scooter Parking	No

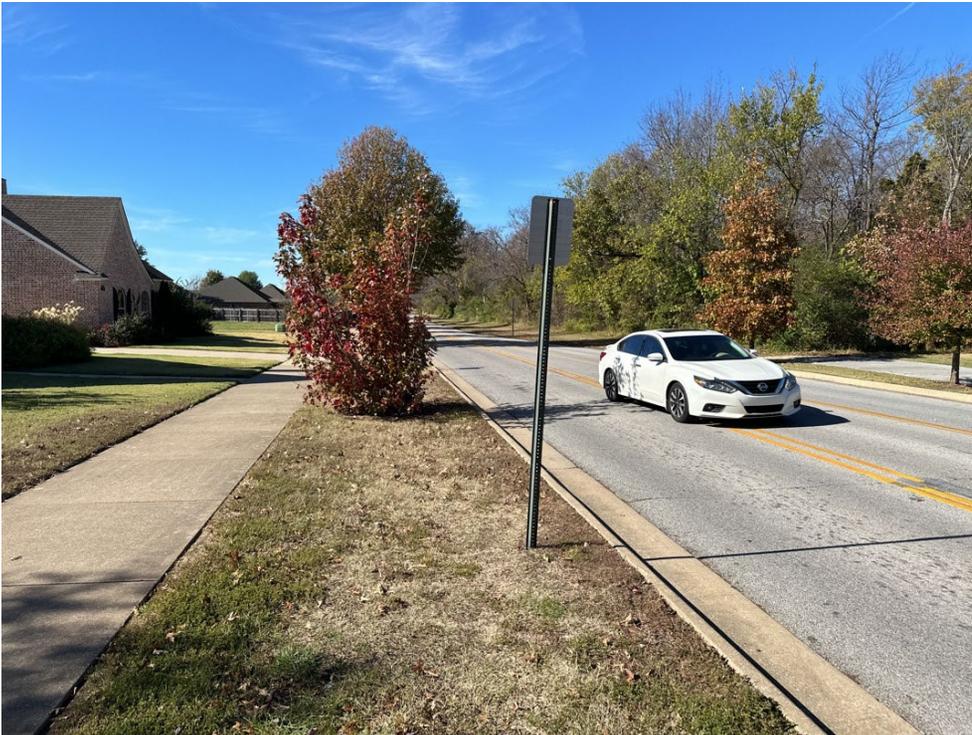
Weekday Activity	13.5
Weekend Activity	2.2
Stop Position	Near-side
Adjacent Property Description	Apartment Building, Residence - detached
Landing Area	Grass
Sidewalk	Yes
Sidewalk Condition	4 = good - No immediate repair
Shelter	No
Seating	No
Lighting	No
Bicycle Parking	No
Scooter Parking	No

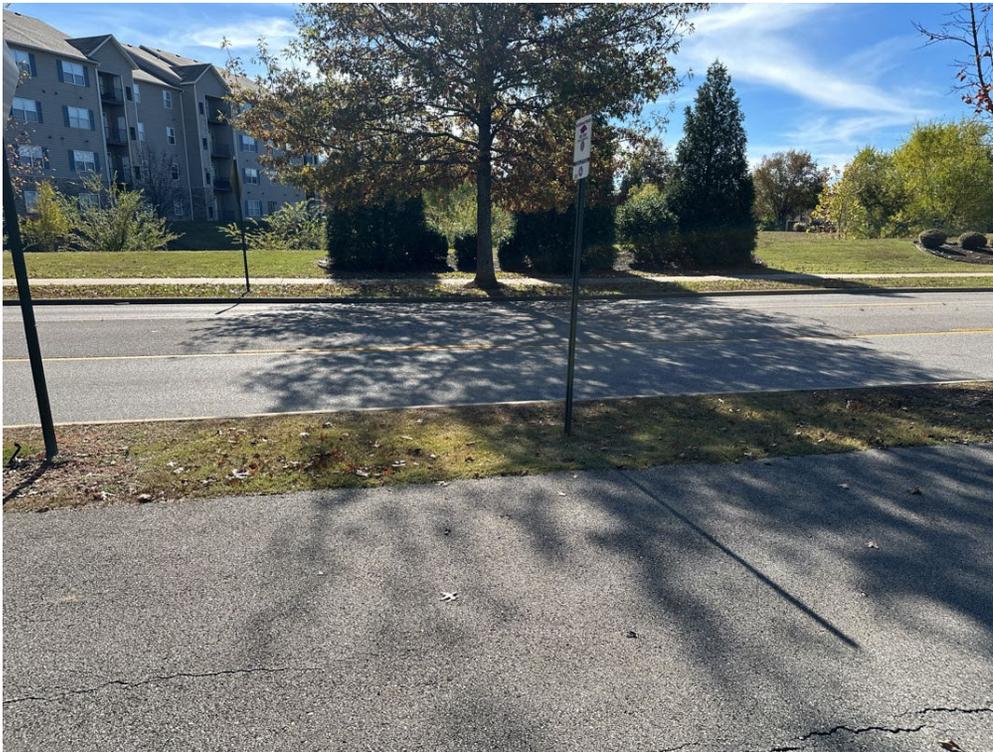
Moderate-ridership alighting stop with signpost in grass between curb and wide sidewalk. Sign visibility is limited due to placement behind a "Stop Ahead" sign. No landing pad or amenities present. While shelter is not recommended based on stop type, site could accommodate future improvements. Recommend relocating or raising sign for visibility and adding accessible landing pad. Site is not currently shelter ready.

Weekday Activity	22.3
Weekend Activity	0.7
Stop Position	Near-side
Adjacent Property Description	Apartment Building, Residence - detached
Landing Area	Grass
Sidewalk	Yes
Sidewalk Condition	3 = Fair - minor root uplifting and breaks
Shelter	No
Seating	No
Lighting	Yes
Bicycle Parking	No
Scooter Parking	No

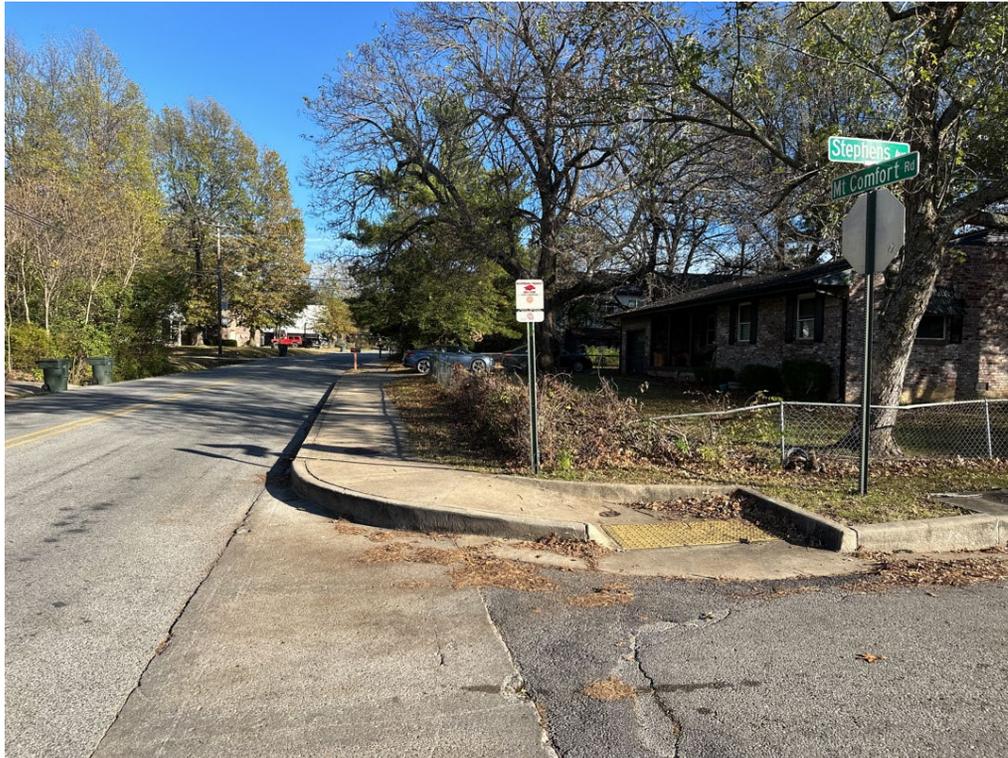
Moderate-ridership boarding stop located in grass at the apex of a driveway along Mt. Comfort. Signpost is short and lacks visibility due to placement. No landing pad is present, but surrounding sidewalk and grass provide space for future improvements. Recommend installing accessible landing pad, replacing signpost, and evaluating shelter installation if ridership increases. Site is not currently shelter ready but has potential.

Weekday Activity	35.8
Weekend Activity	1.1
Stop Position	Far-side
Adjacent Property Description	Residence - detached
Landing Area	Concrete
Sidewalk	Yes
Sidewalk Condition	4 = good - No immediate repair
Shelter	No
Seating	No
Lighting	Yes
Bicycle Parking	No
Scooter Parking	No

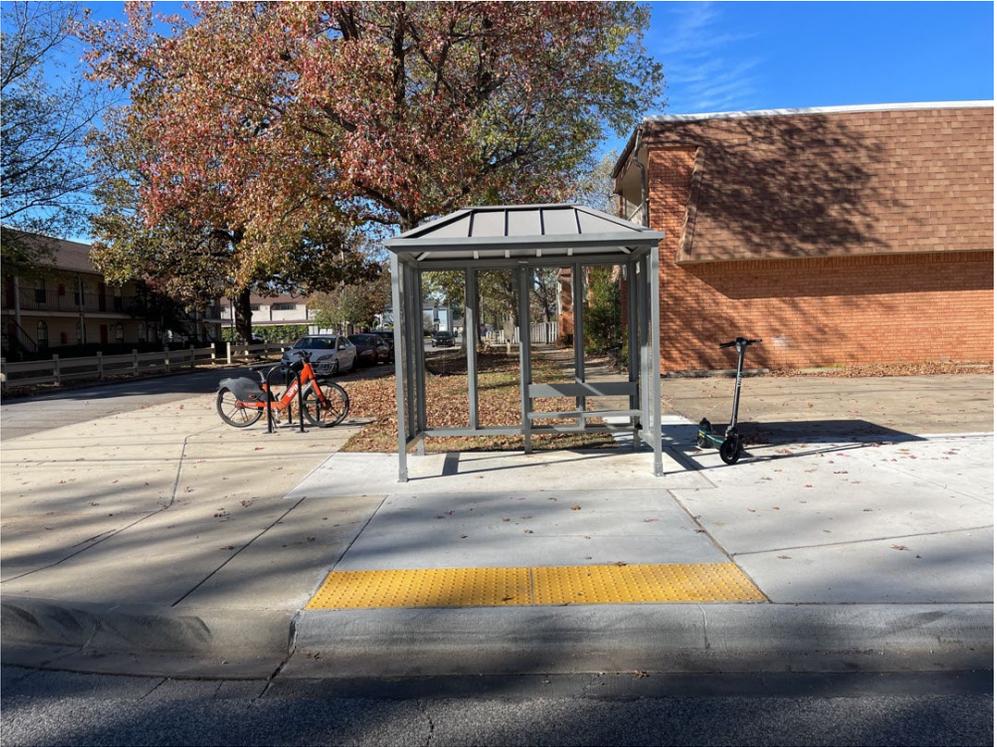
Moderate-ridership boarding stop in excellent condition with full shelter, landing pad, and clear sidewalk access. Micromobility parking is present, but additional capacity is recommended due to visible scooter congestion. Coordinate with sister stop 149579 to ensure consistency and improve access across both directions. No other improvements needed.

Weekday Activity	91.9
Weekend Activity	19.8
Stop Position	Near-side
Adjacent Property Description	Apartment Building
Landing Area	Concrete
Sidewalk	Yes
Sidewalk Condition	5 = new or cosmetically excellent
Shelter	Yes
Seating	Yes
Lighting	No
Bicycle Parking	Yes
Scooter Parking	Yes

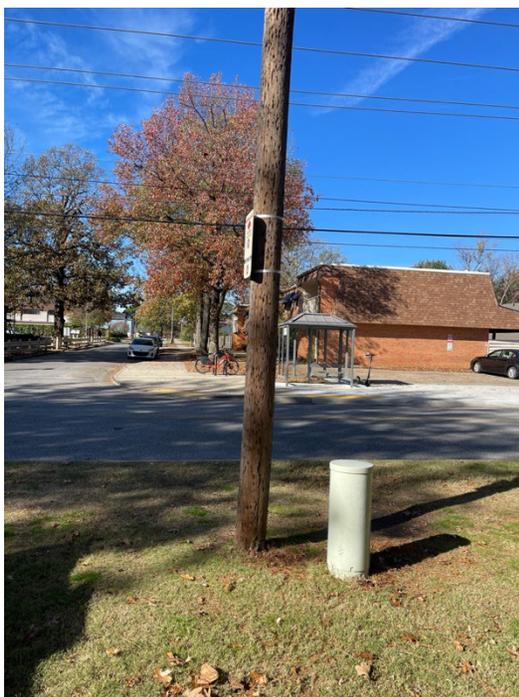
High-ridership alighting stop on utility pole in grass with no sidewalk or boarding infrastructure. Site is a relocation candidate, new location slightly further north may be more functional. If retained, recommend pouring a landing pad and shelter pad to support comfort and future flexibility. Shelter not essential but feasible. Improve visibility and access through basic site upgrades.

Weekday Activity	90.8
Weekend Activity	19.9
Stop Position	N/A
Adjacent Property Description	Apartment Building
Landing Area	Dirt, Grass
Sidewalk	No
Sidewalk Condition	N/A
Shelter	No
Seating	No
Lighting	No
Bicycle Parking	No
Scooter Parking	No

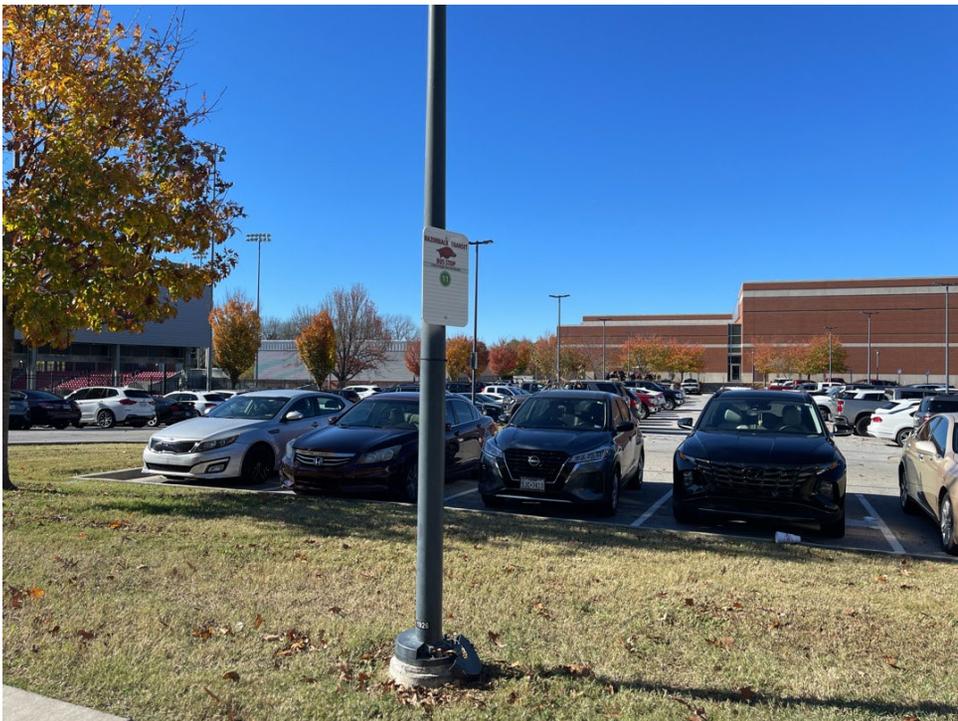
High-ridership boarding stop with no defined landing area. Passengers board from a grassy area next to a damaged curb. The sign is in good condition and clearly visible. No seating or shelter is present. Install an accessible concrete landing pad and add a bench. While the site is not currently shelter-ready, modest site work could support future installation. A shelter is recommended due to high ridership and strong visibility..

Weekday Activity	158.1
Weekend Activity	0
Stop Position	Far-side
Adjacent Property Description	Park and Ride
Landing Area	Concrete, Grass
Sidewalk	Yes
Sidewalk Condition	5 = new or cosmetically excellent
Shelter	No
Seating	No
Lighting	Yes
Bicycle Parking	No
Scooter Parking	No

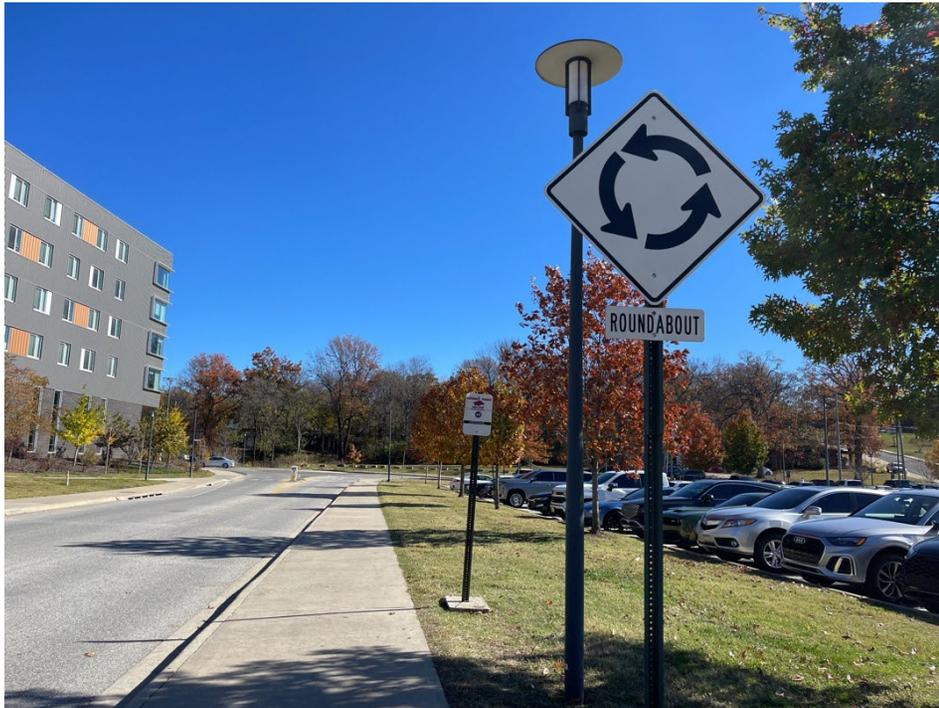
Low-ridership balanced stop with adequate landing area, sidewalk present, and no seating, lighting present. Basic stop with signage only and no designated boarding area or landing pad. Stop is not shelter ready but could become so with concrete installation. Recommend adding a landing pad to improve accessibility and consider shelter installation if ridership increases. Monitor for scooter clutter near adjacent curb ramps and evaluate feasibility of designated micromobility parking.

Weekday Activity	4.7
Weekend Activity	1
Stop Position	Near-side
Adjacent Property Description	Parking Lot
Landing Area	Concrete
Sidewalk	Yes
Sidewalk Condition	5 = new or cosmetically excellent
Shelter	No
Seating	No
Lighting	Yes
Bicycle Parking	No
Scooter Parking	No

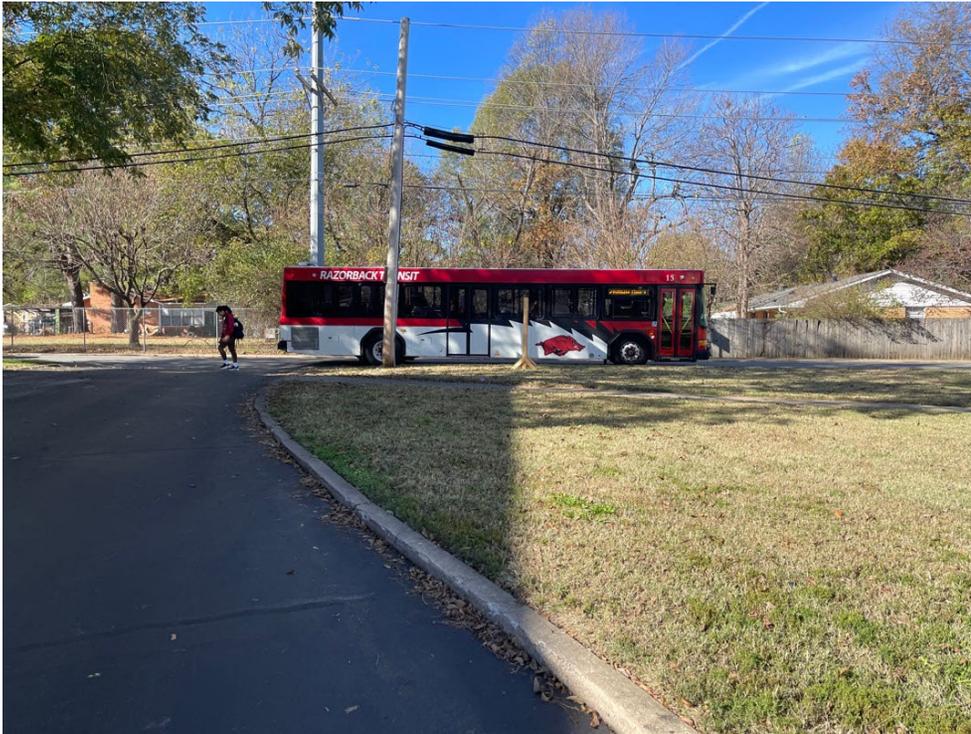
Weekday Activity	No Data Available
Weekend Activity	No Data Available
Stop Position	Far-side
Adjacent Property Description	Apartment Building
Landing Area	Dirt, Grass
Sidewalk	Yes
Sidewalk Condition	3 = Fair - minor root uplifting and breaks
Shelter	No
Seating	No
Lighting	No
Bicycle Parking	No
Scooter Parking	No

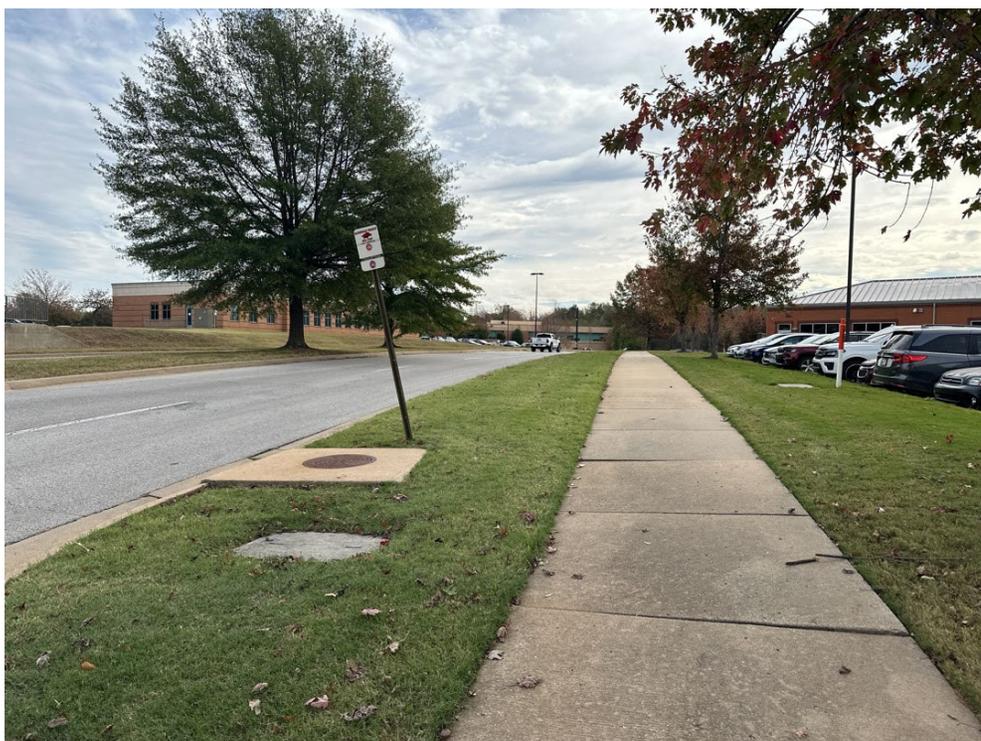
Low-ridership balanced stop in grass with signpost and no formal boarding surface. Existing landing area includes a manhole cover and is not connected to the sidewalk. Grass buffer separates sidewalk from curb. Recommend installing accessible landing pad away from utility conflict, as well as pedestrian improvements including high-visibility crosswalks and curb ramps at the intersection of N Northhills Boulevard and E Monte Painter Drive. Coordinate upgrades with sister stop 149583 to support safe access in all directions.

Weekday Activity	5.6
Weekend Activity	2.3
Stop Position	Far-side
Adjacent Property Description	Hospital
Landing Area	Concrete, Grass
Sidewalk	Yes
Sidewalk Condition	4 = good - No immediate repair
Shelter	No
Seating	No
Lighting	Yes
Bicycle Parking	No
Scooter Parking	No

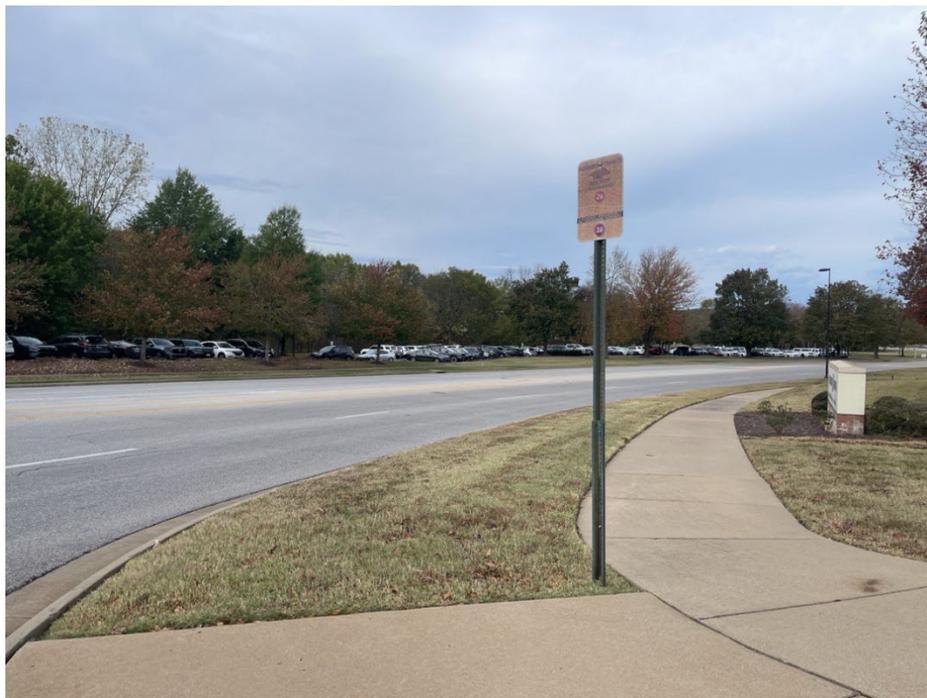
Low-ridership balanced stop on grass at edge of sidewalk along a curved road segment. Sign is mounted on a pole in the grass; no landing pad is present and road curvature may limit sightlines. Recommend installing accessible landing pad and relocating sign for improved visibility, as well as pedestrian improvements including high-visibility crosswalks and curb ramps at the intersection of N Northhills Boulevard and E Monte Painter Drive. Coordinate upgrades with sister stop 149584 to support safe access in all directions.

Weekday Activity	3.8
Weekend Activity	1
Stop Position	Far-side
Adjacent Property Description	Hospital
Landing Area	Asphalt
Sidewalk	Yes
Sidewalk Condition	4 = good - No immediate repair
Shelter	No
Seating	No
Lighting	Yes
Bicycle Parking	No
Scooter Parking	No

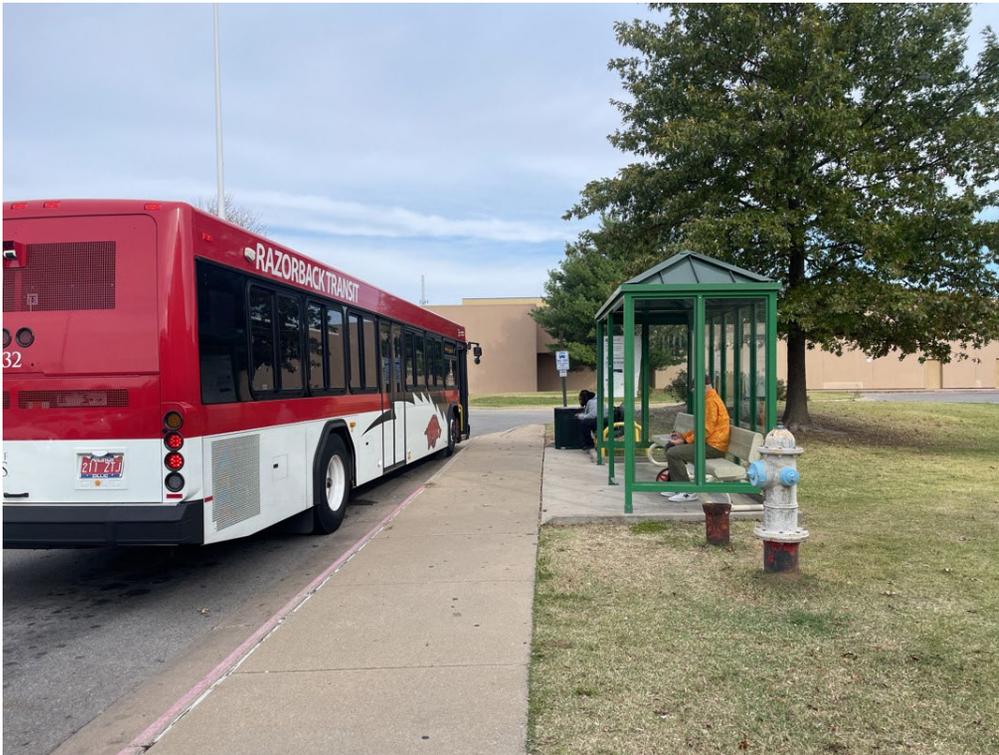
High-ridership balanced stop with shelter and accessible landing pad shared with ORT. Shelter appears to be in good condition, but no in-shelter lighting is visible. Recommend adding or confirming shelter lighting to improve nighttime safety. No other improvements needed at this time; monitor for continued coordination with ORT.

Weekday Activity	143.4
Weekend Activity	59.8
Stop Position	Not Near an Intersection
Adjacent Property Description	Place of Worship
Landing Area	Concrete
Sidewalk	Yes
Sidewalk Condition	4 = good - No immediate repair
Shelter	Yes
Seating	Yes
Lighting	Yes
Bicycle Parking	No
Scooter Parking	No

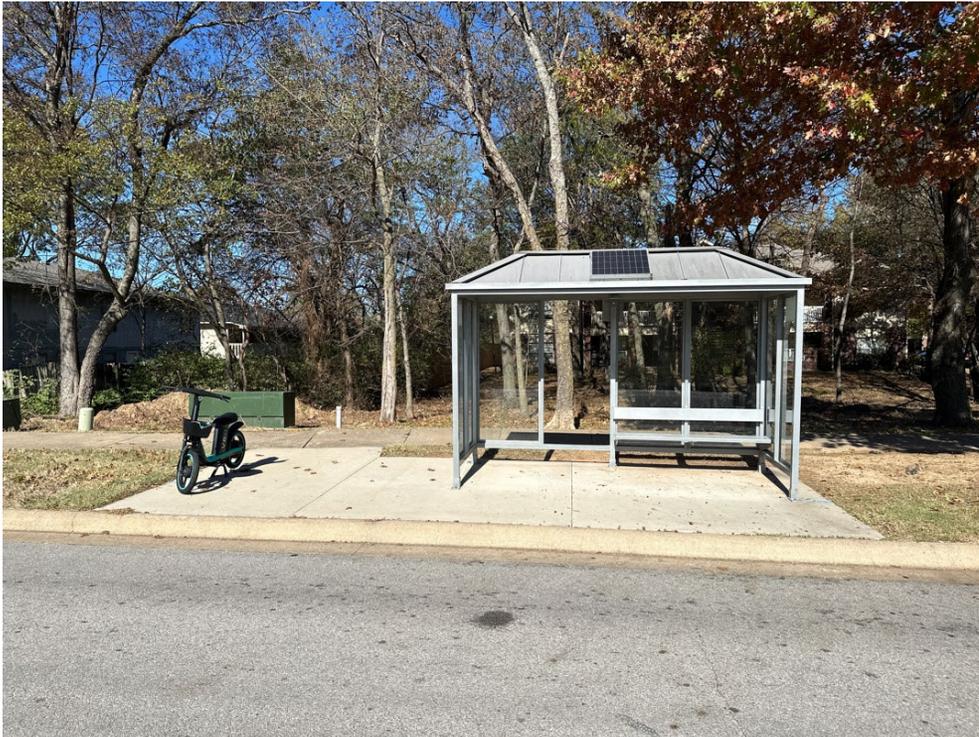
Low-ridership balanced stop with shelter, small landing pad, and in-shelter lighting. Neither the landing pad nor shelter connect directly to the sidewalk, limiting accessibility. Micromobility clutter observed nearby. Recommend constructing a connecting path to sidewalk and adding designated micromobility parking to maintain access and reduce obstruction.

Weekday Activity	16.4
Weekend Activity	2.4
Stop Position	Far-side
Adjacent Property Description	Apartment Building
Landing Area	Concrete
Sidewalk	Yes
Sidewalk Condition	3 = Fair - minor root uplifting and breaks
Shelter	Yes
Seating	Yes
Lighting	Yes
Bicycle Parking	No
Scooter Parking	No

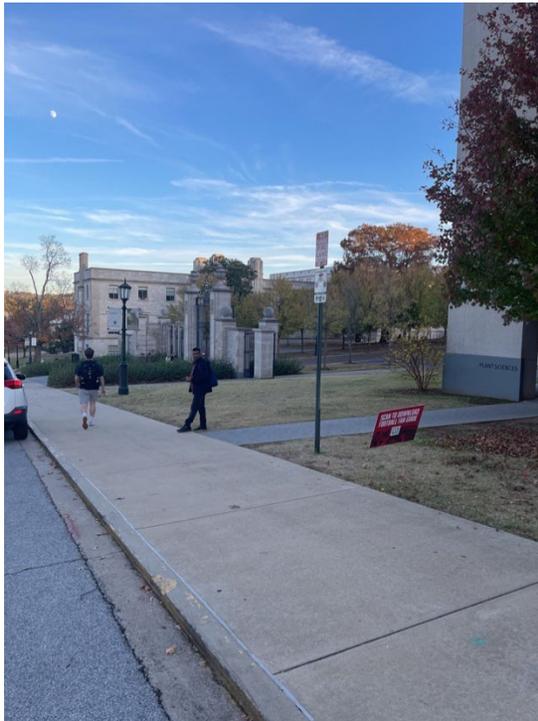
High-ridership boarding stop with signpost in grass and sidewalk-level landing area. Site sits on a sloped street segment; landing pad is present via sidewalk connection, but stop pole is in grass and partially obscured. Micromobility clutter noted near stop. Recommend relocating signpost to sidewalk edge, add full shelter package, formalize micromobility parking, and confirming placement complies with adjacent “No Parking Fire Lane” restrictions. Bus stop improvements are included in the Maple Street reconstruction project currently underway.

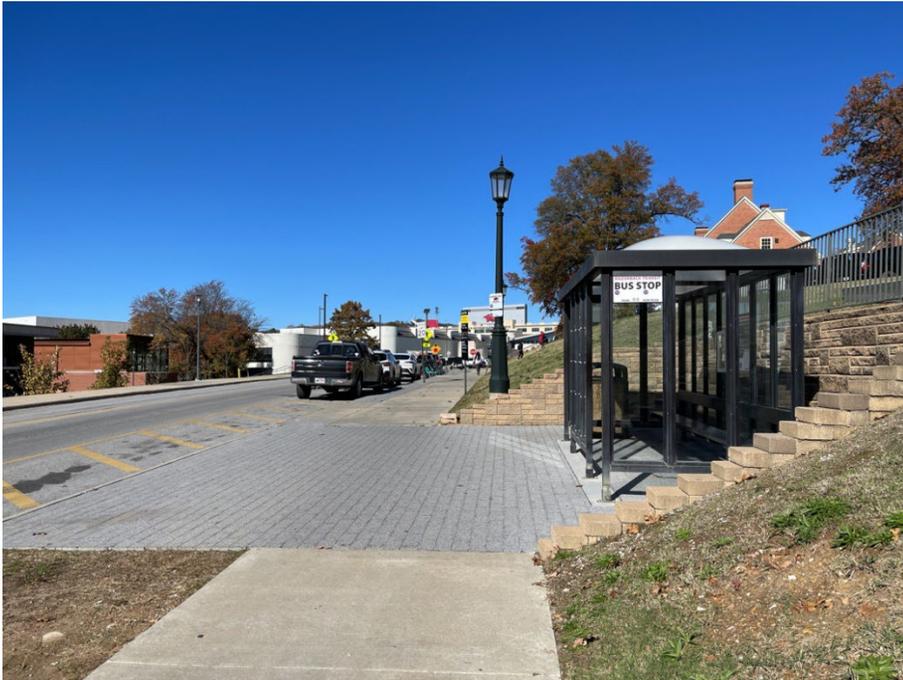
Low-ridership boarding stop with long shelter built into a hillside and connected landing/waiting area. Sign is mounted on adjacent light pole set into slope; site includes trash can and retaining wall surrounding the stop. No improvements needed at this time, but monitor shelter and wall for wear due to hillside placement and confirm sign visibility from roadway.

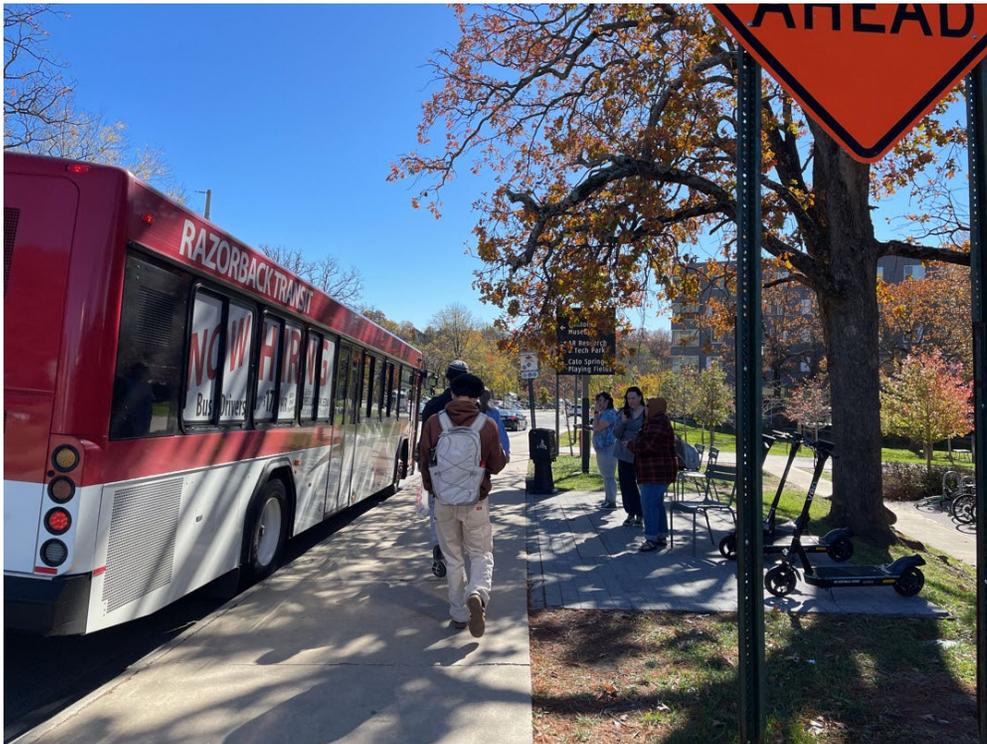
**STOP NAME: Pomfret (Outbound)**

High-ridership balanced stop with landing pad and sidewalk access, but no formal shelter. Informal seating has been added to shelter pad, indicating strong demand. Multiple signposts in vicinity may limit visibility. Recommend installing shelter and bench, and consolidating signage to improve clarity. Consider adding micromobility parking to manage nearby scooter presence.

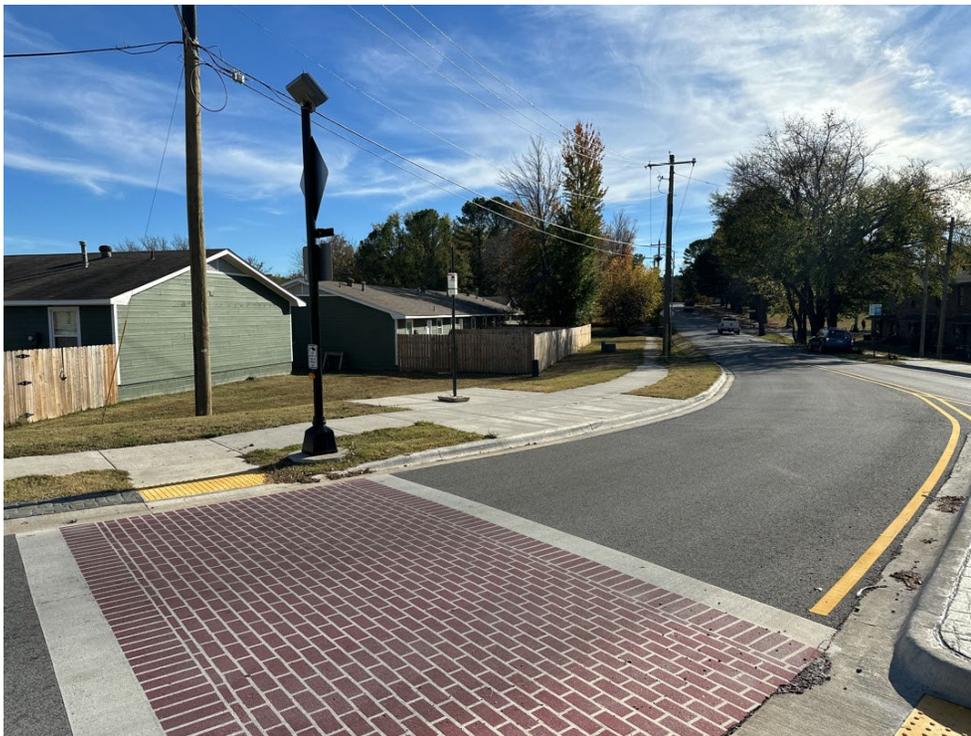
Moderate-ridership balanced stop with with a new concrete pad and sidewalk connection adjacent to a school serving developmentally disabled individuals. No shelter, seating, or lighting currently in place. Signpost is in good condition but lacks high visibility. Consider installing a bench and adding lighting to support users with accessibility needs. Evaluate need for a shelter based on observed usage and coordination with the adjacent school.

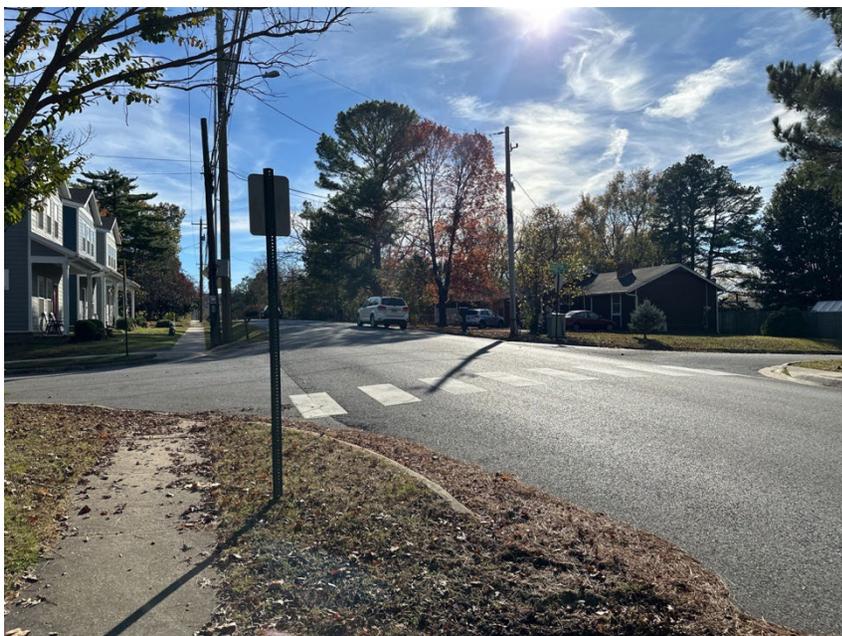
Low-ridership alighting stop located on a narrow, uneven sidewalk set behind a utility pole. The sign is mounted high and partially obstructed. Vegetation encroaches on the walkway, and there is no seating or shelter. The curb is sharply elevated, creating a tripping hazard and limiting accessibility. Lighting is present but not integrated with the stop. Install an accessible landing pad to provide a safe, defined alighting space. Relocate the stop sign to a lower, more visible position. Trim or remove surrounding vegetation and regrade the curb edge to improve accessibility. Due to space limitations, a shelter is not recommended at this time, but the stop should be monitored for future ridership growth

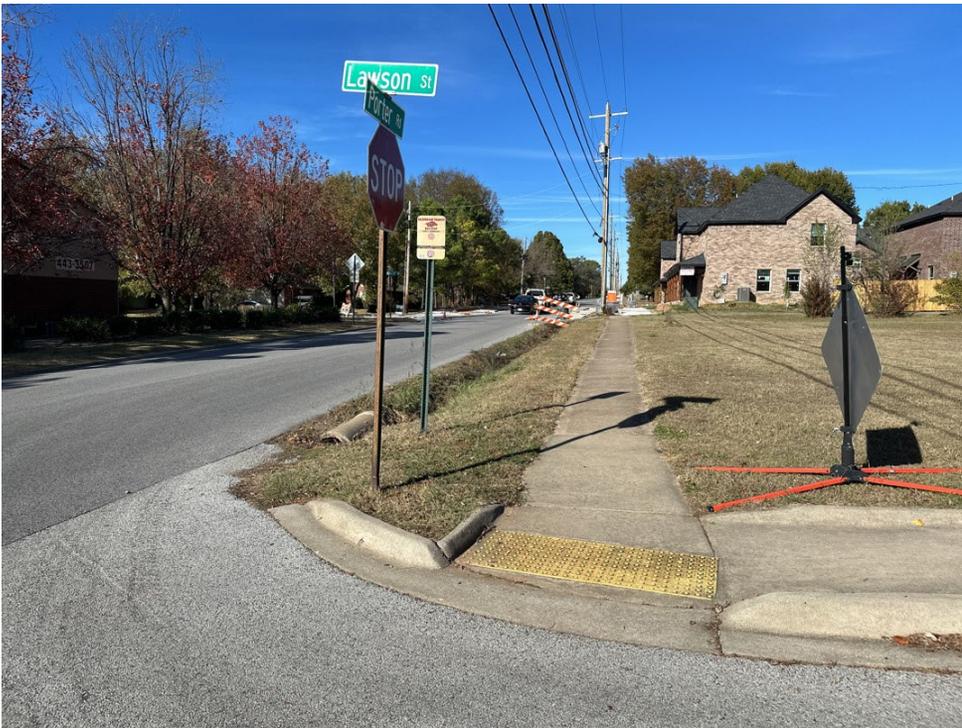
Moderate-ridership balanced stop located at a corner with sidewalk connection but no landing pad. Sign is mounted behind a stop sign at the back of sidewalk, limiting visibility. No seating, shelter, or lighting. Add landing pad and relocate signpost closer to the curb in a more visible position. Consider adding lighting and a bench if use increases.

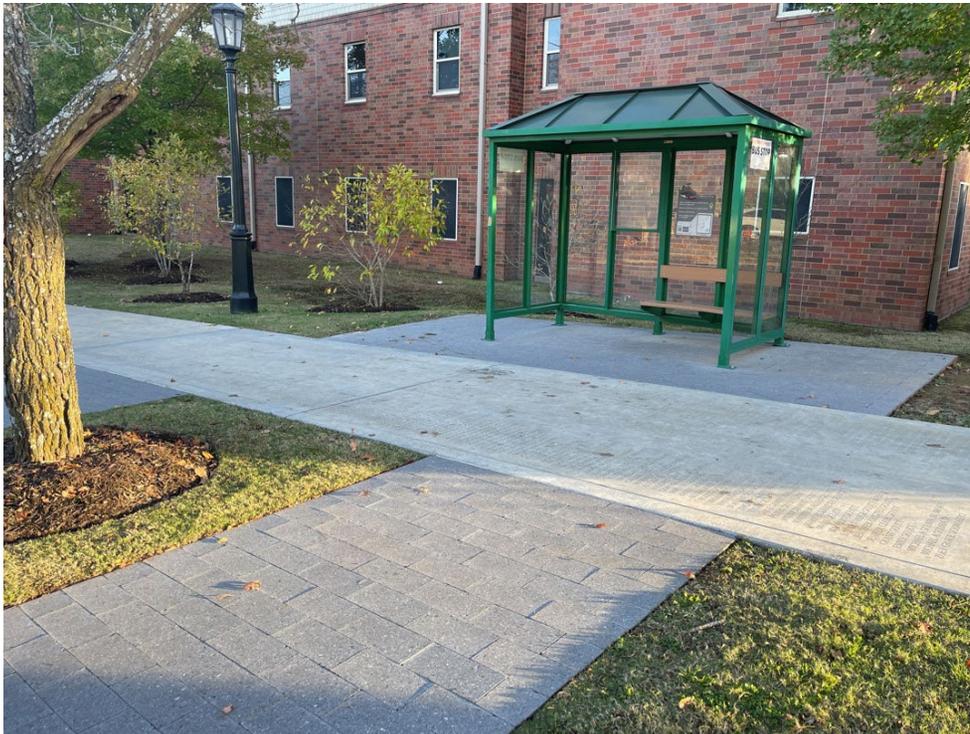
Low-ridership balanced stop in excellent condition with a new shelter, seating, landing area, and decorative paving. Shelter is located along a well-lit pedestrian corridor near student housing. No in-shelter lighting is visible. Maintain existing infrastructure and consider adding in-shelter lighting to enhance comfort and visibility during early morning or evening hours.

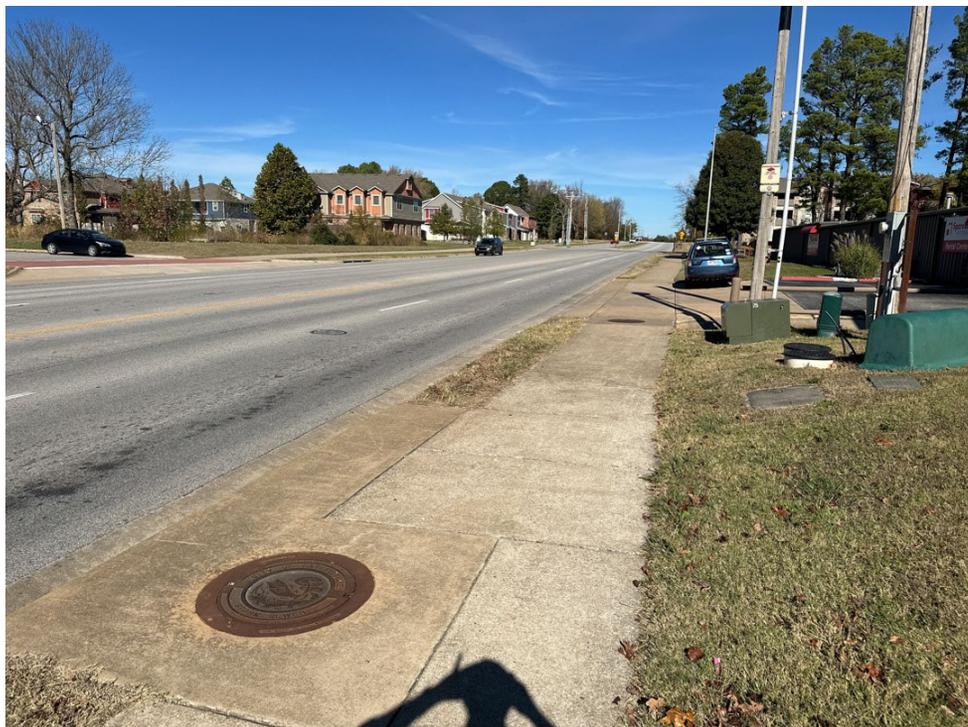
Moderate-ridership stop near regional trail with sidewalk access and grassy buffer. Signpost is mounted to a utility pole surrounded by utility boxes, limiting visibility and enhancement options. No shelter, seating, or landing pad. Consider relocating the stop slightly north or south to avoid utility conflicts and enable installation of a landing pad and future shelter. Add bench and trash receptacle once relocated.

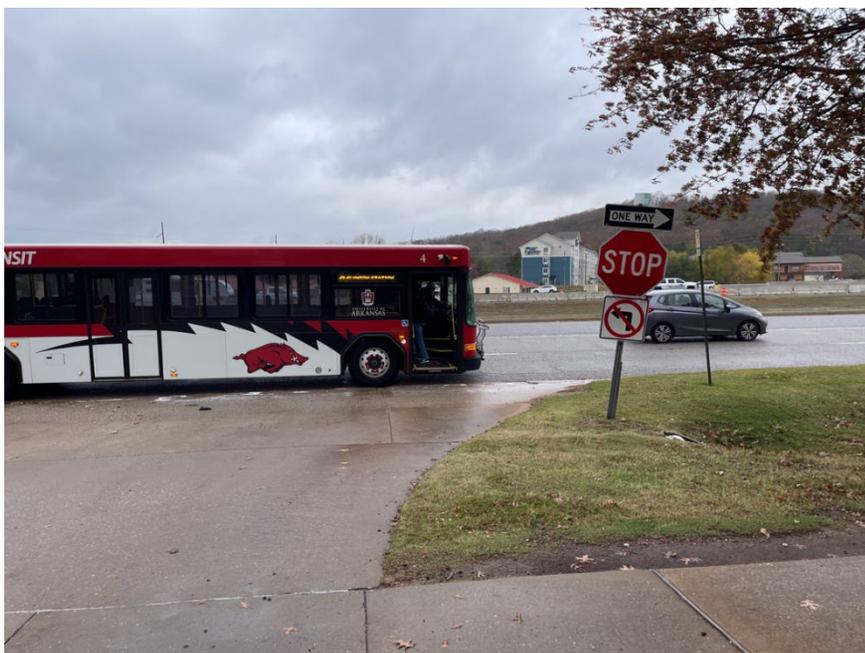
Low-ridership balanced stop with no sidewalk at the stop location and boarding occurring from a driveway apron. The site lacks a defined landing pad, seating, or lighting, and presents safety concerns due to poor visibility, mixed traffic conditions, and lack of pedestrian protection. Evaluate relocating the stop to a safer, more accessible location with better sidewalk and curb infrastructure. If retained, construct an accessible landing pad and add lighting and a bench to improve safety and rider comfort.

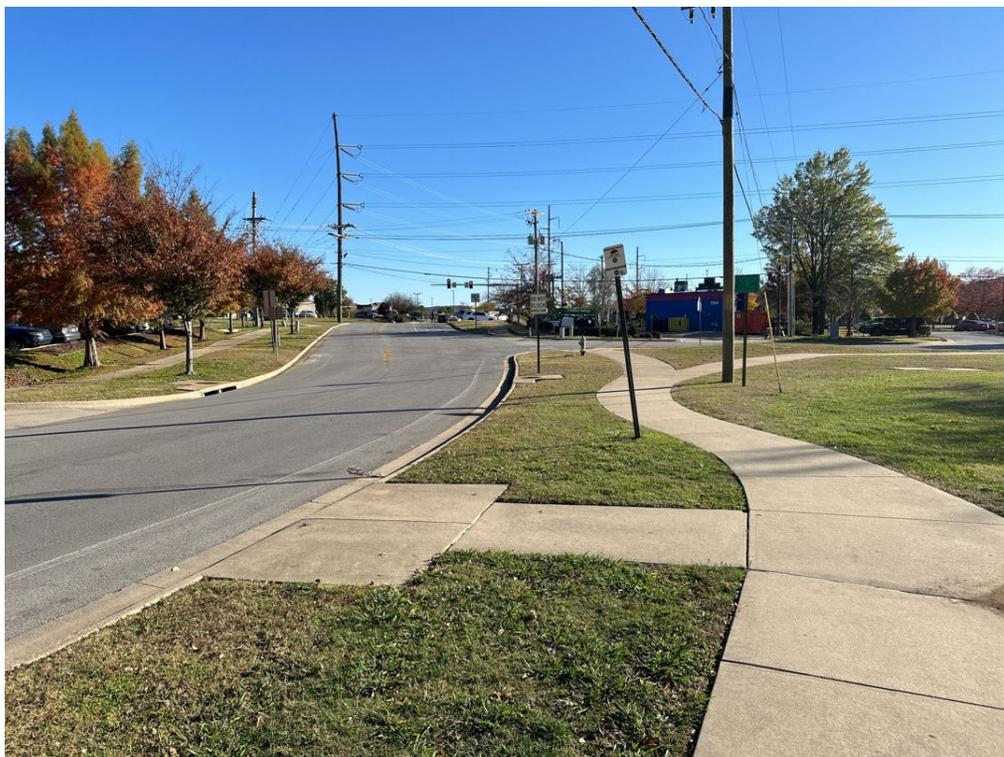
Low-ridership boarding stop with sidewalk access but no defined landing pad, seating, shelter, or lighting. The signpost is set back along a winding sidewalk and is poorly visible to both riders and operators. Boarding occurs from an undefined grassy edge, which limits accessibility and consistency. Relocate the sign closer to the curb and construct a defined, accessible landing pad. Monitor ridership over time to evaluate the need for additional amenities such as seating or a shelter.

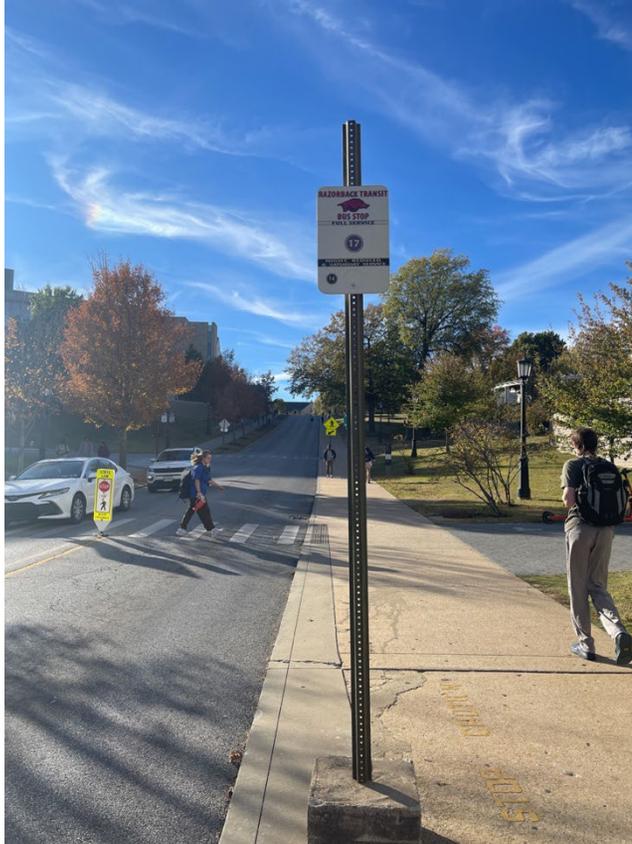
Moderate-ridership alighting stop with minimal amenities. Signpost is installed in a concrete block near the curb at a marked crosswalk. No seating or shelter. Lighting and pedestrian visibility appear adequate. Although a shelter is not needed for an alighting stop, the location could be made shelter-ready if paired with improvements at the boarding stop across the street (149603).

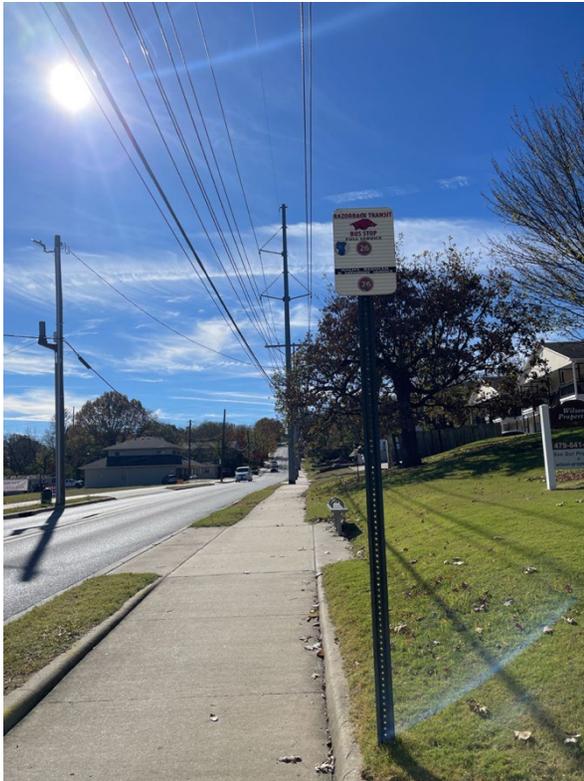
High-ridership balanced stop with good sidewalk connection and crosswalk access. Bench is located at the base of a grass slope; signpost is positioned lower on the hill and may be difficult for operators to see. Shelter is located across the street at sister stop 149606. Add a landing pad near the signpost and consider relocating signage to improve visibility. Install a shelter if funding available.

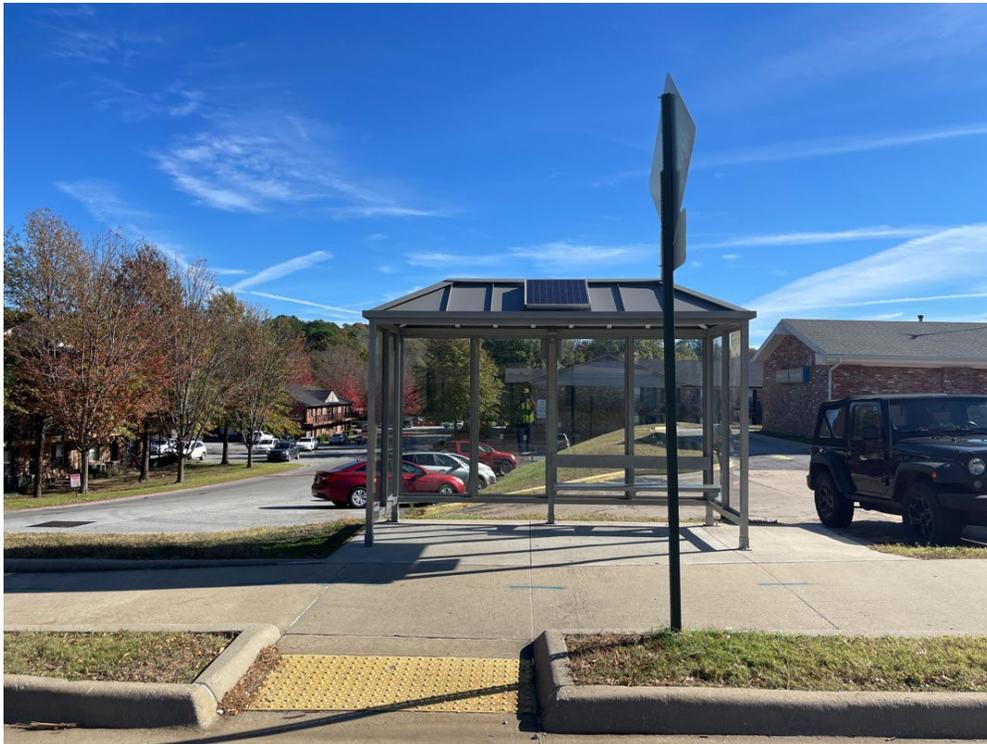
Moderate-ridership alighting stop in good condition with full shelter and clear sidewalk connection. Landing pad is slightly offset from shelter location, and a grass strip separates the shelter from the curb. Maintain shelter and monitor for wear. If sidewalk reconstruction occurs, consider extending hardscape to improve boarding access.

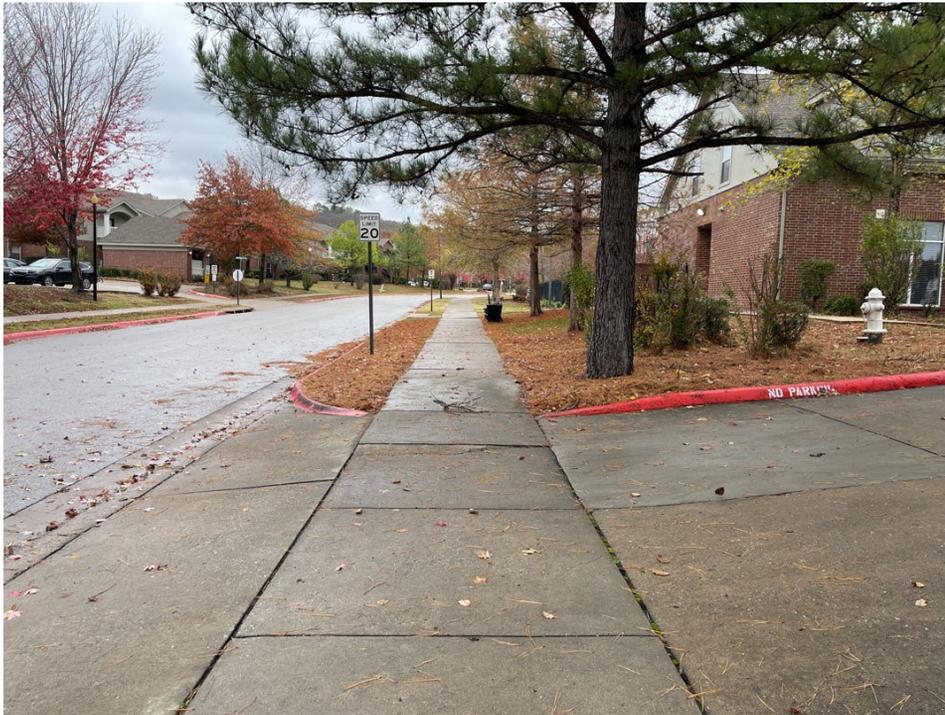
Low-ridership balanced stop with no defined landing area, sidewalk present, and seating present, no lighting. Landing area includes a manhole cover and is partially obstructed by heaving sidewalk caused by tree roots. Signpost is visible and close to the curb. Monitor pavement condition and consider tree root mitigation. Evaluate feasibility of pad reconstruction if shelter is desired in the future.

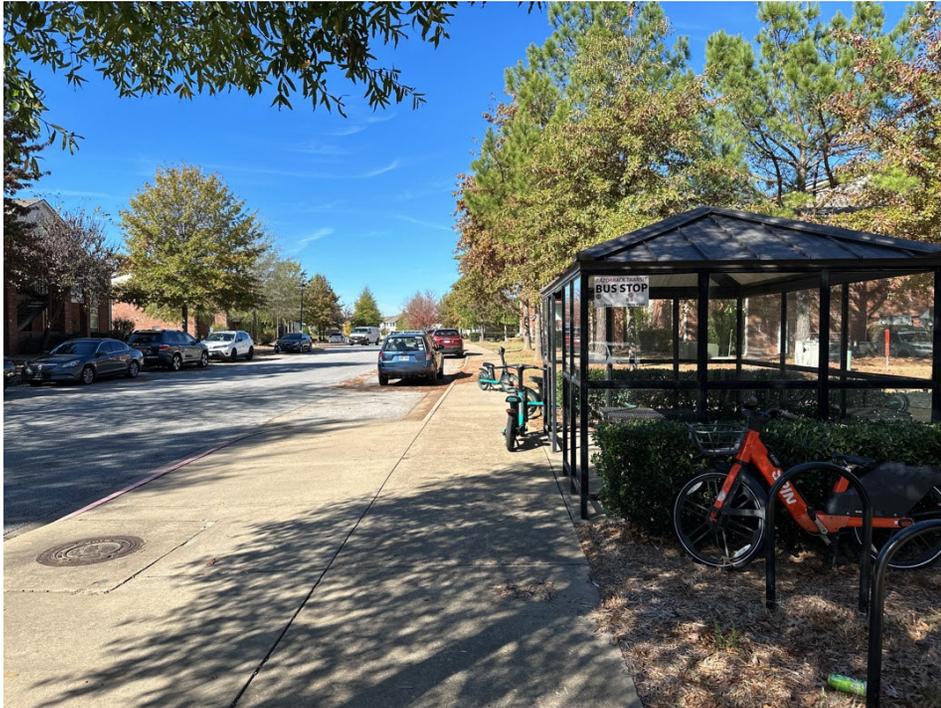
High-ridership stop with full shelter, seating, and a paved boarding area. Shelter pad is in good condition and includes accessible space, but a manhole cover is located near the front boarding zone. No in-shelter lighting is present. Micromobility clutter is visible; consider adding designated scooter and bike parking to maintain clear access. Lighting and signage appear adequate.
