# **NORTHWEST ARKANSAS REGIONAL PLANNING COMMISSION**

## **RAZORBACK TRANSIT BUS STOP ENHANCEMENT PLAN**

October 2025 | FINAL

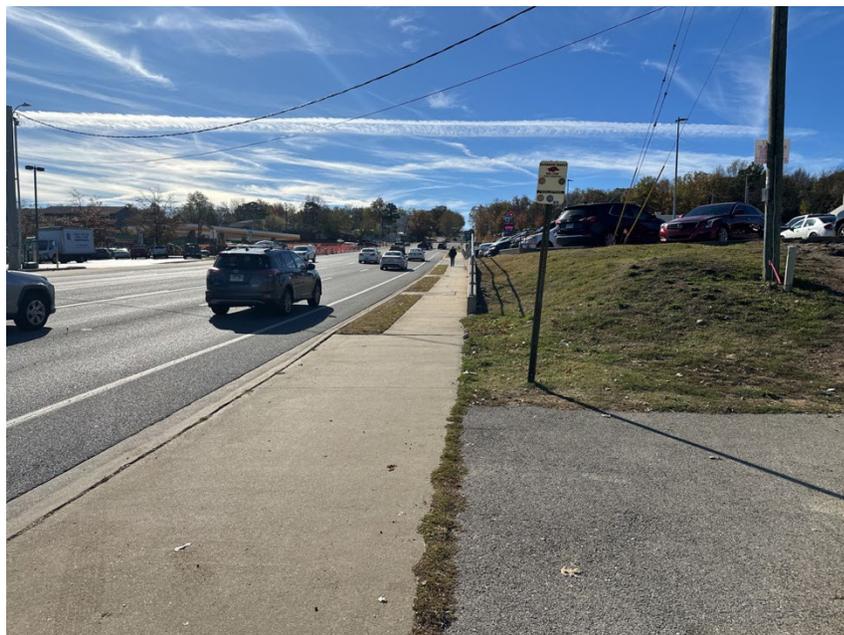
High-ridership boarding stop located at a heavily trafficked corridor, with a disconnected gravel path between the sidewalk and boarding area. The stop is located far from the curb, with no clear pedestrian desire line, and the sign is positioned, reducing visibility. There is no shelter, seating, or lighting. Scooter parking is informally present, but there is no defined micromobility infrastructure. Relocate the stop closer to Joyce Blvd to align with rider desire lines and improve visibility. Construct an accessible landing pad connected directly to the sidewalk. Install a full shelter package with lighting, seating, and dedicated micromobility parking to accommodate high ridership and enhance safety and comfort.

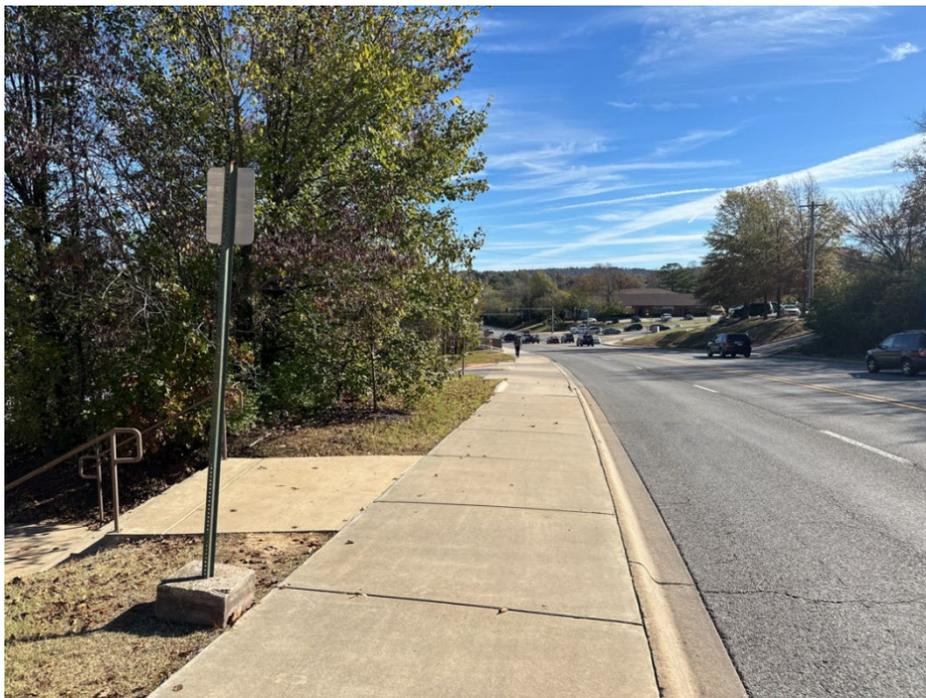
High-ridership alighting stop with adequate landing area, sidewalk present, and no seating, no lighting. Stop is on ARDOT right-of-way in fair condition. Concrete sidewalk provides a functional landing area, but signpost is mounted in a temporary base and lacks lighting or amenities. Site is on a slope adjacent to apartment access. Explore coordination with ARDOT for permanent sign installation. Consider adding shelter with lighting and bench and relocating the pole for better visibility.

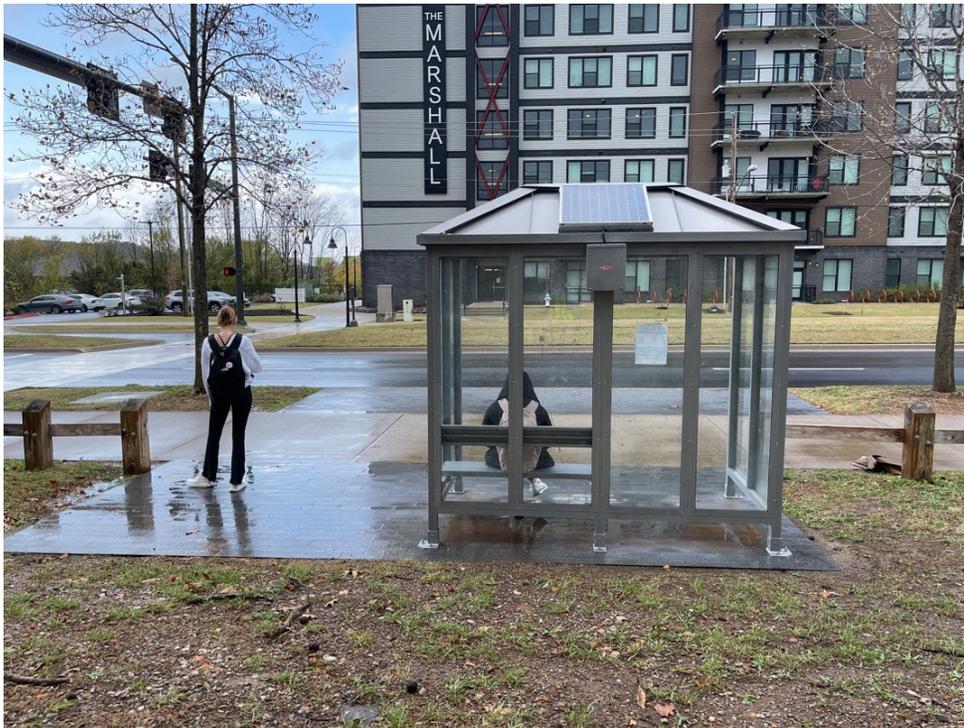
High-ridership boarding stop in excellent condition with full shelter, seating, paved boarding area, and strong pedestrian access. Shelter is positioned well with clear visibility. Trash receptacle and micromobility parking are present. Monitor for potential crowding during peak periods.

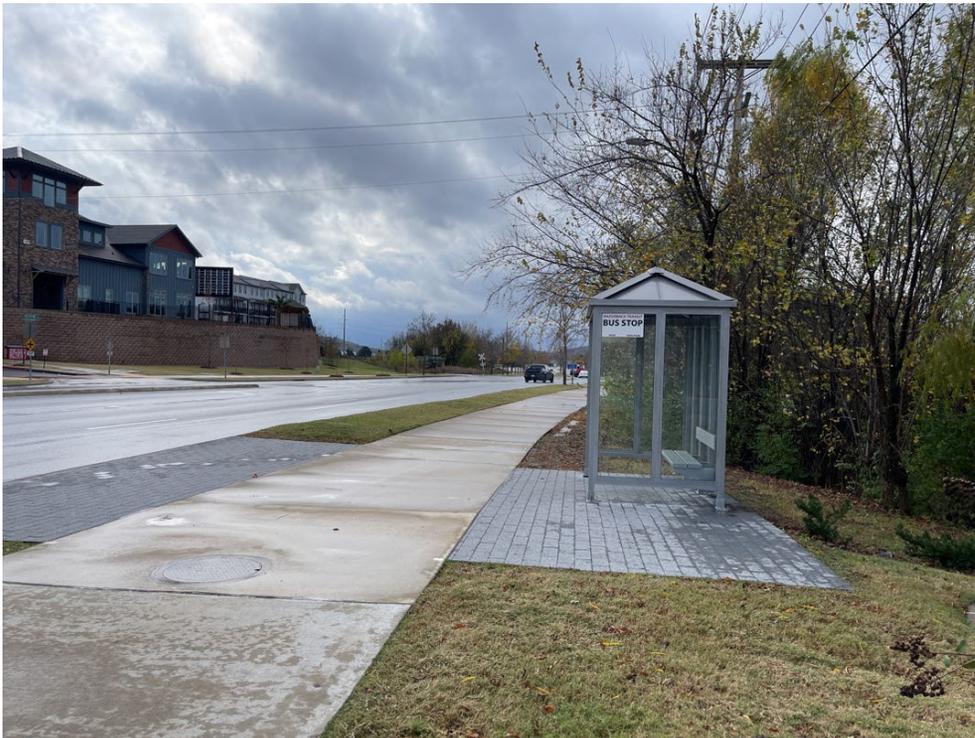
High-ridership alighting stop in excellent condition with full shelter, seating, and paved boarding area. Shelter lacks in-unit lighting. Positioned at the edge of the sidewalk with strong visibility and pedestrian access.

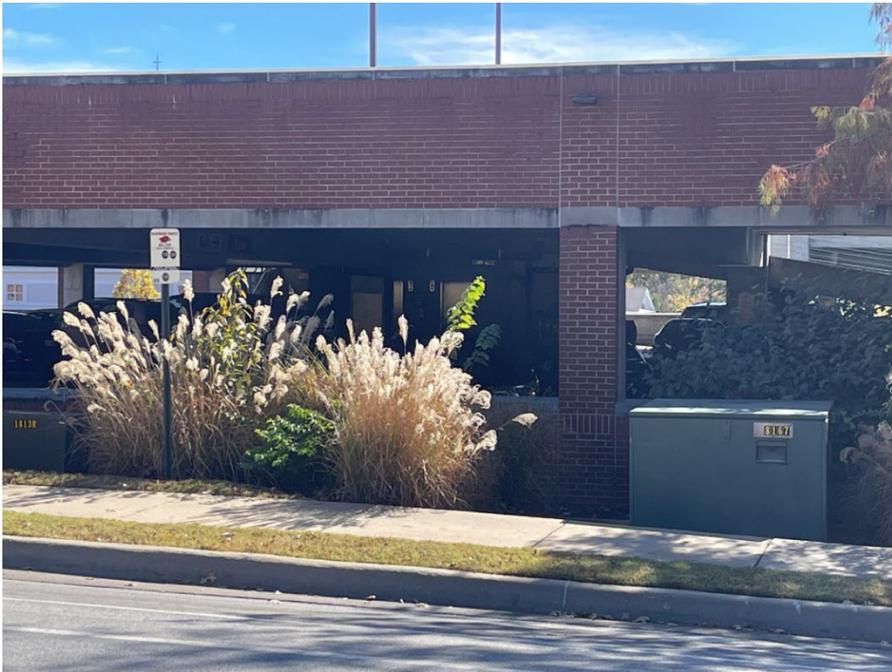
High-ridership balanced stop with signpost located along sidewalk adjacent to parking garage. Grass buffer between sidewalk and curb prevents accessible boarding. No seating, shelter, or lighting present. Stop visibility is limited due to overgrown vegetation. Add landing pad to provide accessible boarding. Trim landscaping to improve visibility. Consider installing a bench if space allows. Site is not currently shelter-ready due to limited clearance and adjacent utility boxes.

Weekday Activity	63.5
Weekend Activity	7.8
Stop Position	N/A
Adjacent Property Description	Parking Garage, Place of Worship
Landing Area	Concrete, Grass
Sidewalk	Yes
Sidewalk Condition	4 = good - No immediate repair
Shelter	No
Seating	Yes
Lighting	Yes
Bicycle Parking	No
Scooter Parking	No

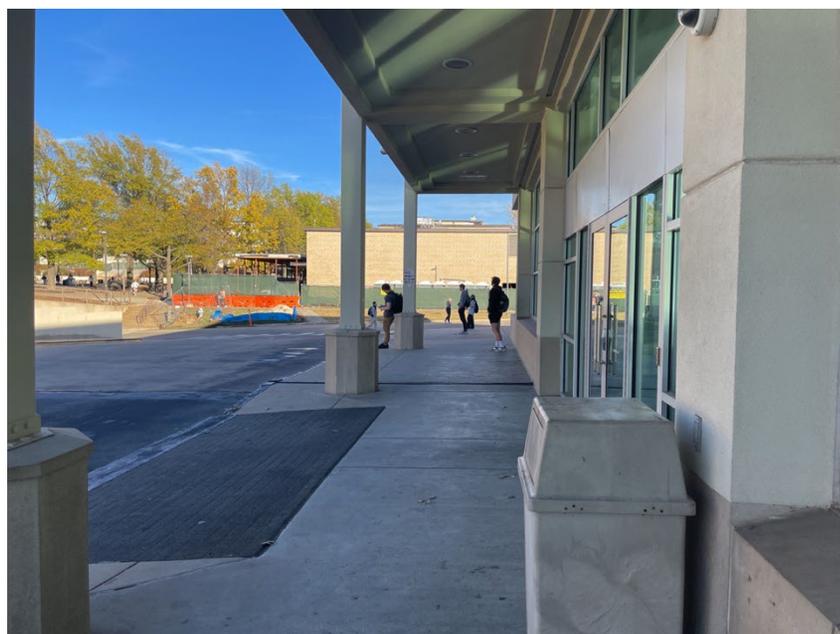
High-ridership balanced stop with adequate landing area, sidewalk present, and seating present, lighting present, bike parking, scooter parking. High-ridership hub in excellent condition with covered waiting area, ample seating, and accessible boarding zone. Amenities located indoors include seating and restrooms. Consider adding real-time arrival information outside at boarding area to improve visibility for passengers waiting outdoors. Strong candidate for branding and wayfinding enhancements.

Weekday Activity	4881.5
Weekend Activity	449
Stop Position	N/A
Adjacent Property Description	Transit Station/Center
Landing Area	Concrete
Sidewalk	Yes
Sidewalk Condition	4 = good - No immediate repair
Shelter	Yes
Seating	Yes
Lighting	Yes
Bicycle Parking	Yes
Scooter Parking	Yes

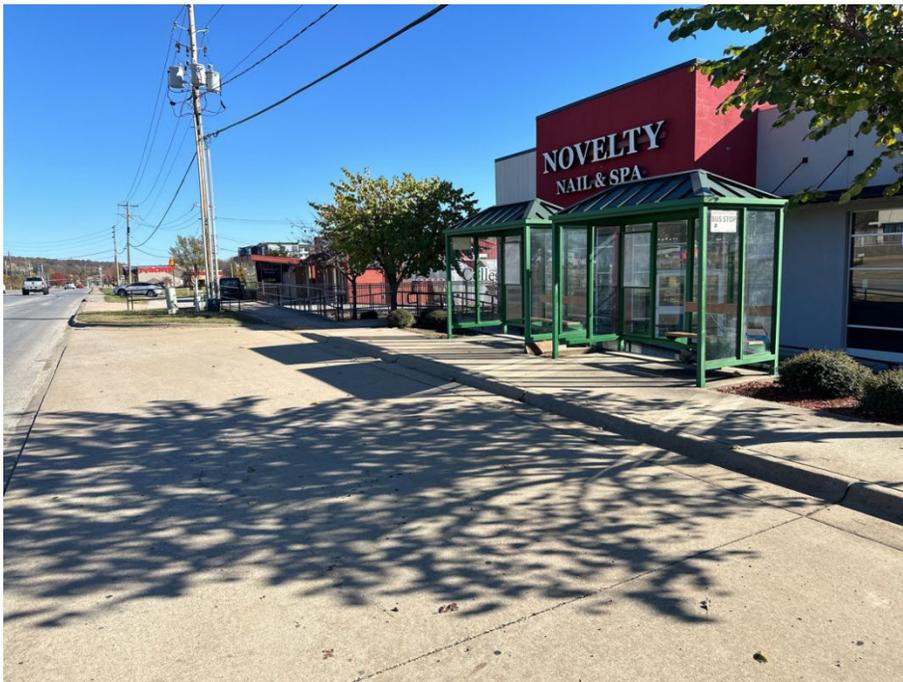
Moderate-ridership boarding stop located within a bus cutout adjacent to retail. The site includes dual shelters with benches, an accessible landing pad, and good sidewalk connectivity. A ramp and stairs provide access to nearby shops, supporting strong pedestrian flow. Lighting from nearby parking lots improves general visibility, though no in-shelter lighting is present. If bus cutouts are removed in the future, reconfiguration will be necessary to preserve safe and accessible boarding. Add in-shelter lighting for improved nighttime safety, and install designated micromobility parking to manage scooter clutter and maintain clear walkways.

Weekday Activity	24
Weekend Activity	6
Stop Position	Near-side
Adjacent Property Description	Mall/Shopping Center, Restaurant
Landing Area	Concrete
Sidewalk	Yes
Sidewalk Condition	4 = good - No immediate repair
Shelter	Yes
Seating	Yes
Lighting	Yes
Bicycle Parking	No
Scooter Parking	No

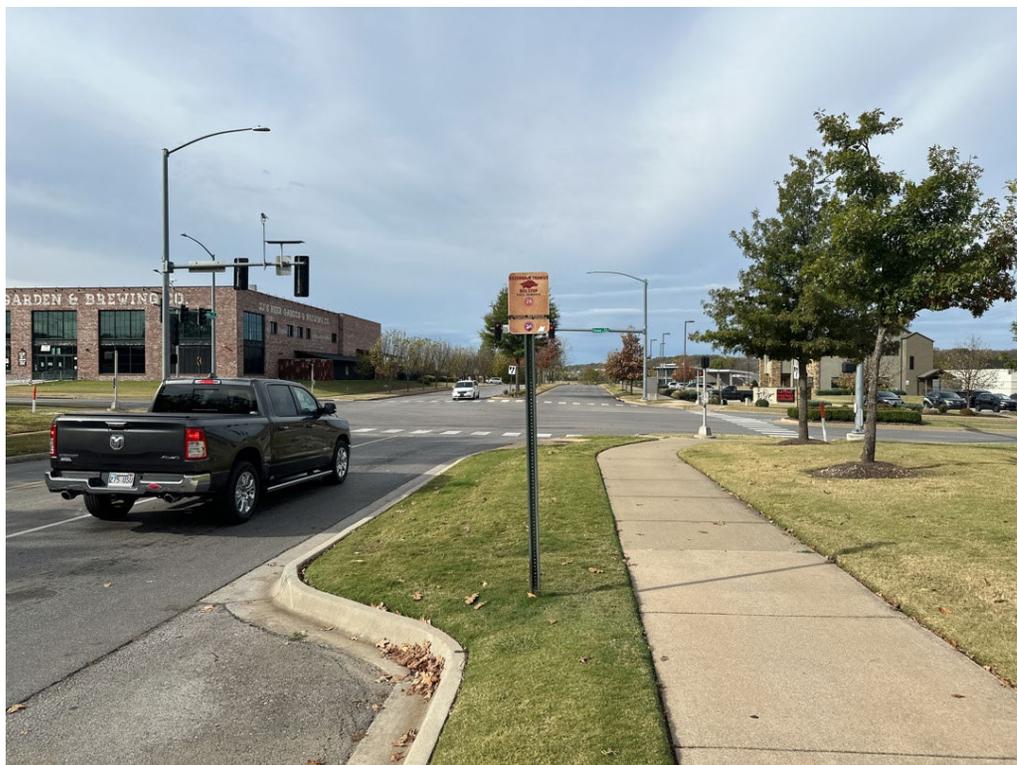
Low-ridership stop located near residential and commercial destinations. Signpost is in good condition and installed in grass between sidewalk and curb. No seating, shelter, or lighting present. Sidewalk is wide and level, but no dedicated landing pad is provided. Add a landing pad and shelter to improve waiting conditions. Add lighting to enhance safety and visibility.

Weekday Activity	17.7
Weekend Activity	9.6
Stop Position	Near-side
Adjacent Property Description	Apartment Building
Landing Area	Grass
Sidewalk	Yes
Sidewalk Condition	4 = good - No immediate repair
Shelter	No
Seating	No
Lighting	Yes
Bicycle Parking	No
Scooter Parking	No

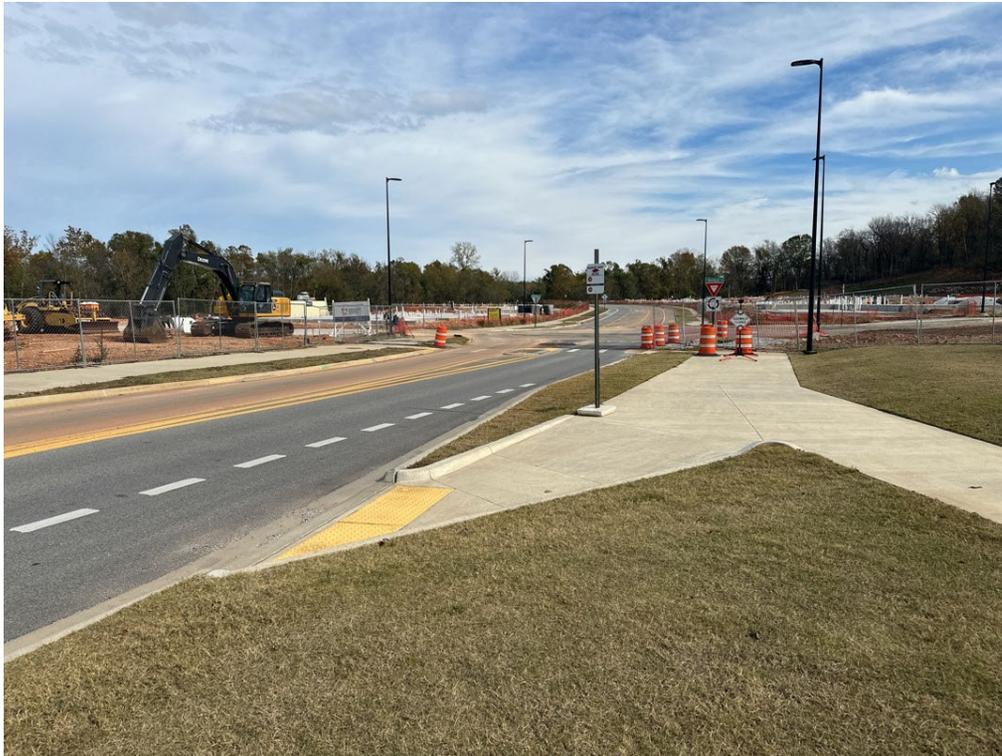
This stop is in new condition with sidewalk connection. No shelter or seating present. Signpost is mounted in a temporary concrete base. Consider installing a dedicated landing pad with shelter and seating if demand increases. Add in-shelter lighting if shelter is provided. Replace temporary sign base with permanent installation.

Weekday Activity	No Data Available
Weekend Activity	No Data Available
Stop Position	Near-side
Adjacent Property Description	School
Landing Area	Concrete
Sidewalk	Yes
Sidewalk Condition	5 = new or cosmetically excellent
Shelter	No
Seating	No
Lighting	Yes
Bicycle Parking	No
Scooter Parking	No

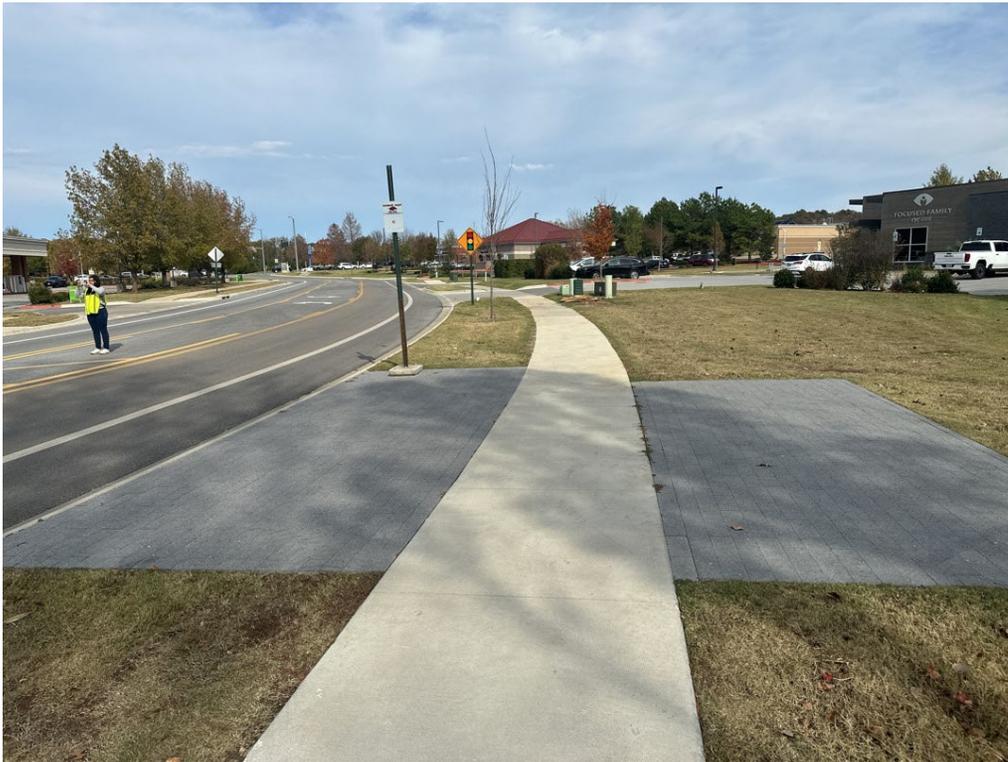
Moderate-ridership stop in excellent physical condition with dedicated landing pad, sidewalk connection, and clear boarding area. No shelter, seating, or lighting present. Signpost is mounted in a temporary concrete base. Consider installing a shelter and seating if demand increases. Add in-shelter lighting if shelter is provided. Replace temporary sign base with permanent installation.

Weekday Activity	24.1
Weekend Activity	5.7
Stop Position	Mid-block
Adjacent Property Description	Office Building
Landing Area	Pavers
Sidewalk	Yes
Sidewalk Condition	5 = new or cosmetically excellent
Shelter	No
Seating	No
Lighting	No
Bicycle Parking	No
Scooter Parking	No

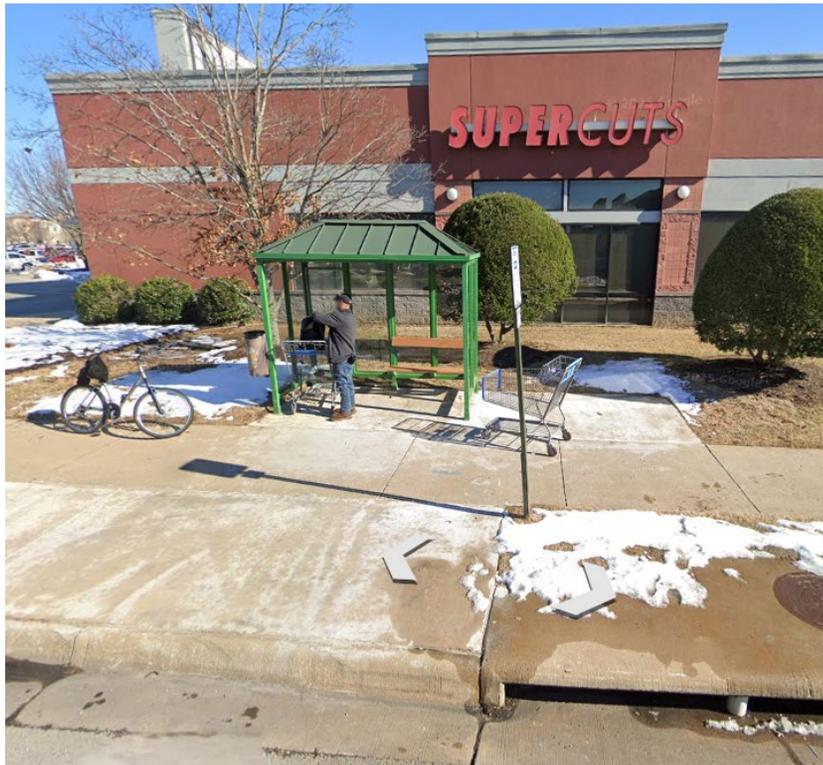
**STOP NAME: Walmart**

Low-ridership balanced stop in good condition with shelter, seating, and a dedicated boarding area. No visible in-shelter lighting. Shopping carts and bikes stored at the shelter suggest a need for micromobility and cart management. Add lighting if feasible and consider bike rack installation to reduce sidewalk clutter. Monitor for crowding or access issues.

Weekday Activity	14.1
Weekend Activity	12.8
Stop Position	Mid-block
Adjacent Property Description	Retail Store
Landing Area	Concrete
Sidewalk	Yes
Sidewalk Condition	4 = good - No immediate repair
Shelter	Yes
Seating	Yes
Lighting	Yes
Bicycle Parking	No
Scooter Parking	No

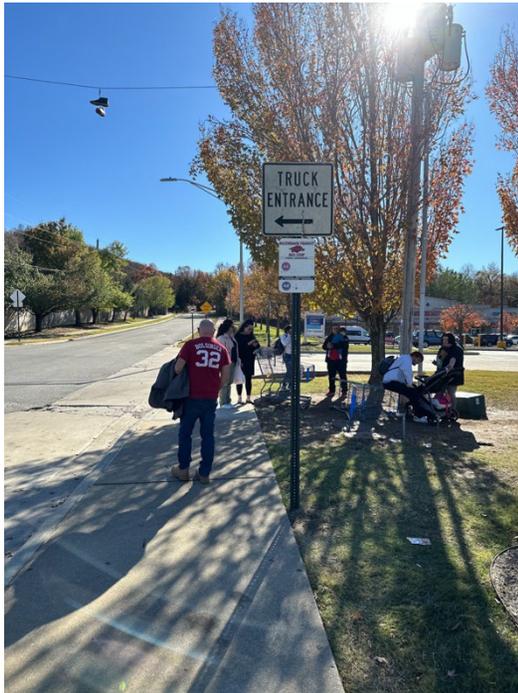
High-ridership stop adjacent to Walmart with sidewalk boarding area and multiple benches. No shelter present. Signpost shared with truck entrance signage may limit visibility. Consider installing a shelter and trash receptacle to accommodate volumes. Monitor for pedestrian conflicts with turning vehicles and shopping cart clutter.

Weekday Activity	78.1
Weekend Activity	33.4
Stop Position	Far-side
Adjacent Property Description	Supermarket
Landing Area	Concrete
Sidewalk	Yes
Sidewalk Condition	5 = new or cosmetically excellent
Shelter	No
Seating	No
Lighting	Yes
Bicycle Parking	No
Scooter Parking	No

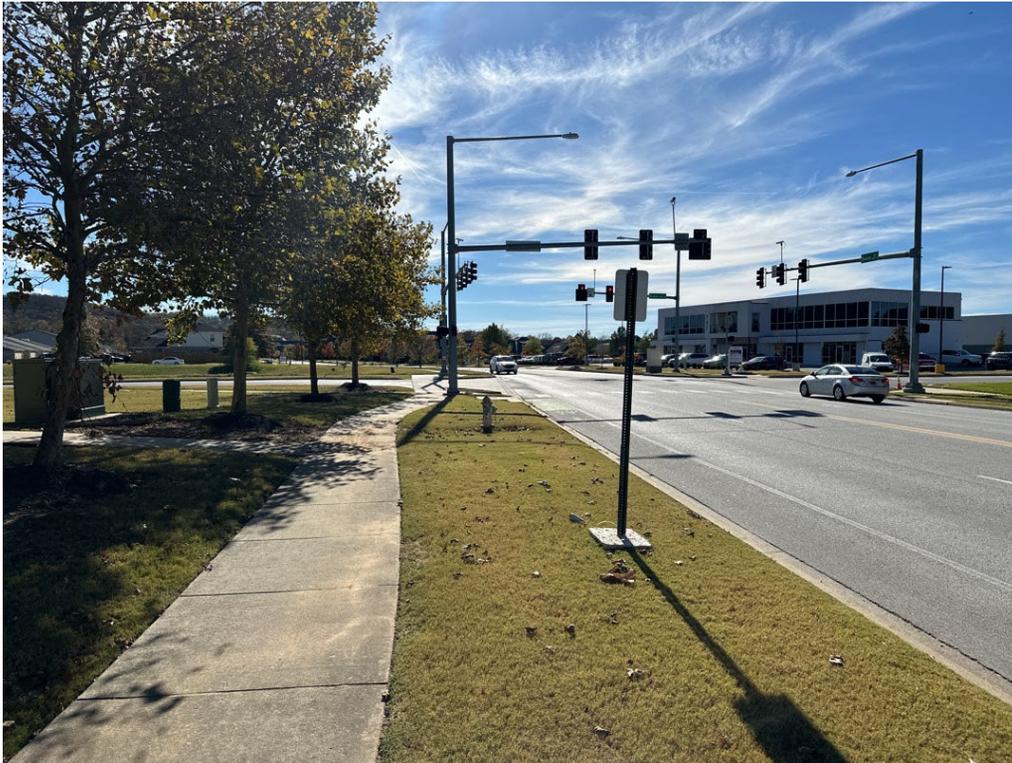
Low-ridership stop in good condition with sidewalk boarding area. Signpost is in turf buffer between sidewalk and curb, with no seating, shelter, or lighting. Located near retail but distant from primary activity centers. Add landing pad and consider bench and shelter if adjacent development intensifies.

Weekday Activity	7.6
Weekend Activity	1.7
Stop Position	Far-side
Adjacent Property Description	Mall/Shopping Center
Landing Area	Grass
Sidewalk	Yes
Sidewalk Condition	4 = good - No immediate repair
Shelter	No
Seating	No
Lighting	No
Bicycle Parking	Yes
Scooter Parking	No

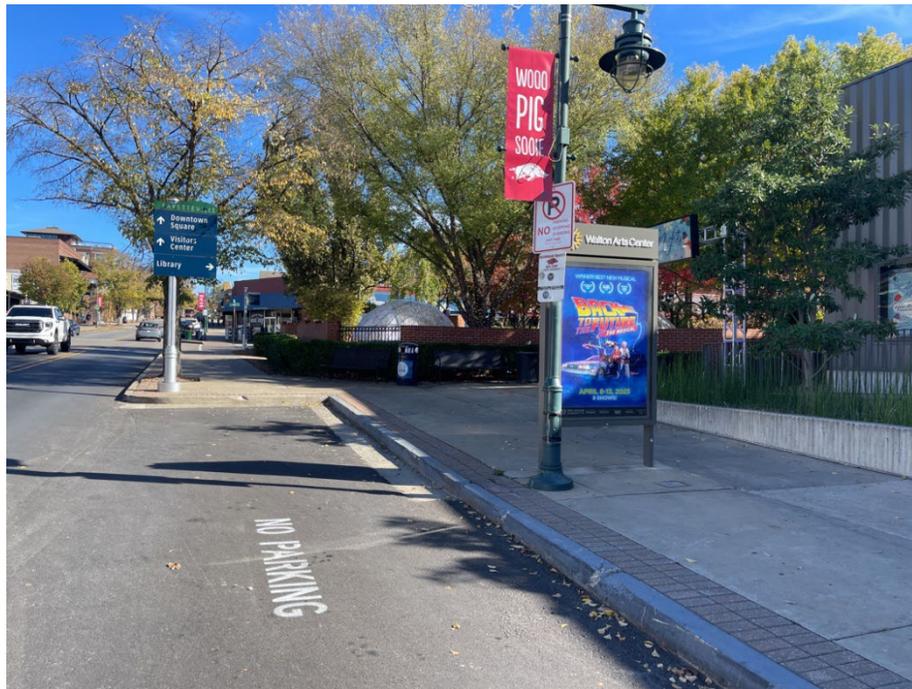
Low-ridership balanced stop located in a curb cutout in front of Walton Arts Center. Includes a bench, trash receptacle, and overhead lighting. No shelter is present, but an adjacent awning offers limited weather protection. The stop is well-integrated into the pedestrian zone with a direct sidewalk connection. A shelter is not currently needed but could be considered if ridership increases and site constraints are resolved. Monitor future changes to the cutout configuration before pursuing upgrades.

Weekday Activity	0.6
Weekend Activity	1.7
Stop Position	Near-side
Adjacent Property Description	Theater
Landing Area	Concrete, Pavers
Sidewalk	Yes
Sidewalk Condition	4 = good - No immediate repair
Shelter	No
Seating	Yes
Lighting	Yes
Bicycle Parking	No
Scooter Parking	No

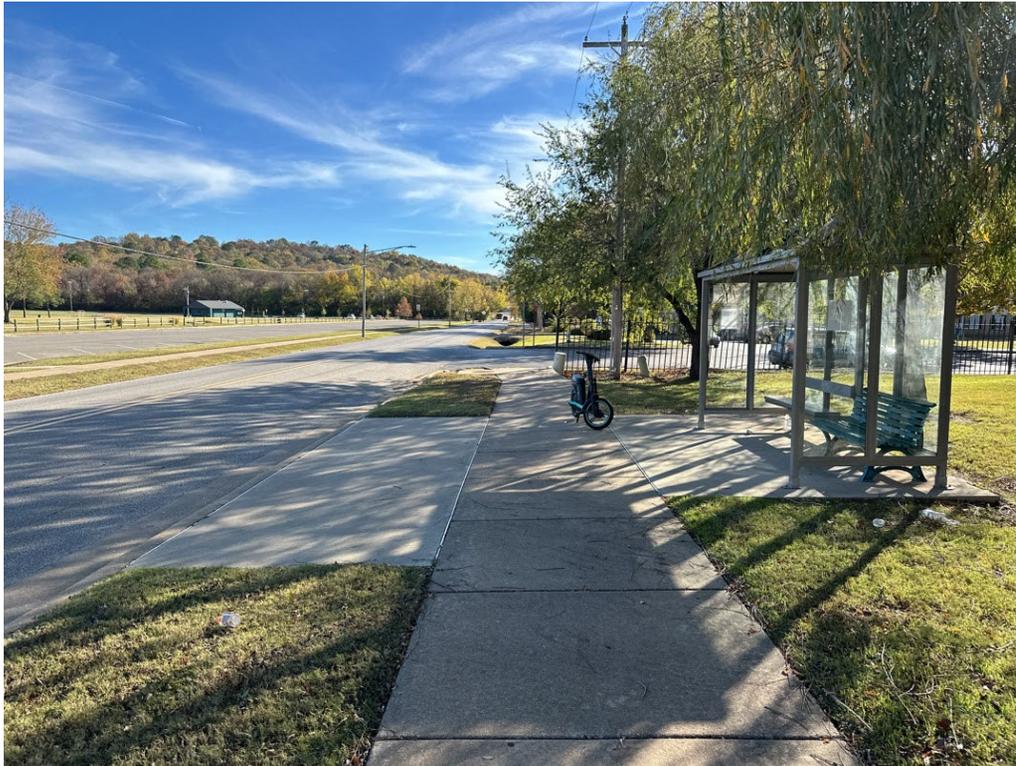
Low-ridership balanced stop in good condition with full shelter and seating on a concrete pad. No visible lighting. Located on a quiet roadway adjacent to a large open field. Shelter is partially obscured by overhanging trees, and some litter is present. Consider trimming vegetation, adding lighting, and monitoring usage before making further improvements.

Weekday Activity	9.3
Weekend Activity	1.3
Stop Position	Near-side
Adjacent Property Description	Apartment Building
Landing Area	Concrete
Sidewalk	Yes
Sidewalk Condition	3 = Fair - minor root uplifting and breaks
Shelter	Yes
Seating	Yes
Lighting	No
Bicycle Parking	No
Scooter Parking	No

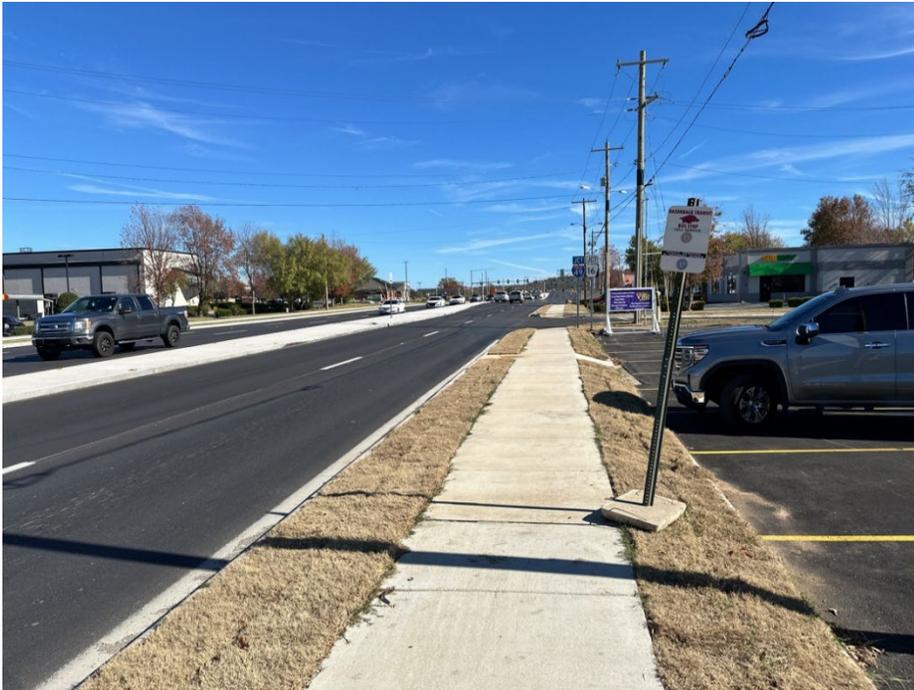
Low-ridership balanced stop with newly poured sidewalk but no designated landing pad. Signpost is leaning and mounted in a temporary concrete base. No shelter, seating, or lighting. Located along a high-speed arterial with limited pedestrian amenities. Consider straightening and permanently mounting the signpost, adding a landing pad, and monitoring ridership before adding further amenities.

Weekday Activity	14
Weekend Activity	4.6
Stop Position	Near-side
Adjacent Property Description	Retail Store
Landing Area	Grass, Uneven sod
Sidewalk	Yes
Sidewalk Condition	5 = new or cosmetically excellent
Shelter	No
Seating	No
Lighting	Yes
Bicycle Parking	No
Scooter Parking	No

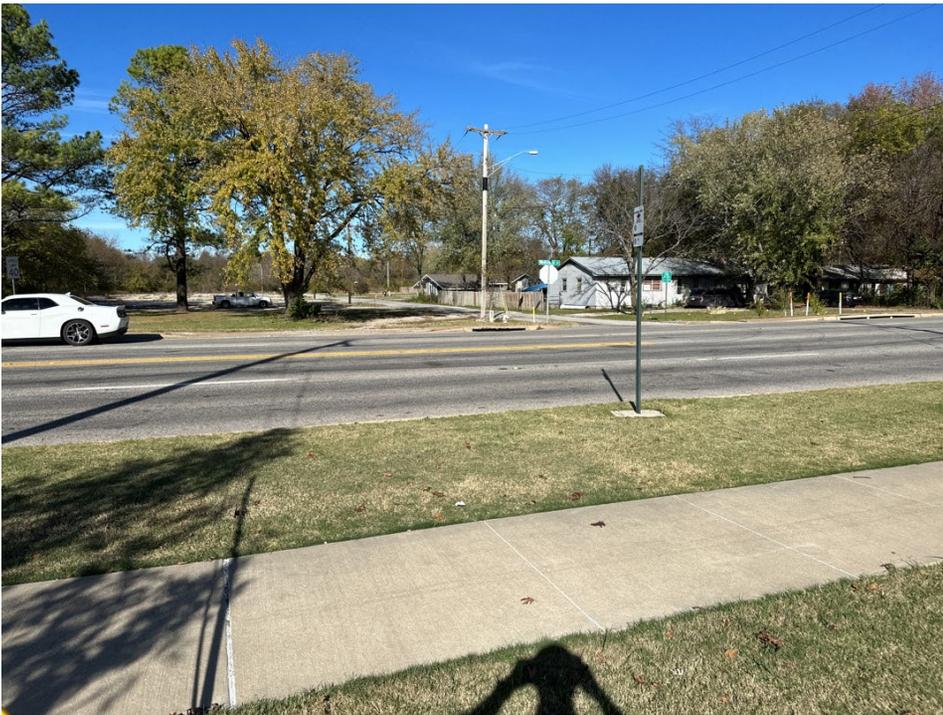
**STOP NAME: Wedington & Futral**

Low-ridership stop located near recent development activity. No defined landing pad is present, and the site lacks basic amenities such as seating, shelter, and dedicated lighting. Construct an accessible landing pad. Add lighting and install a bench to improve comfort and safety. Consider adding a shelter if future ridership increases. Coordinate with nearby developments to ensure stop upgrades are consistent with surrounding infrastructure improvements.

Weekday Activity	4.4
Weekend Activity	0.2
Stop Position	Far-side
Adjacent Property Description	Place of Worship
Landing Area	Grass
Sidewalk	Yes
Sidewalk Condition	3 = Fair - minor root uplifting and breaks
Shelter	No
Seating	No
Lighting	No
Bicycle Parking	No
Scooter Parking	No

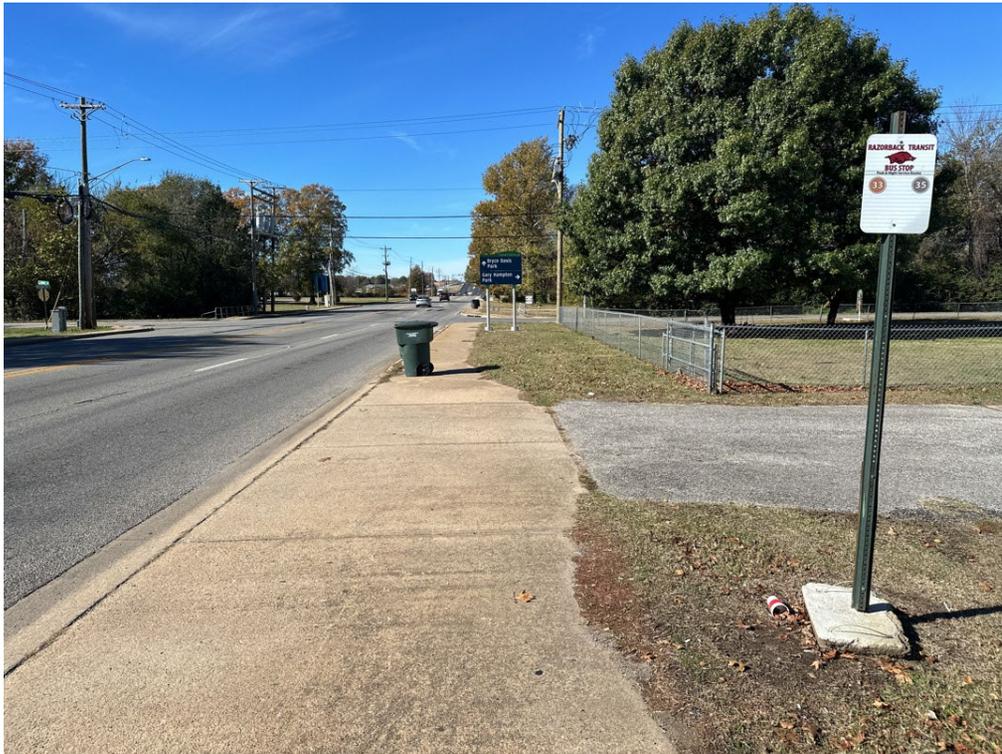
Low-ridership balanced stop with no shelter, seating, or lighting. Signpost is placed in a temporary concrete base and set back from the sidewalk, potentially limiting visibility. No designated landing pad, and the adjacent driveway interrupts the curb zone. Add a landing pad and permanently mount the signpost closer to the sidewalk edge. Monitor usage before considering additional amenities.

Weekday Activity	15.7
Weekend Activity	3.5
Stop Position	Near-side
Adjacent Property Description	Residence - detached, Retail Store
Landing Area	Concrete
Sidewalk	Yes
Sidewalk Condition	4 = good - No immediate repair
Shelter	No
Seating	No
Lighting	Yes
Bicycle Parking	No
Scooter Parking	No

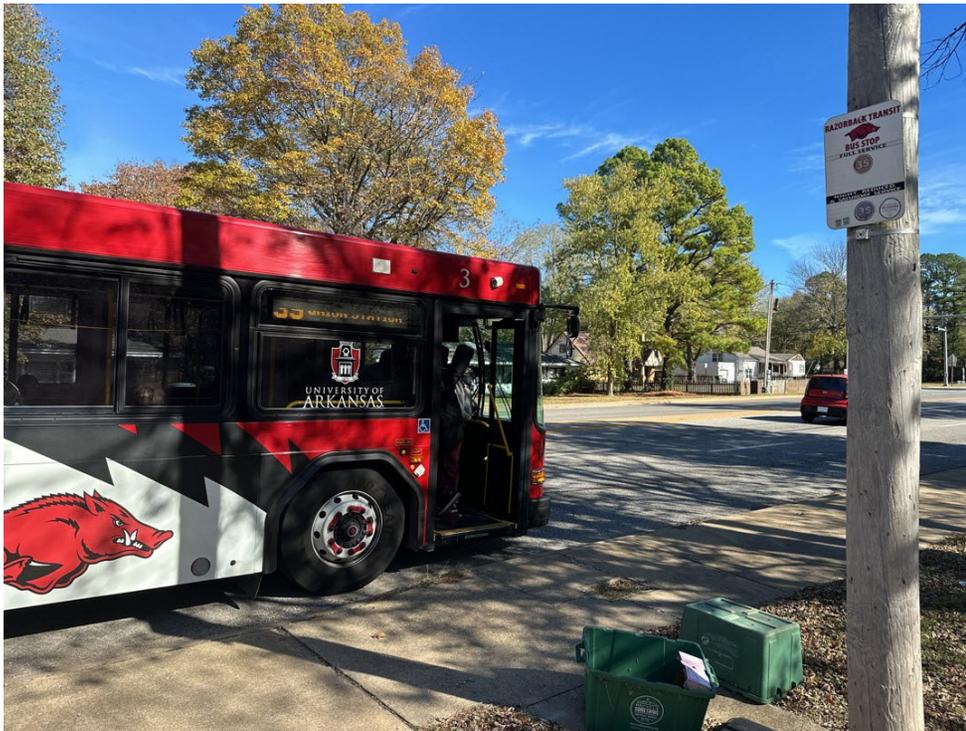
Low-ridership balanced stop with sign mounted on a utility pole, limiting visibility and flexibility. No shelter, seating, or lighting present. Landing area is sidewalk-only with no designated pad or curb ramp. Trash bins at the base of the pole may impede access. Relocate signpost to dedicated mount near curb. Add landing pad and evaluate for bench or trash receptacle based on usage.

Weekday Activity	12.4
Weekend Activity	2.3
Stop Position	Near-side
Adjacent Property Description	Residence - detached
Landing Area	Concrete
Sidewalk	Yes
Sidewalk Condition	2 = Poor Shape, some cracks or breaks
Shelter	No
Seating	No
Lighting	Yes
Bicycle Parking	No
Scooter Parking	No

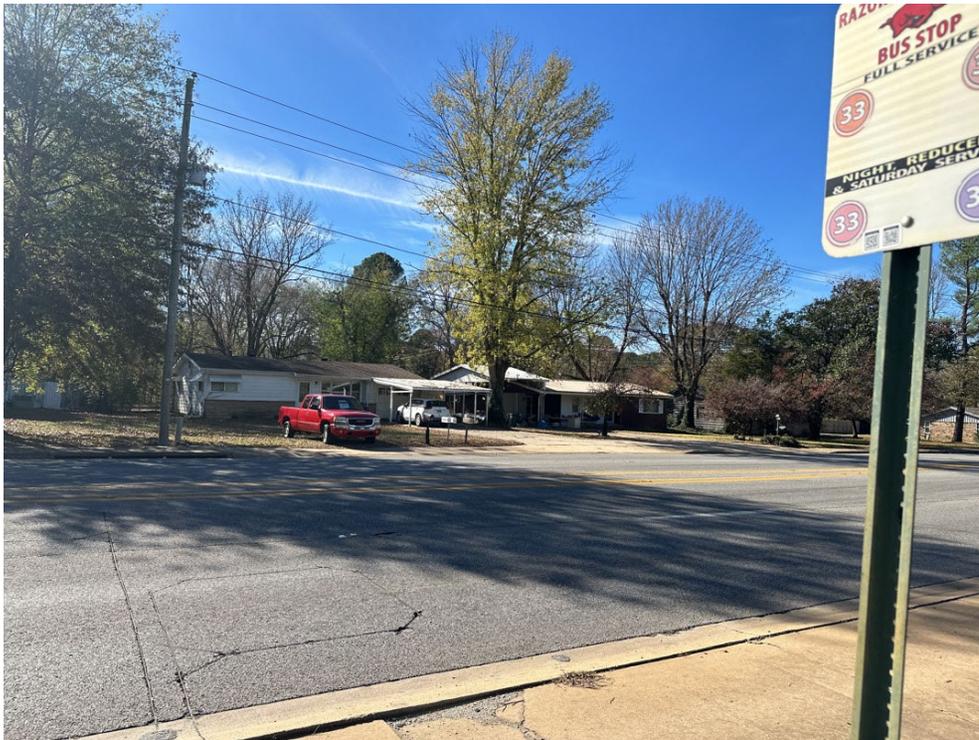
Moderate-ridership balanced stop with basic sidewalk boarding area. Signpost is set in a concrete base but lacks a defined landing pad. No shelter, seating, or lighting. Adjacent utility infrastructure and fencing limit space for upgrades. Add a landing pad and consider relocating sign closer to the curb for visibility and access. Evaluate seating only if usage increases.

Weekday Activity	23.4
Weekend Activity	2.7
Stop Position	Near-side
Adjacent Property Description	Residence - detached
Landing Area	Concrete
Sidewalk	Yes
Sidewalk Condition	2 = Poor Shape, some cracks or breaks
Shelter	No
Seating	No
Lighting	No
Bicycle Parking	No
Scooter Parking	No

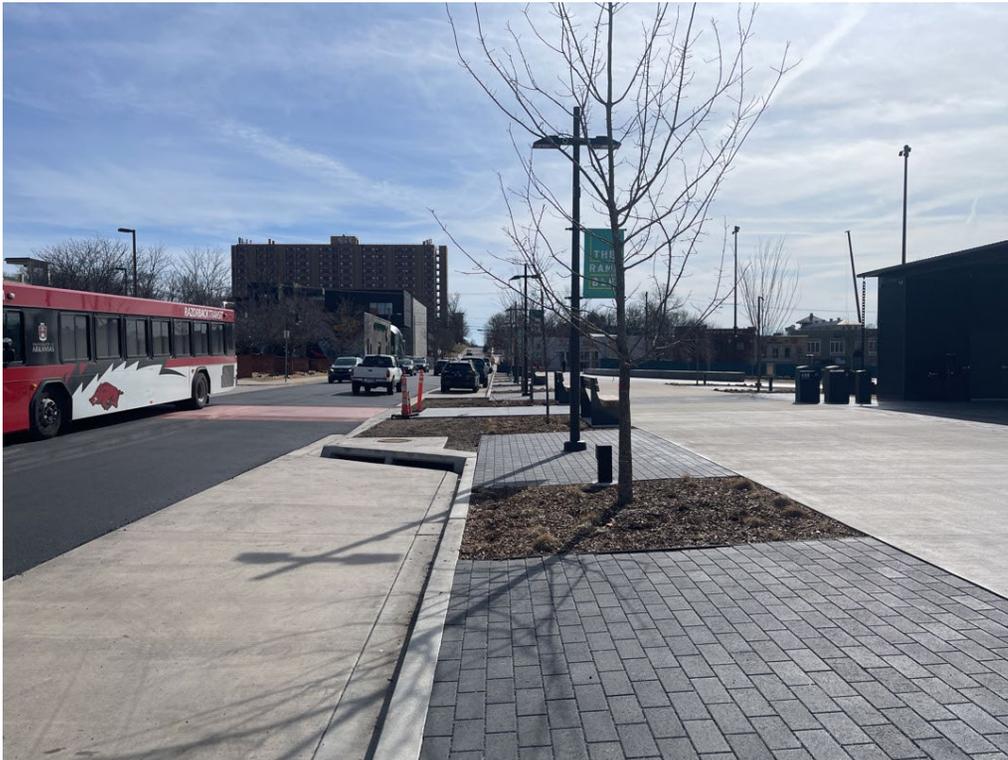
Low-ridership balanced stop in good condition with wide sidewalk and direct access to adjacent plaza. No seating, shelter, or lighting currently present. Signpost is freestanding and clearly visible. Stop is located mid-block near the Walton Arts Center and adjacent to a marked crosswalk. Consider adding a bench if usage increases. No further upgrades warranted at this time.

Weekday Activity	0.4
Weekend Activity	1
Stop Position	Mid-block
Adjacent Property Description	Walton Arts Center
Landing Area	Yes
Sidewalk	Yes
Sidewalk Condition	5 = new or cosmetically excellent
Shelter	No
Seating	No
Lighting	Street Lighting
Bicycle Parking	No
Scooter Parking	No

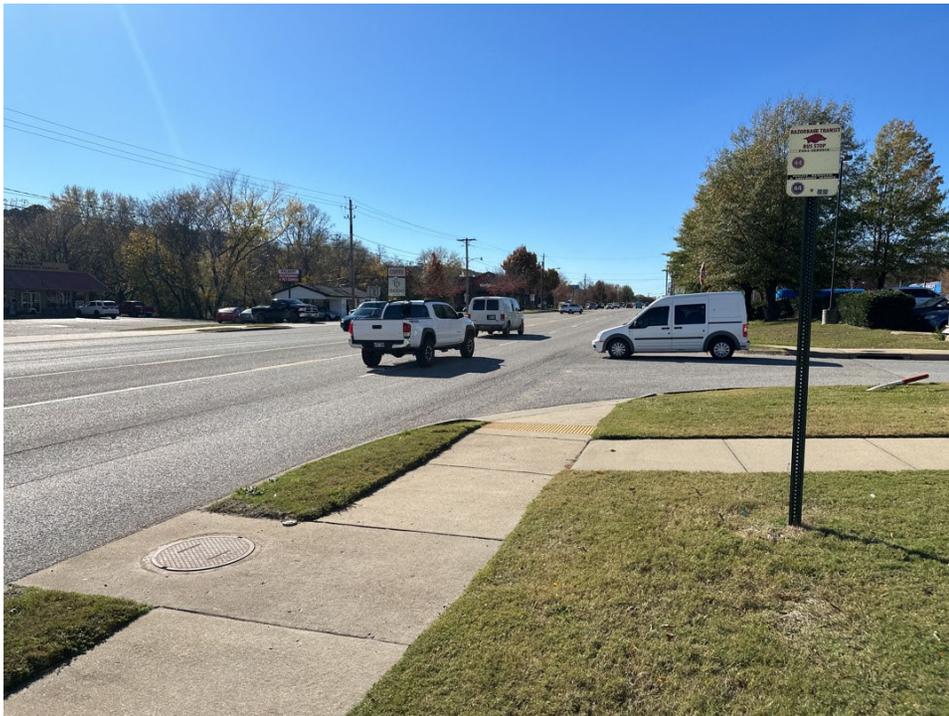
Low-ridership stop on a high-speed arterial with no shelter, seating, or lighting. Sign is located in grass between sidewalk and curb, with limited visibility due to grade and adjacent signage. Sidewalk and curb ramp are present, but no defined boarding area. Consider adding a landing pad, bench, and trash receptacle. Monitor for future changes in ridership or adjacent land use that may warrant further investment.

Weekday Activity	17.5
Weekend Activity	7.2
Stop Position	Near-side
Adjacent Property Description	Mall/Shopping Center
Landing Area	Concrete
Sidewalk	Yes
Sidewalk Condition	4 = good - No immediate repair
Shelter	No
Seating	No
Lighting	No
Bicycle Parking	No
Scooter Parking	No

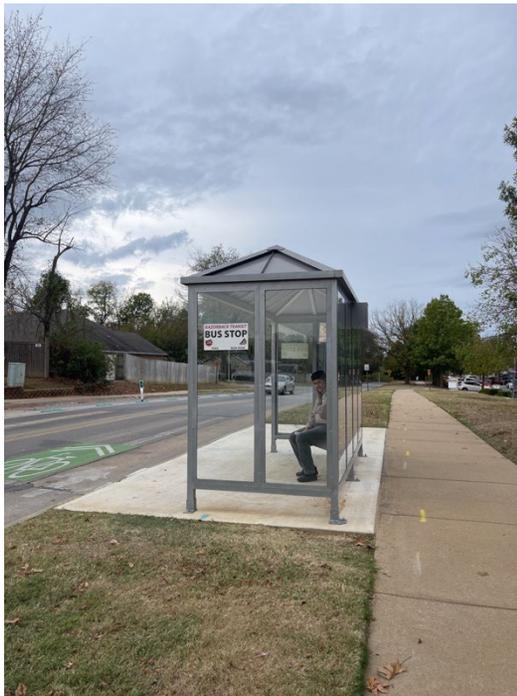
Low-ridership balanced stop in good condition with full shelter, seating, trash receptacle, lighting, and clear boarding area. Located adjacent to the Washington Regional Emergency Center with sidewalk and tactile ramps connecting to a marked crosswalk. Shelter has solar-powered lighting and is situated along a bike lane. Sign is mounted on its own pole but is in poor condition, replace sign.

Weekday Activity	17.3
Weekend Activity	6.2
Stop Position	Far-side
Adjacent Property Description	Hospital
Landing Area	Concrete
Sidewalk	Yes
Sidewalk Condition	5 = new or cosmetically excellent
Shelter	Yes
Seating	Yes
Lighting	Yes
Bicycle Parking	No
Scooter Parking	No

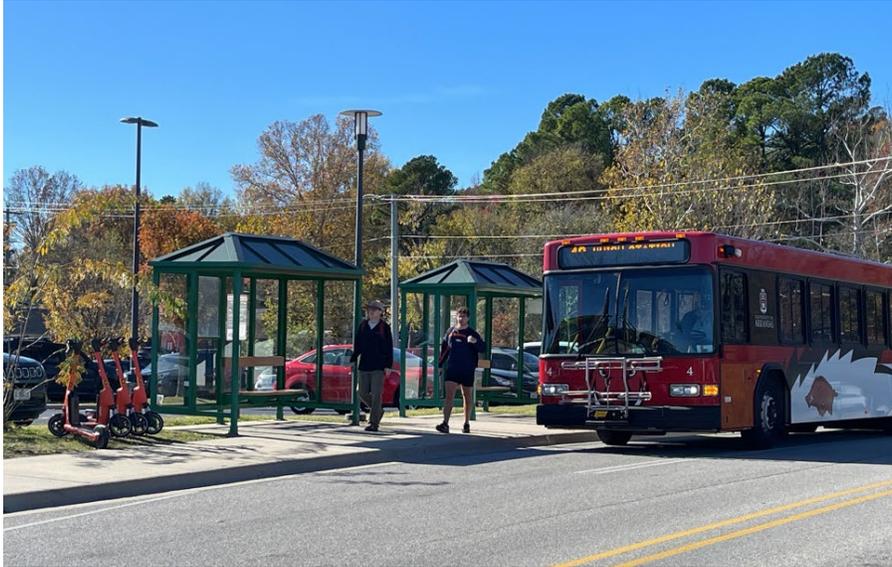
**Figure 11: Bus Stopped in Pull-off Lane at Lot 212 (Inbound) Bus Stop**

**Three stops** provide some form of dedicated space for bus boarding. Notably, Union Station functions as a terminal with a designated bus bay, and Lot 212 (Inbound) includes a partial pull-off lane marked by double white lines, approximately 8.5 feet wide. However, due to the limited width and adjacent travel lane intrusion, even this pull-off fails to fully remove the bus from the roadway, limiting its safety benefit.

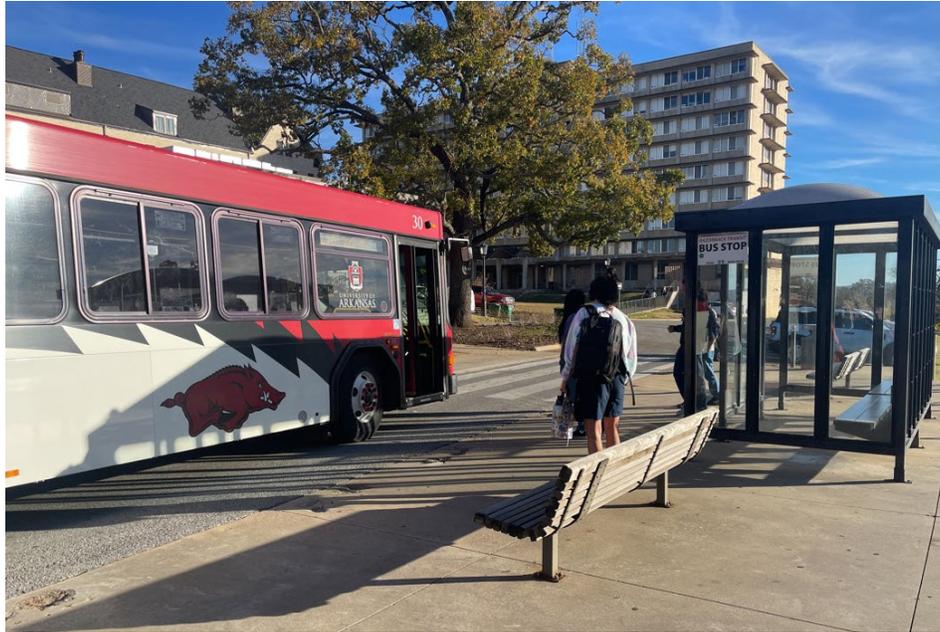
**Figure 12: Students Boarding at 1021 Dining Hall Bus Stop**

All Route 11 stops are connected to pedestrian paths via sidewalks that are at least 5 feet wide, which generally align with recommended minimum widths for accessible circulation. Nine of the ten stops feature sidewalks in good or new condition and appear to provide clear, navigable paths for most users. However, the sidewalk at the **1021 Dining Hall stop** is in visibly poor condition, with missing concrete creating uneven surfaces and depressions. These conditions may present significant barriers for individuals using mobility devices or anyone with balance challenges, making it difficult or unsafe to reach the stop on foot.

- **Access challenges** at stops like Nolan Richardson & Stadium Drive and 1021 Dining Hall, where uneven surfaces and worn concrete create hazards, particularly for passengers using mobility devices or with balance impairments.

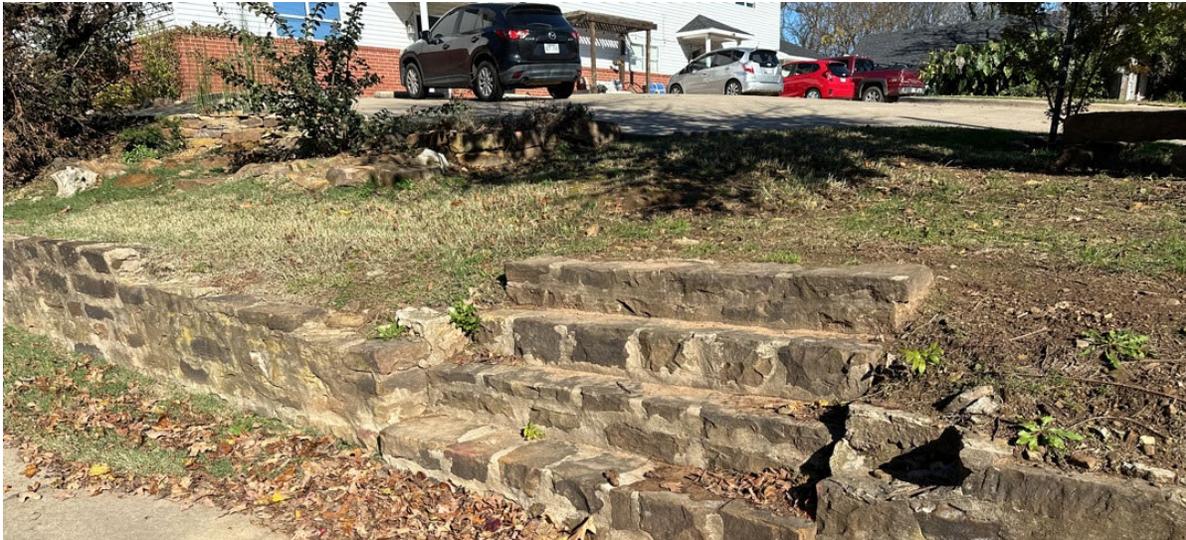
**Figure 15: Stone stairs at Hill & Stone (Outbound)**

- **Hill & Stone (Outbound)** and **Lot 322 East (Route 13)** have sidewalks in good condition, but their narrow width creates accessibility challenges.
- **Hill & Treadwell (Outbound & Inbound)** have sidewalks in fair condition, with obstructions and wear that reduce their functionality for riders with mobility impairments.
- **The Harmon Garage – Duncan Ave Entrance** stop is obstructed by tree roots, utility boxes, and poles, blocking the path to board and alight from the bus. This area is not accessible and requires immediate attention to ensure safe passage for all riders.

- **Inadequate landing locations** at key stops—especially **149525 – Hill & Stone (Outbound)** and **149527 – Hill & Treadwell (Outbound)**—create significant barriers for riders using mobility devices. Boarding often occurs from uneven surfaces, grass, or narrow sidewalks without a smooth transition to the bus.

Where roadway speed, visibility, and curb design present conflicts—such as at FHS or Hill & Stone—**revisiting stop placement or adding curb buffers may be necessary** to improve both rider safety and service reliability.

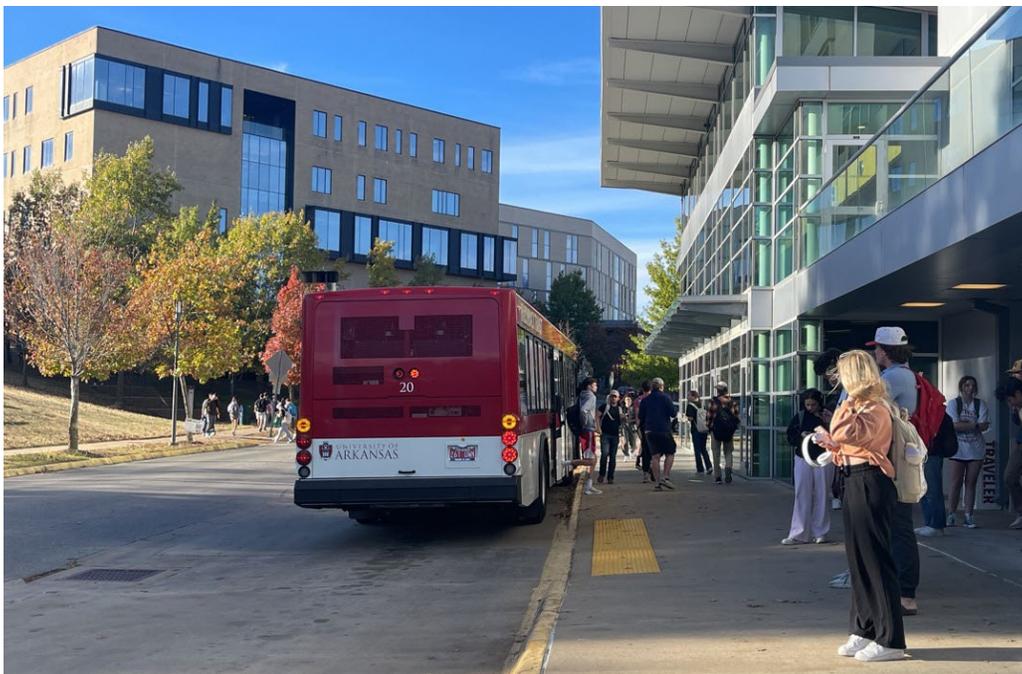
Figure 16: Bus stopped at Harmon Garage- Harmon Ave Entrance

At **149520 – Harmon Garage (Harmon Ave Entrance)**, no formal Razorback Transit signpost is present. However, the location includes visual cues such as a designated pull-off area, a wide pedestrian loading zone, and high foot traffic from nearby housing. While most frequent riders may recognize this as a stop, the **absence of dedicated signage limits clarity for new or occasional users**. Installing a clearly branded stop sign would improve wayfinding and reinforce transit visibility in this key corridor.

- **149520 – Harmon Garage (Harmon Ave Entrance)**, though lacking a formal signpost, includes a well-designed pull-off with a curb extension and wide pedestrian access zone.

Overall, **signage along Route 13 is generally consistent**, but minor upgrades—such as adding or replacing route number decals and formalizing signage at high-use locations—would improve the network’s usability.
