# **NORTHWEST ARKANSAS REGIONAL PLANNING COMMISSION**

## **RAZORBACK TRANSIT BUS STOP ENHANCEMENT PLAN**

October 2025 | FINAL

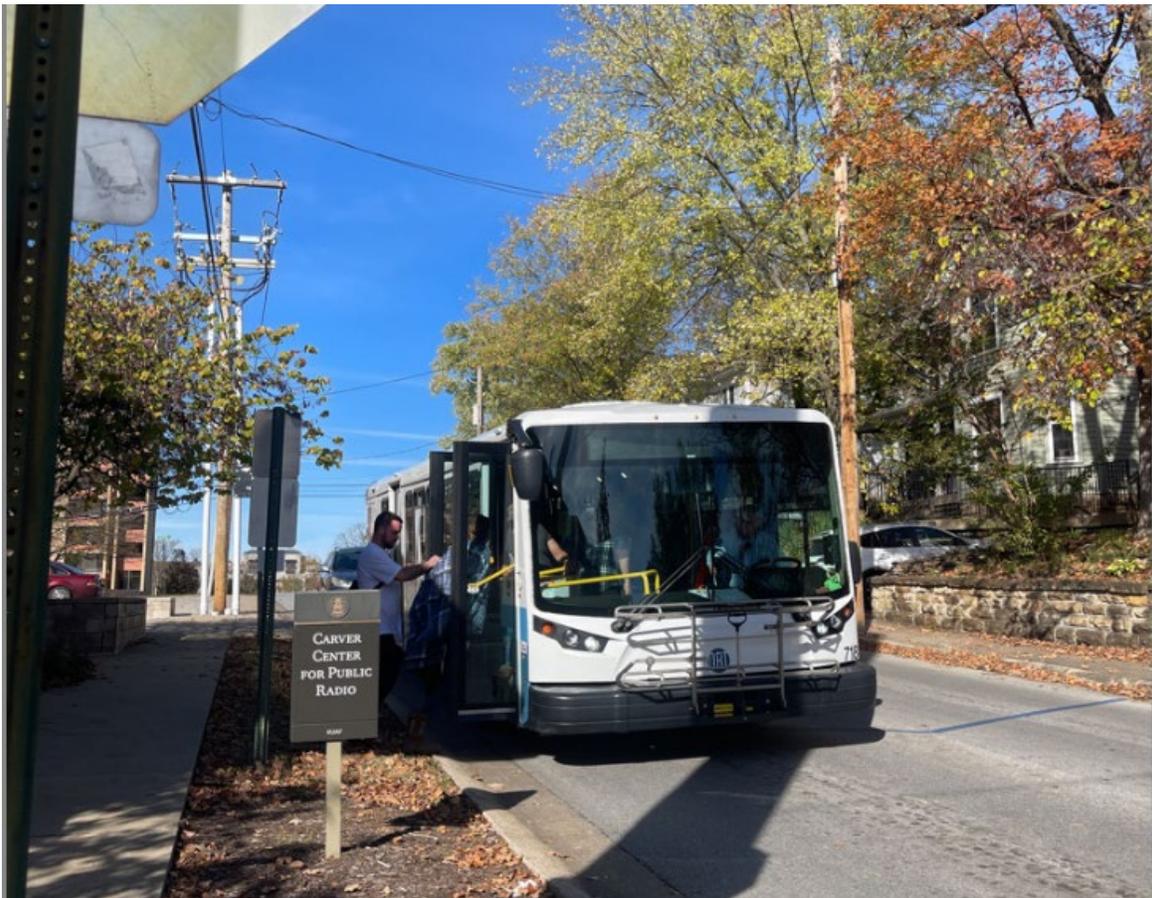
Figure 20: Bus stopped at Fayetteville Library/KUAF

- **149495 – Fayetteville Library/KUAF:** No loading platform; boarding occurs over a vegetated buffer shared with ORT.
- **149616 – UMC Garage:** Gravel and unpaved surface; not usable for riders with mobility devices.
- **149486 – Dickson & Locust** and **149496 – FHS:** Uneven surfaces or storm grates create barriers to safe boarding.

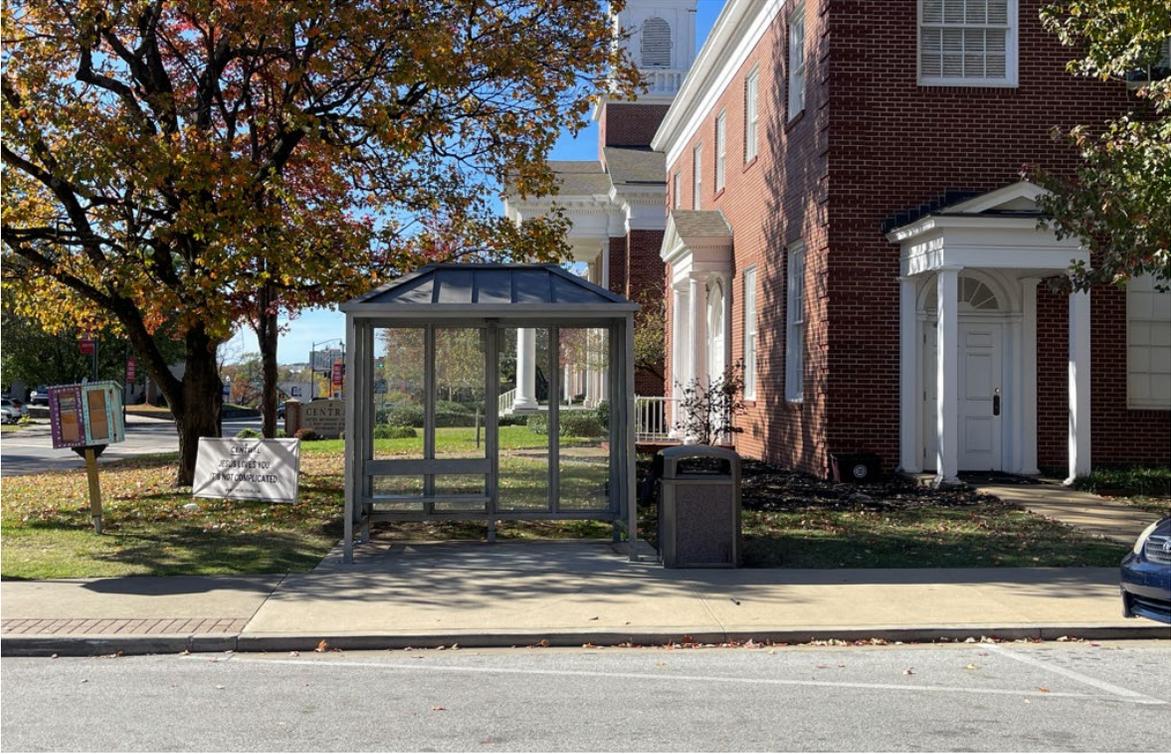
**Figure 21: Bus Stop at Highland & Dickson**

- **149522 – Highland & Dickson**: Stop is partially in a daylighting zone; passengers may board from the street if cars are parked.
- **149616 – UMC Garage**: Bus stops over a narrow bike lane, pushing the rear axle into the vehicular lane. Limited sight distance due to topography adds risk.

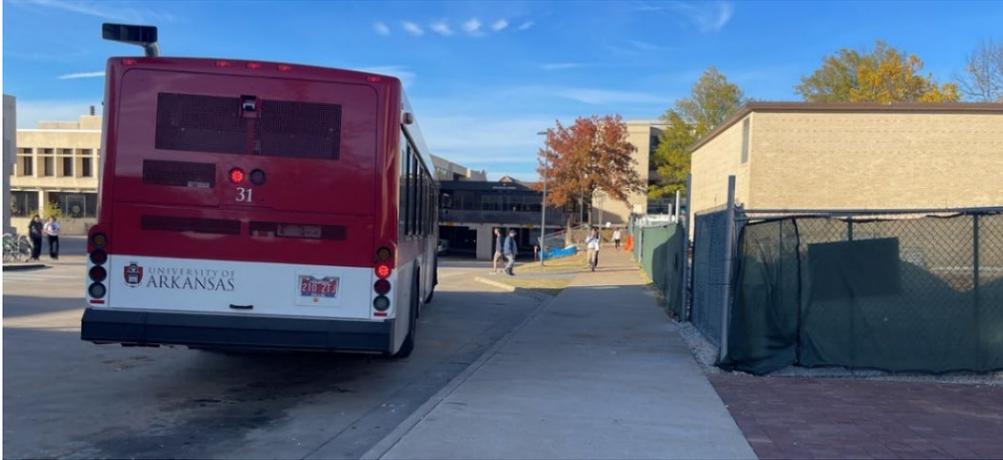
**Figure 26: Bus leaving the Fine Arts bus stop; November 2024.**

All stops except **149497 – Fine Arts** are equipped with Razorback Transit signage. Most signs include visible route information and are mounted on poles or integrated into shelter structures. The missing sign at Fine Arts is likely related to construction. Half of all signs are mounted to utility poles, which may reduce visibility or clarity.

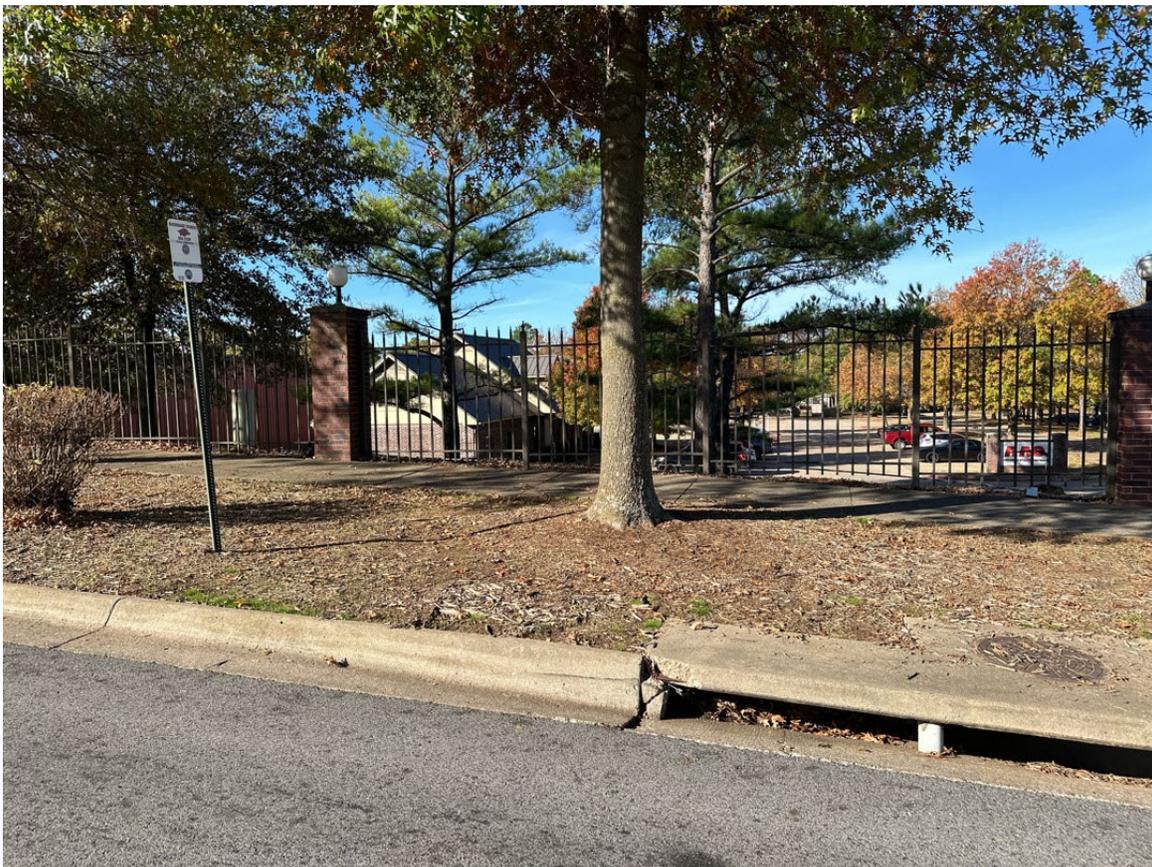
Figure 30: landing location garland & sycamore

- **149494 – Fair Park** and **149481 – Crafton Place**: Riders must board over storm drain inlets or from uneven surfaces, presenting challenges for mobility device users.
- **149506 – Garland & Sycamore (Inbound)**: Storm drain location and uneven pavement require boarding from sloped curb edge.
- **149499 – Food Science**: Shelter is 100–120 feet from the posted boarding zone, with no clear path between.

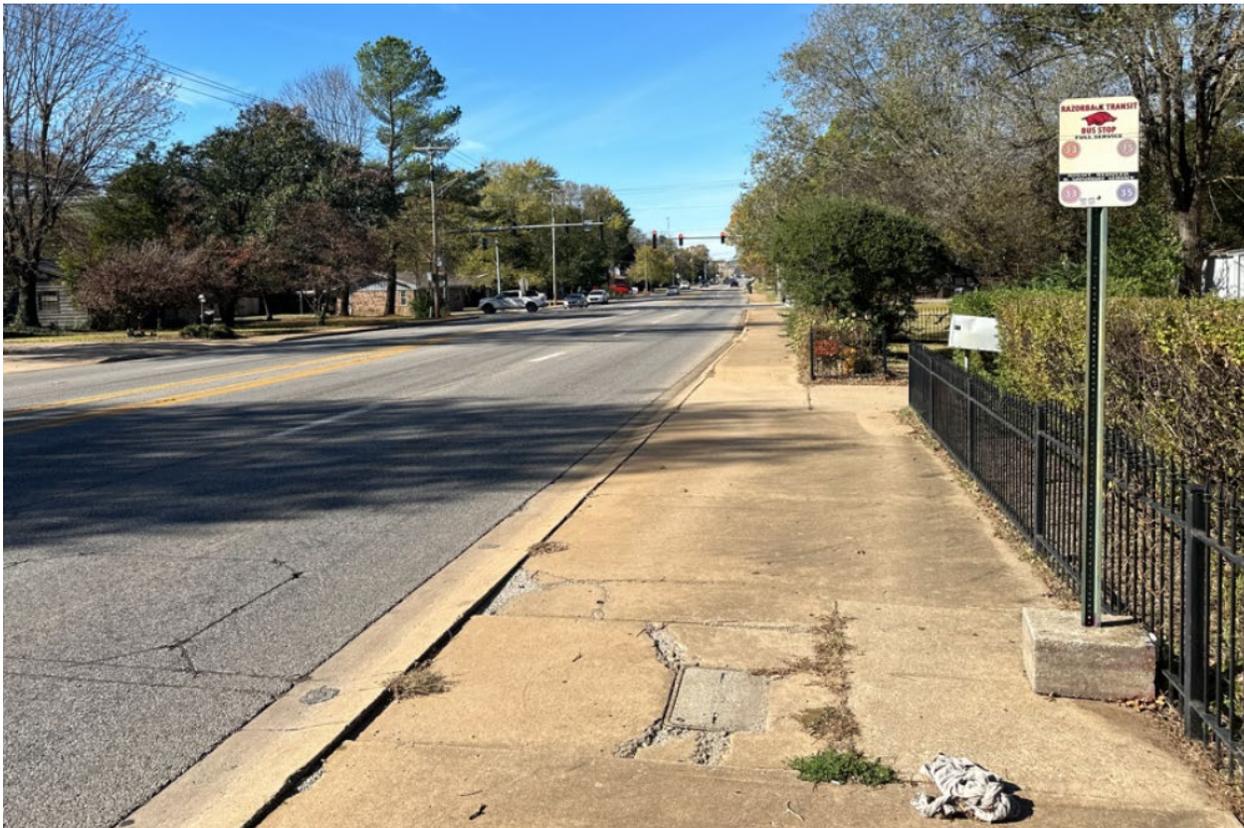
Figure 35: Wedington & Sang (Outbound)

- **Wedington & Sang (Outbound):** Boarding occurs on cracked and uplifted sidewalk. While the surface is wide, it is minimally accessible for mobility device users due to uneven conditions.
- **Porter & Lawson:** Riders must board from the travel lane, as no designated landing zone or curb platform is present.

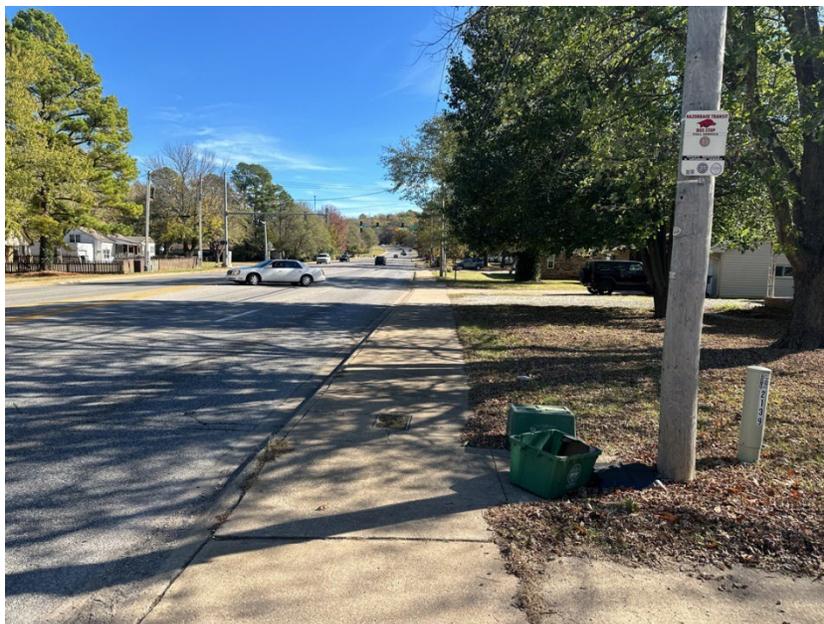
**Figure 42: Wedington & Sang inbound**

- **Wedington & Sang (Inbound):** Landing occurs next to a residential driveway, where a missing utility cover creates a tripping hazard.
- **149475 – Chamberland Square:** Gravel shoulder serves as the landing surface. It is uneven, unpaved, and unconnected to any accessible path. Located near a highway on-ramp with high-speed traffic, this configuration is especially unsafe.

These boarding surfaces fail to meet ADA accessibility standards and increase the likelihood of slips, trips, or falls.

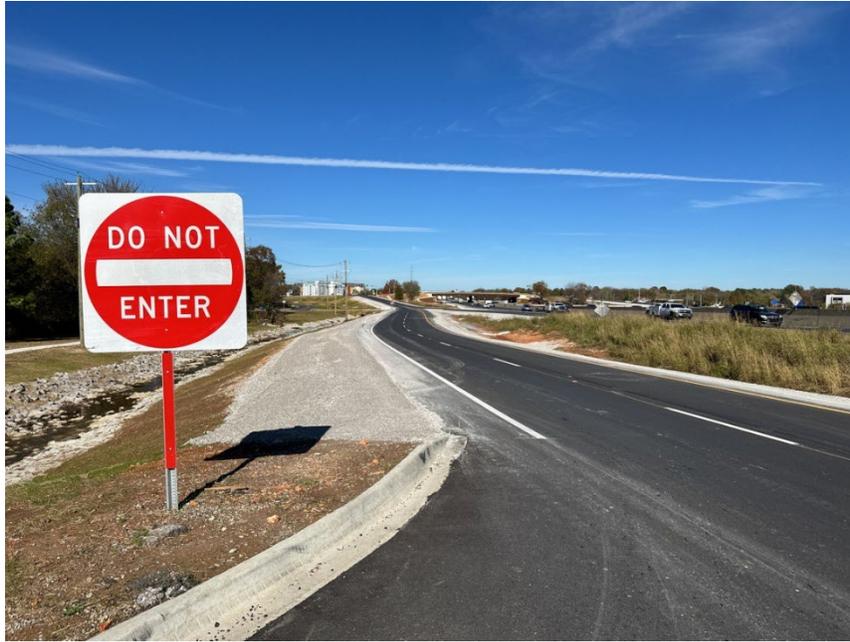
**Figure 43: Chamberland Square**

**Chamberland Square:** This stop is located along N Shiloh Dr, a one way frontage street that recently underwent reconstruction that added a southbound ramp onto I-49. The landing for this stop is a gravel shoulder. This landing is inaccessible because it is an uneven surface and not connected to an accessible path. Its proximity to the high speed, high volume road and the on ramp further makes this landing unsafe for passengers.

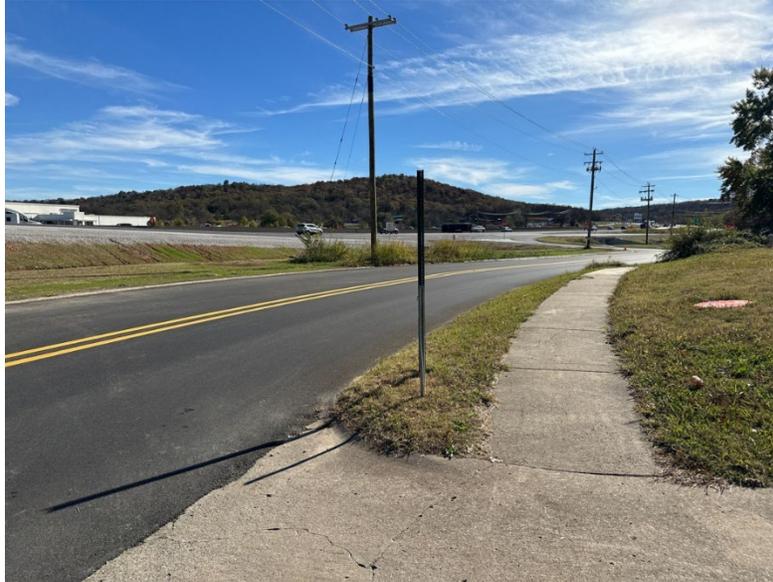
**Figure 44: Jefferson Lines**

- **Chamberland Square** and **Jefferson Lines**: No bus stop signage observed. Chamberland Square may have been affected by nearby roadway construction.

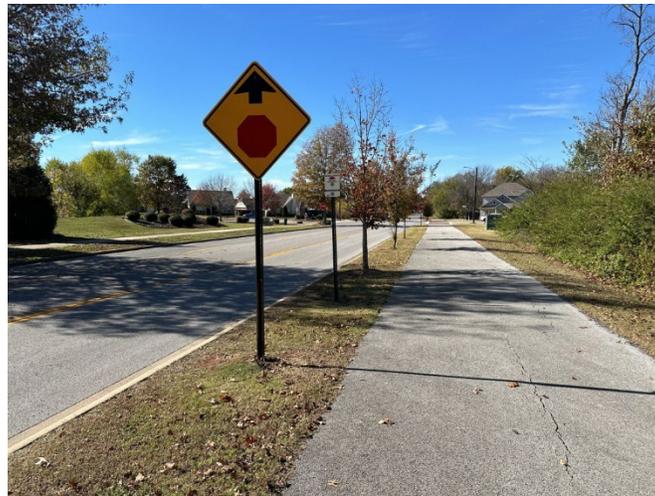
**Figure 45: Mountain Ranch outbound**

**Mountain Ranch (Outbound)**: While there is signage with route information at this stop, a W3-1 “Stop Ahead” warning sign obscures the view for the bus stop sign.

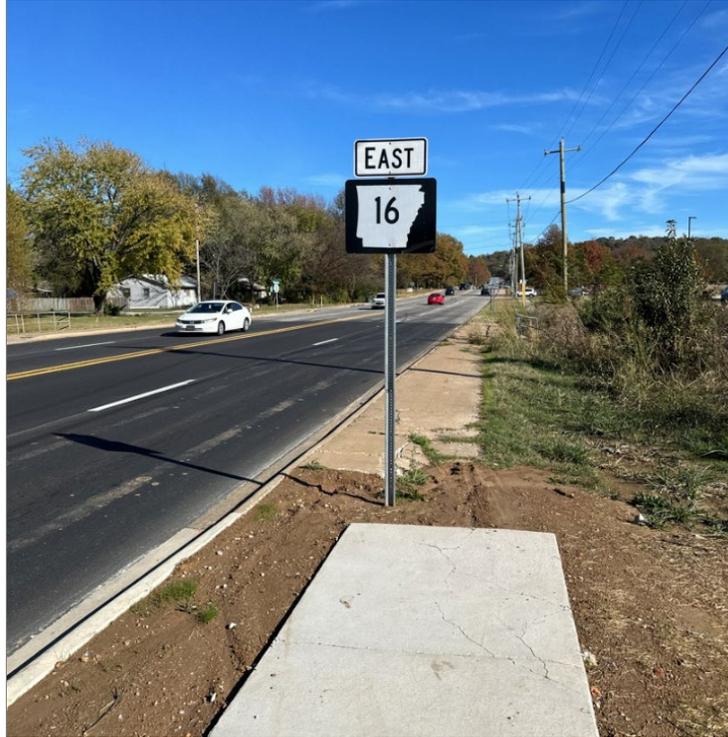
**Figure 46 - Wedington and Futral**

**Wedington & Futral:** The sidewalk connecting this stop to the existing sidewalk along Wedington is discontinued.

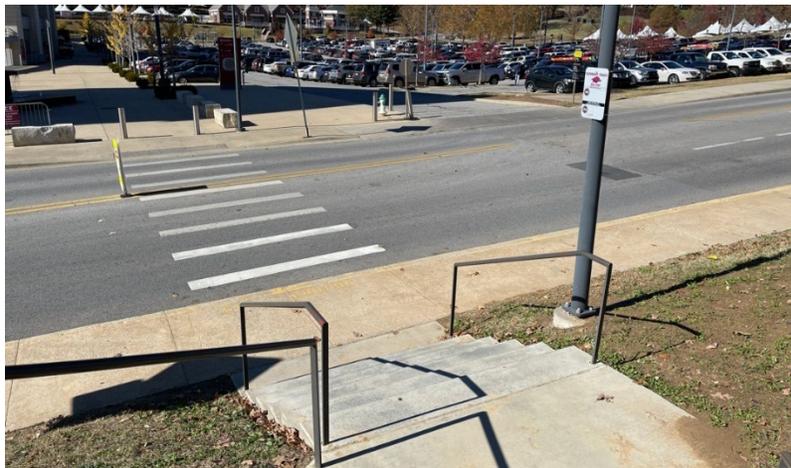
Figure 49 - St. Pete's

- **Saint Pete's:** Positioned on a frontage road near an I-49 merge ramp, this stop has no clear waiting zone and requires passengers to traverse grass, drainage ditches, or pavement transitions in an environment with poor visibility and high-speed traffic.

**Saint Pete's:** The landing location for this stop is a driveway entrance along Futtrall Dr, a frontage road with ramp access to I-49. Positioned just before the merge point, the stop is adjacent to high-speed, high-volume traffic. Passengers wait either in the driveway, on an adjacent grass strip near the sign, or on a sidewalk set back from the roadway—where visibility to approaching drivers is limited. A parallel drainage ditch further restricts access, requiring users to traverse uneven ground to reach the stop. These combined conditions—limited visibility, poor access, and exposure to fast-moving traffic—create a high-risk environment for boarding passengers.

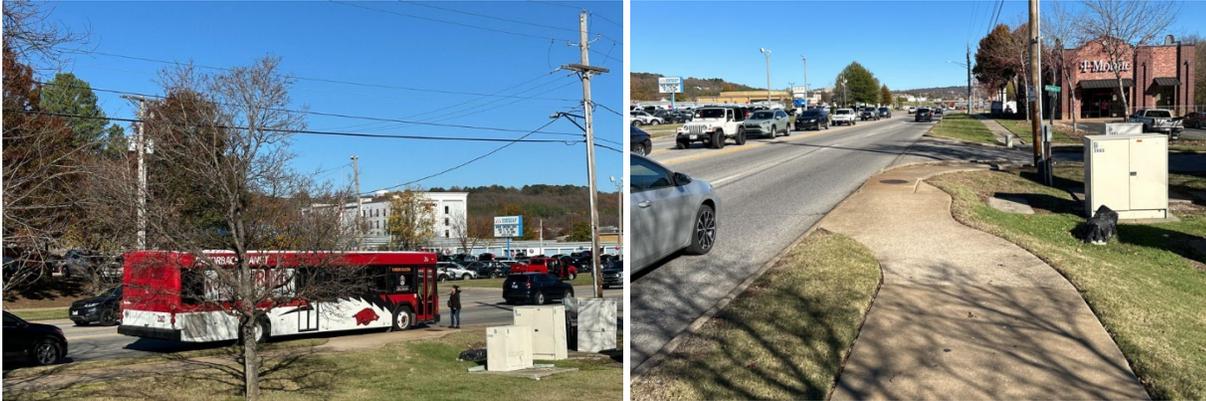
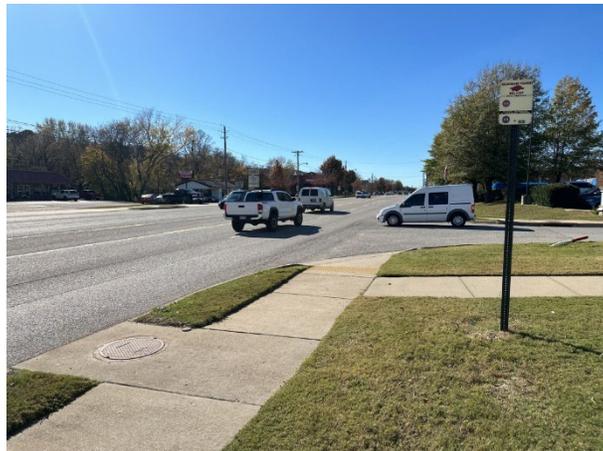
**Figure 50 - MLK and Farmers Dr**

**MLK & Farmers Dr and Westgate Shopping Center:** The landing location for these stops are adjacent but require passengers to step over a drain inlet to board. The proximity of the sidewalk/landing area to a high-speed, high-volume road coupled with the inaccessible landing makes these landings unsafe.

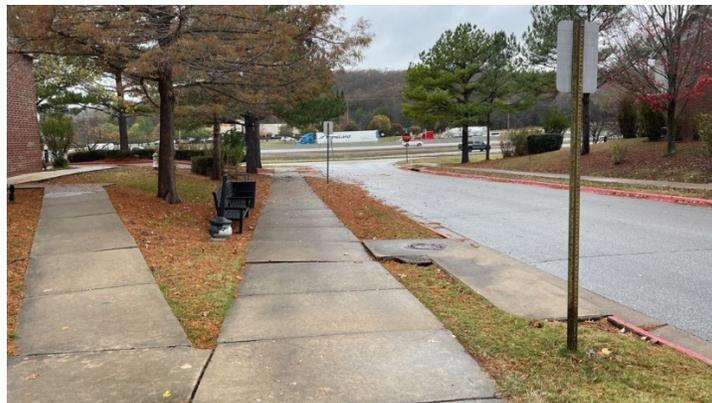
**Southern View:** The landing area requires passengers to board via a storm drain inlet adjacent to the sidewalk, necessitating a step over the drainage structure. The surrounding concrete is severely uplifted and deteriorated, creating an uneven surface that is not ADA-compliant and poses significant barriers for users with mobility devices.

**Southern View** – While this stop has a sidewalk connected that is at least five feet, it was identified to be in hazardous condition as there is major root uplifting, breaks, and cracking.

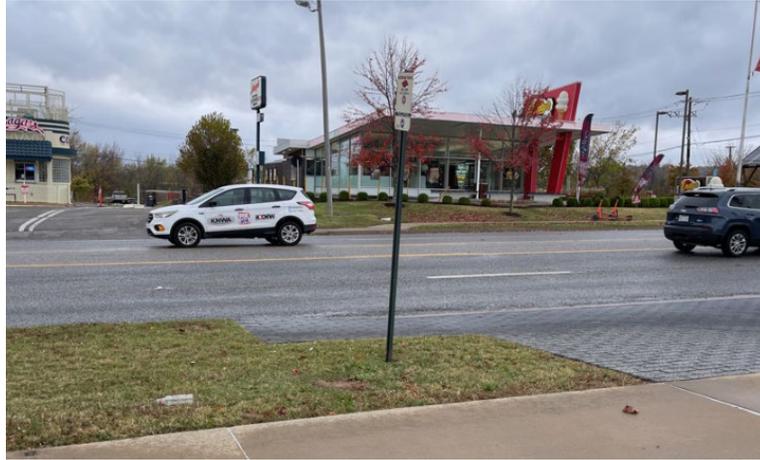
**Figure 51 - Lot 232**

**Lot 232:** The landing location for this stop is a driveway entrance to a parking lot. Passengers typically wait on the sidewalk, adjacent grass, or within the driveway itself. Due to the grade change, boarding occurs from street level, which presents challenges for accessibility and introduces potential conflicts with turning vehicles.

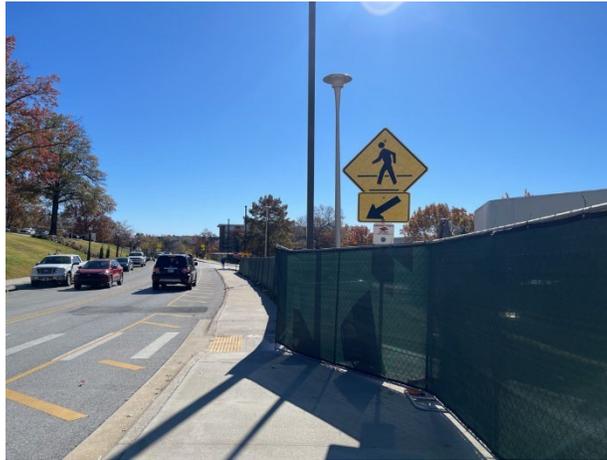
**Figure 52 - HPER Stop**

**HPER:** Signage for this stop is posted on a pedestrian crossing sign (W11-2 & W16-7PL). Construction for the adjacent HPER building was underway November 2024 which blocked visibility of posted routes.

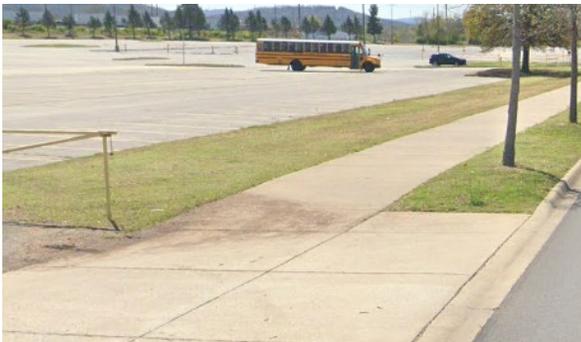
**Baum Stadium (Outbound & Inbound)** – While these stops have a sidewalks connected to them that are at least 5 feet, they have identified to be in fair condition as there is minor root uplifting and breaks, minor cracking. In addition, during rain events, sections of the sidewalk leading up to the stop will flood resulting in standing water making it impassable for users, especially those with mobility issues.
